BASCD Trainers' Pack for Caries Prevalence Studies

Updated: June 2014

*for UK Training & Calibration
exercise for the Deciduous Dentition*

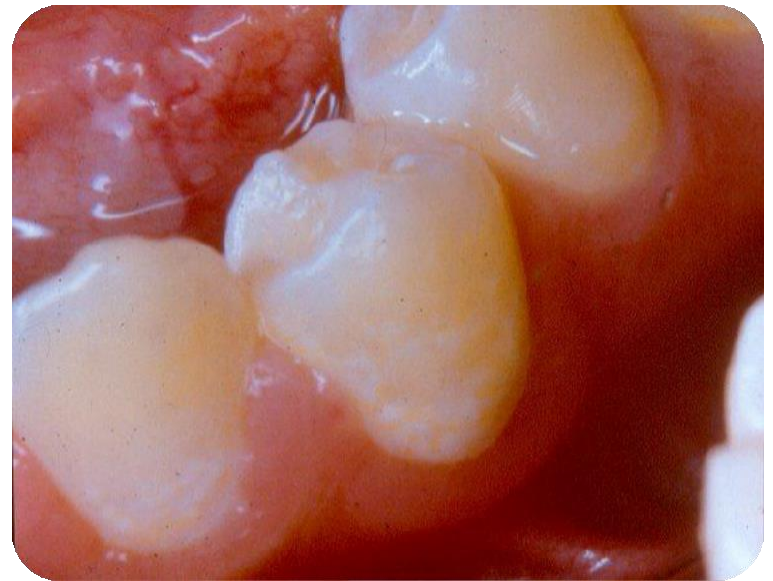
- **LL3 and LL4 –buccal surfaces of these teeth covered with plaque**
- **Visibility is obscured**
- **Therefore, plaque should be gently removed with the blunt ball-ended probe.**

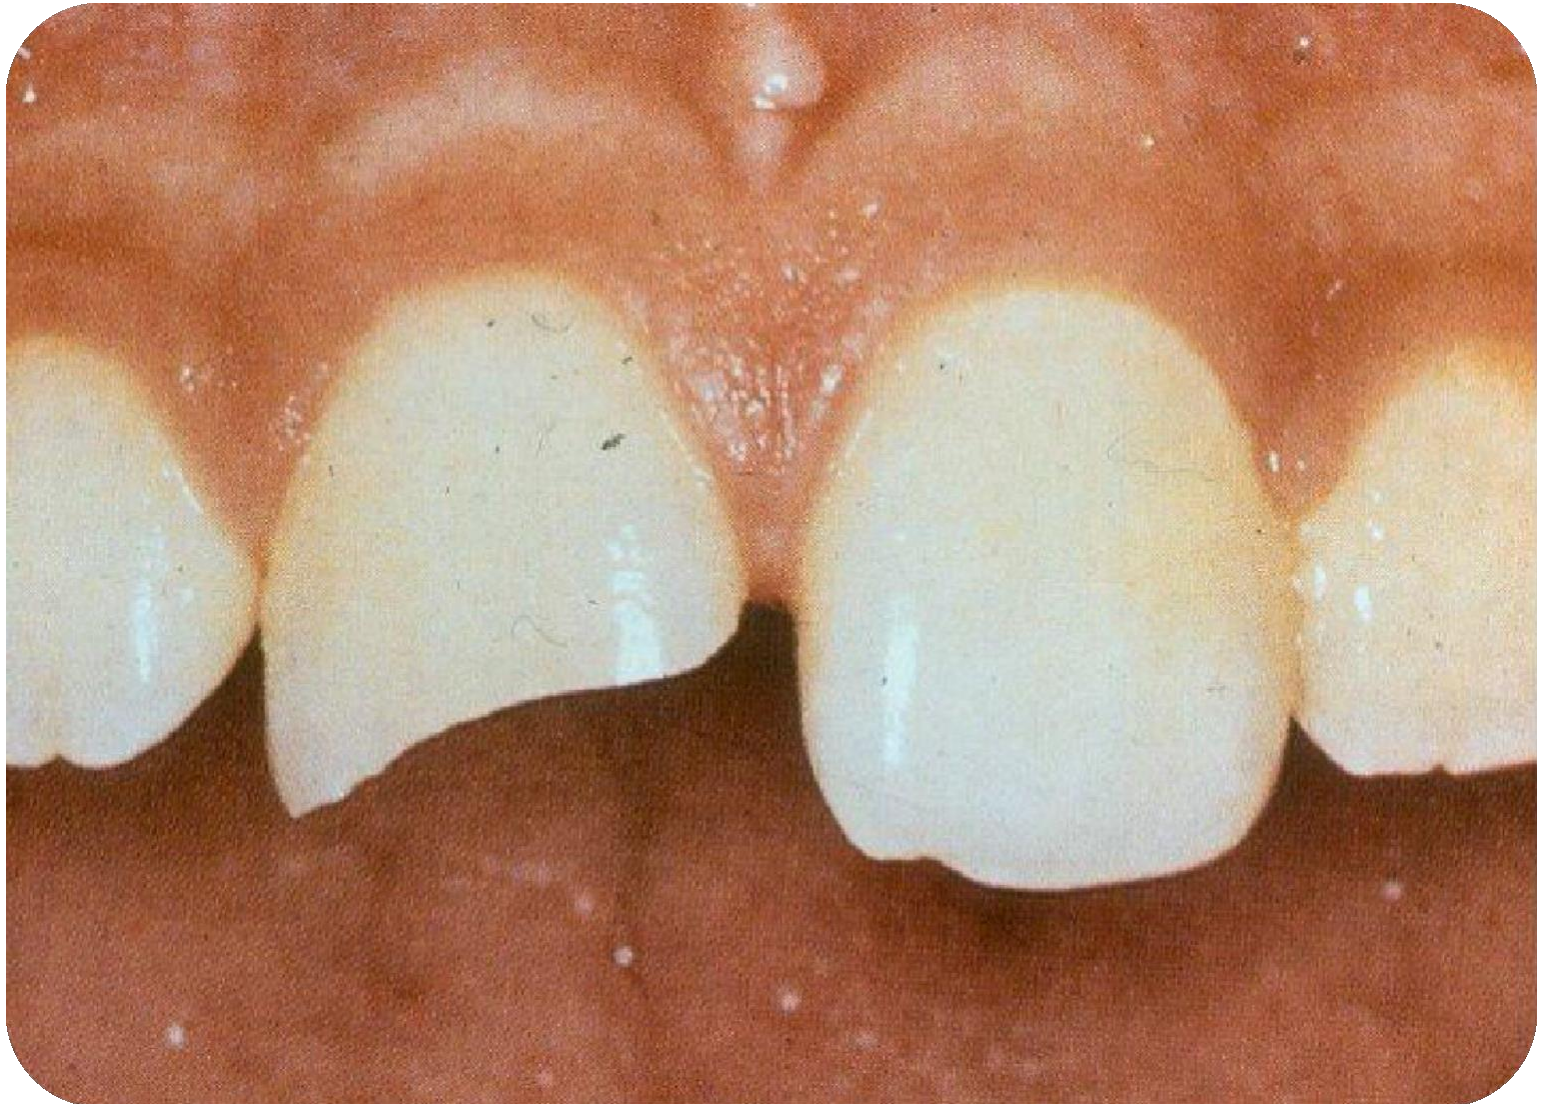
Surface code T – trauma

- UR1 – mesial and buccal surfaces are fractured.
- Fracture involves dentine
- View from all sides to determine which other surfaces are traumatised
- Surface code is T - trauma.

NB. If caries into dentine was also present on these traumatised surfaces, surfaces would be coded for caries as appropriate.

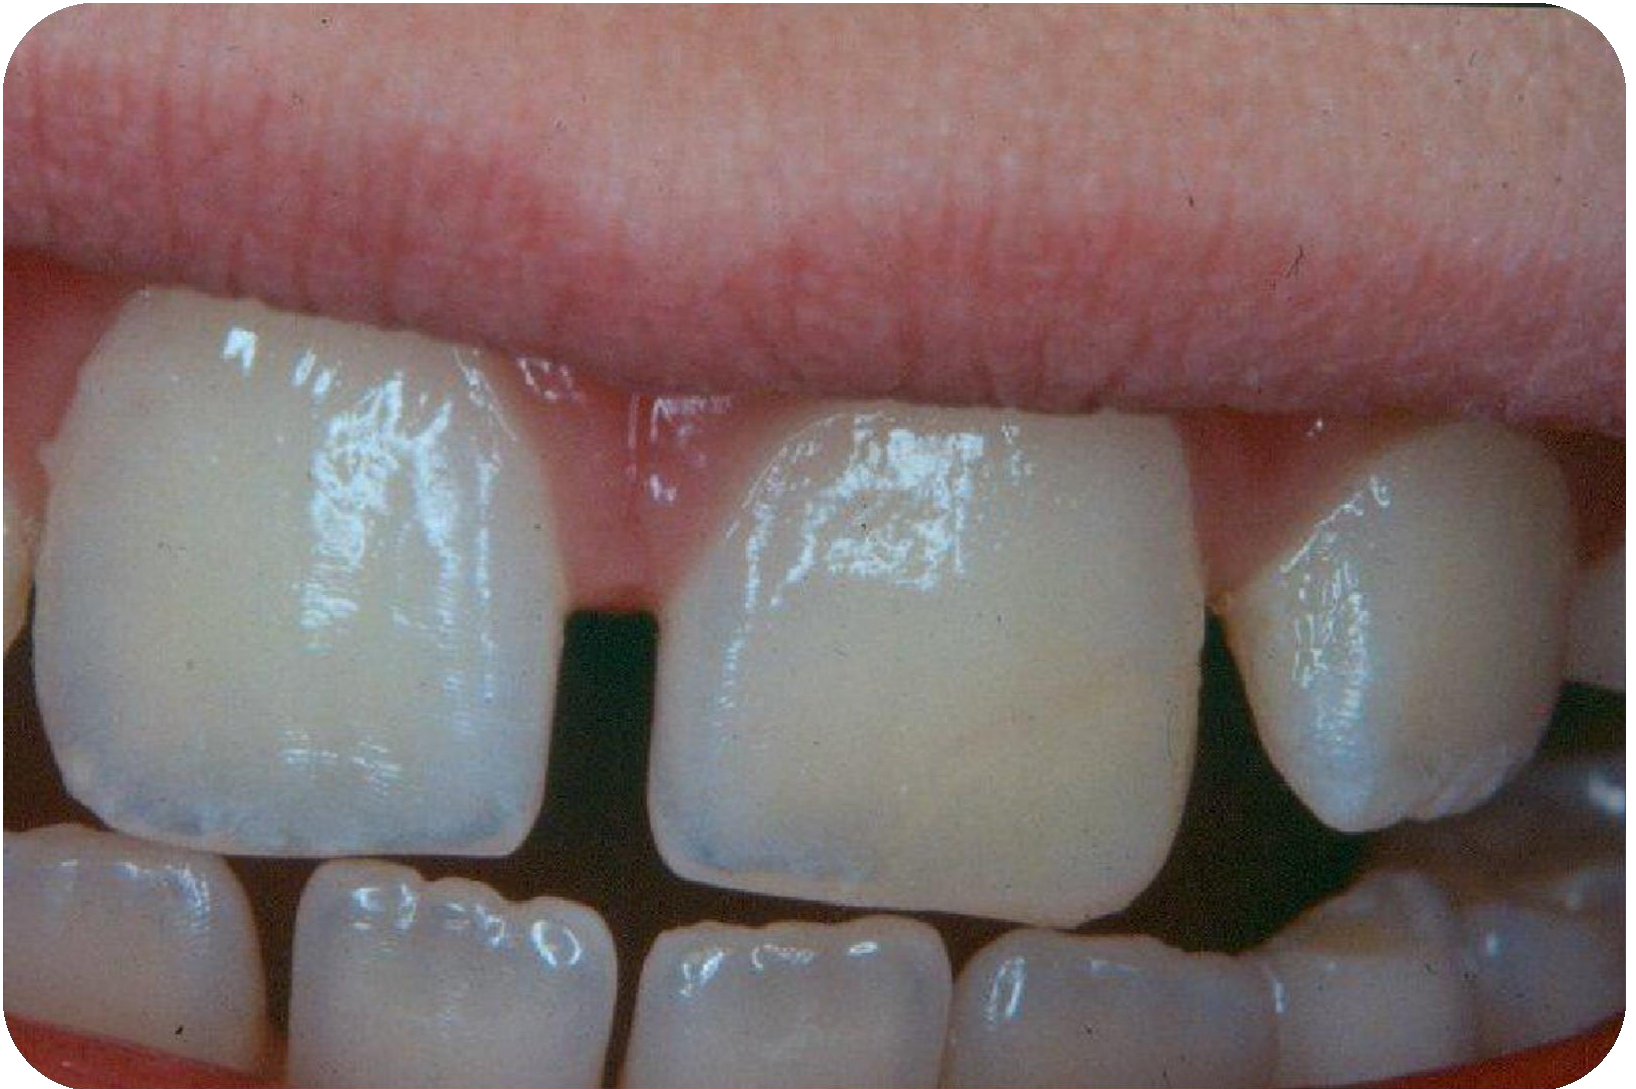
Surface code T – trauma

- **UL1 –tooth has been traumatised and repaired**
- **Restoration involves the distal and buccal surfaces (that are visible from this photo.)**
- **These surfaces would be coded as T.**

NB. Surface code T includes both untreated and treated trauma. Trauma code only used in absence of treated or untreated caries

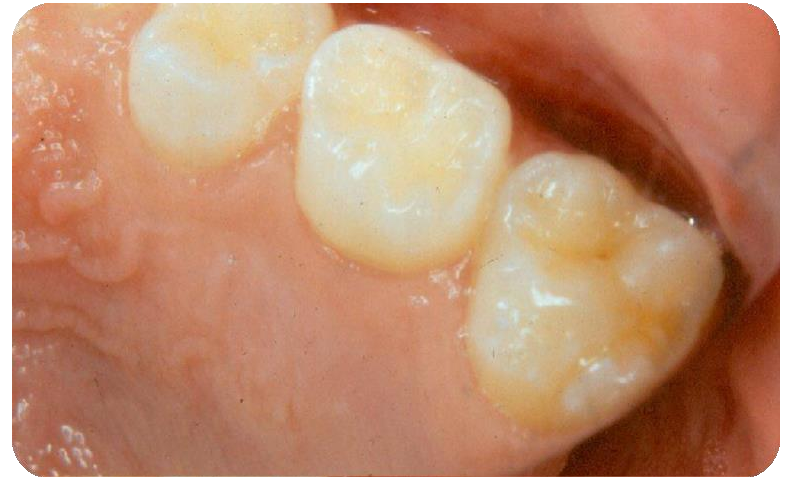
- **ULE –occlusal surface is sound and is coded as 0.**

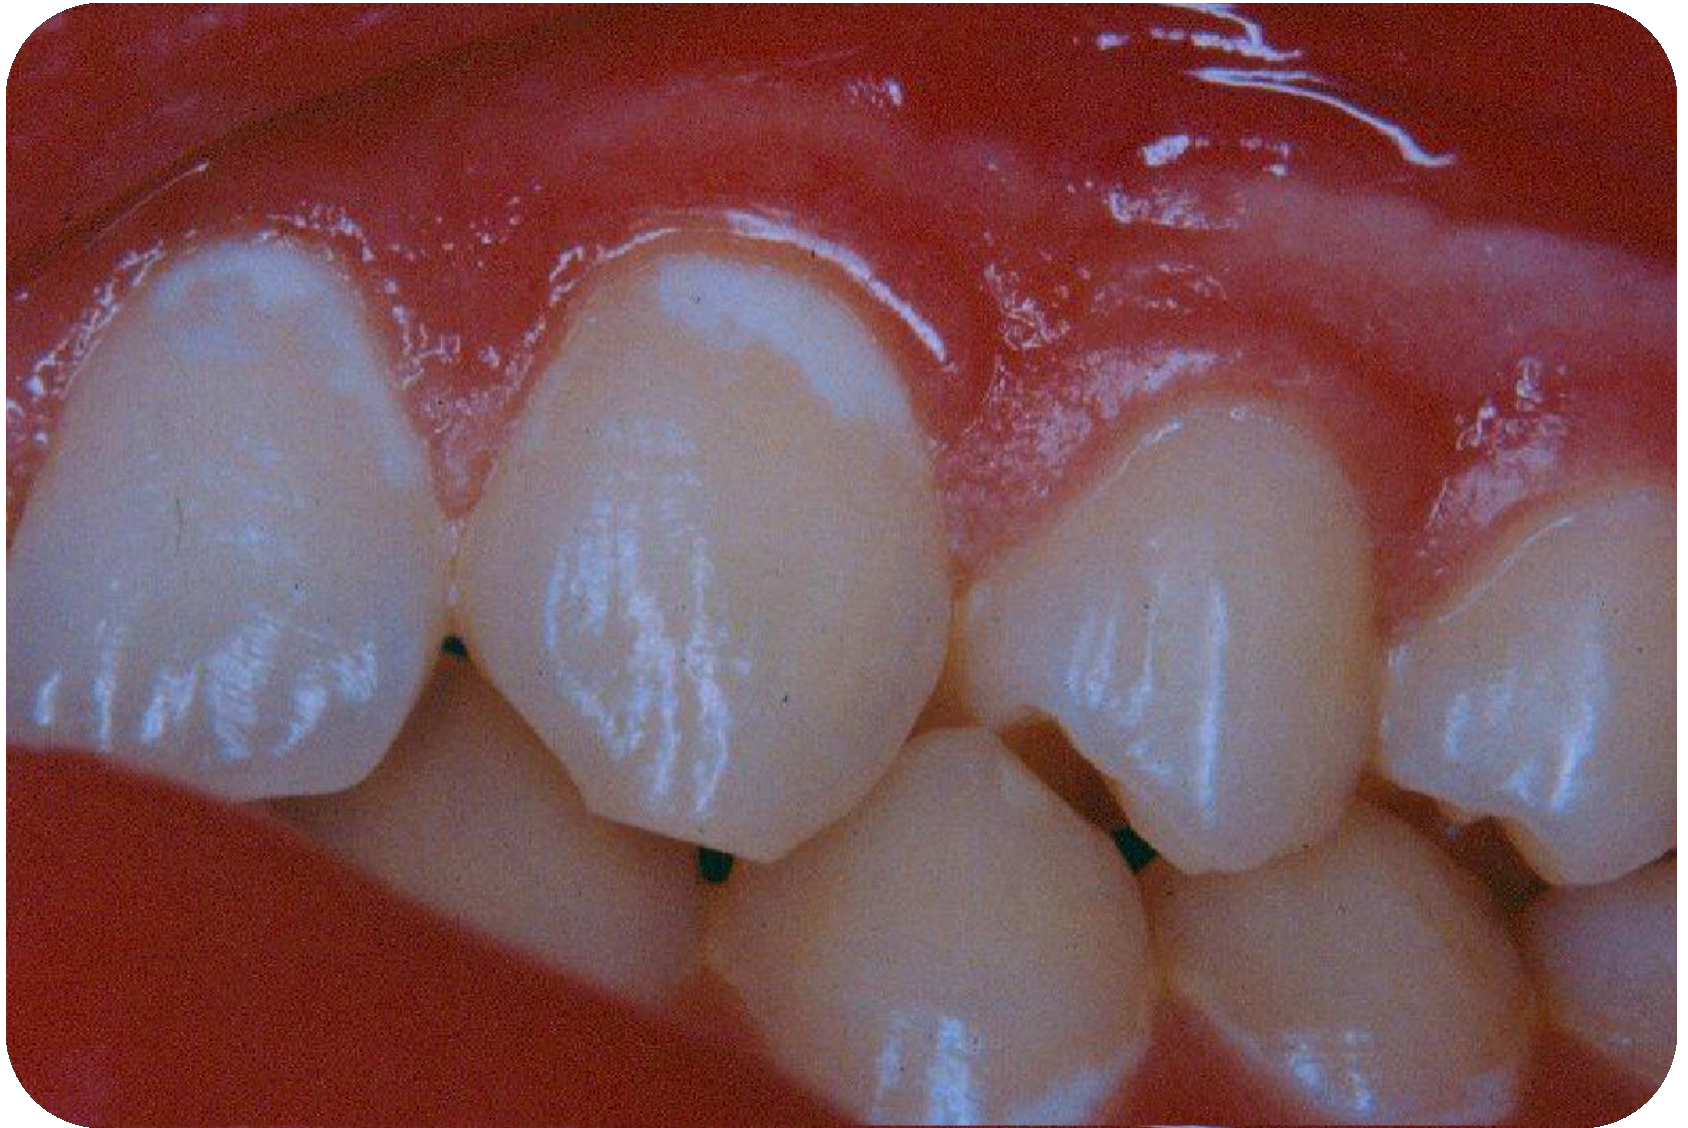
Surface code 0 – present and "sound"

- **UL2 & UL3 buccal surfaces –white spot lesions in a band around the gingival 3rd**

NB. These lesions represent one of the early stages of caries and are excluded from the caries scores, which record at the "caries into dentine" diagnostic threshold, therefore, these surfaces are scored as sound.

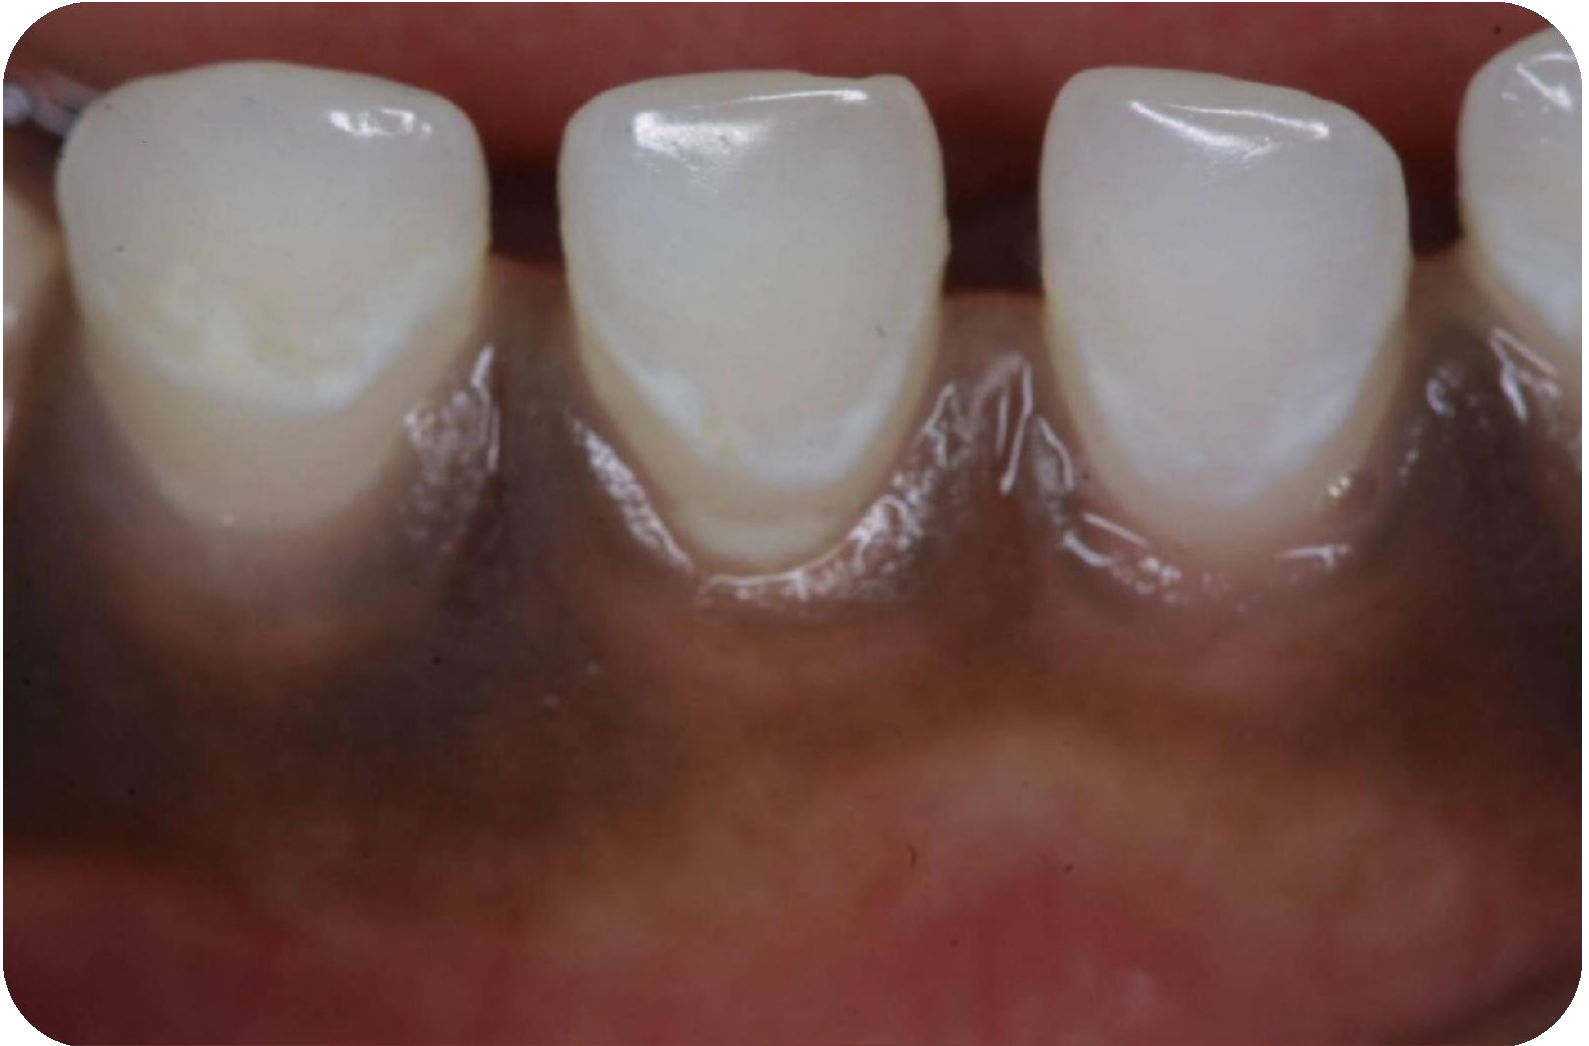
Surface code 0 – present and "sound"

- In these deciduous teeth, the demineralised areas probably correspond with plaque coverage at the original gingival margin.

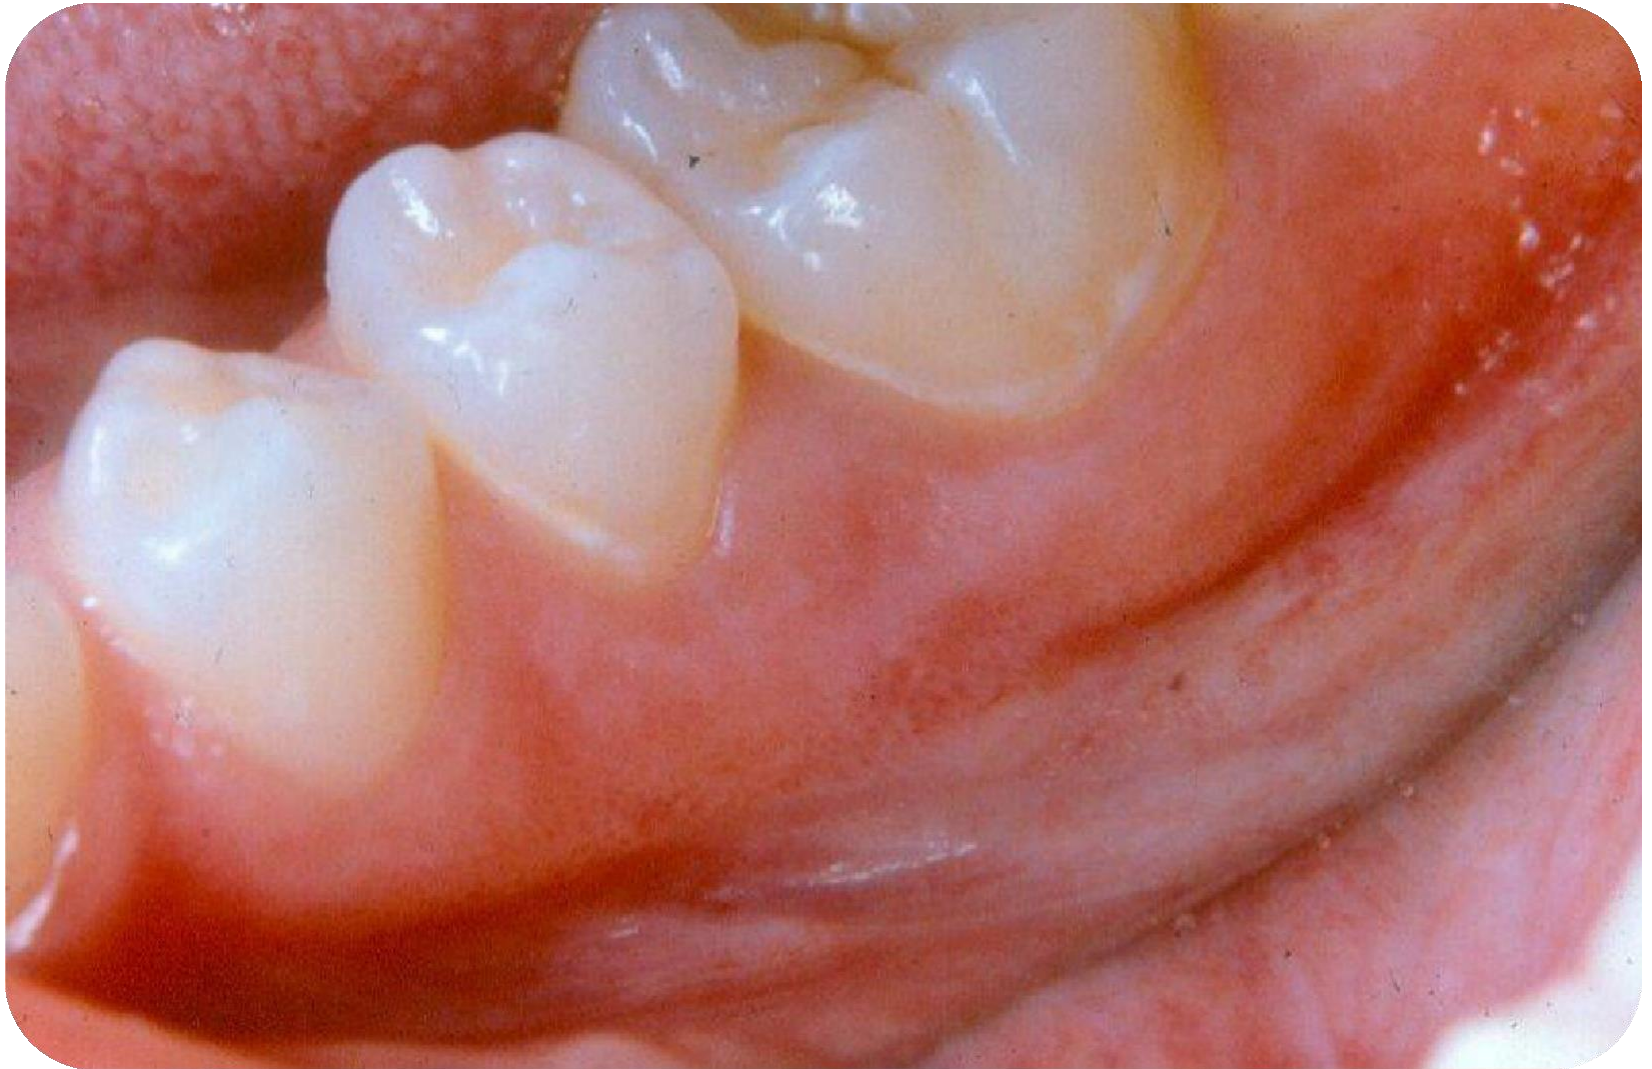
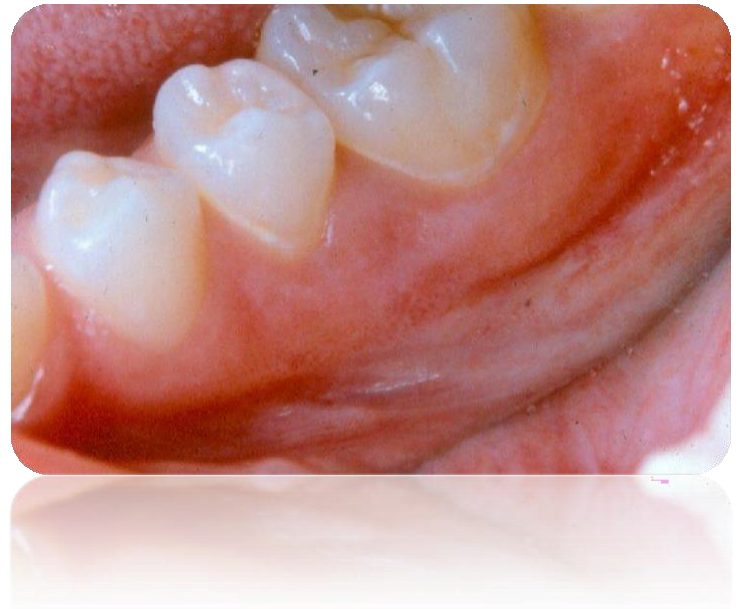
Surface code 0 – present and "sound"

- **LL5 & LL6 buccal surfaces – white spot lesions around the necks of the teeth giving a band-like appearance.**
- **Surfaces are scored as sound.**

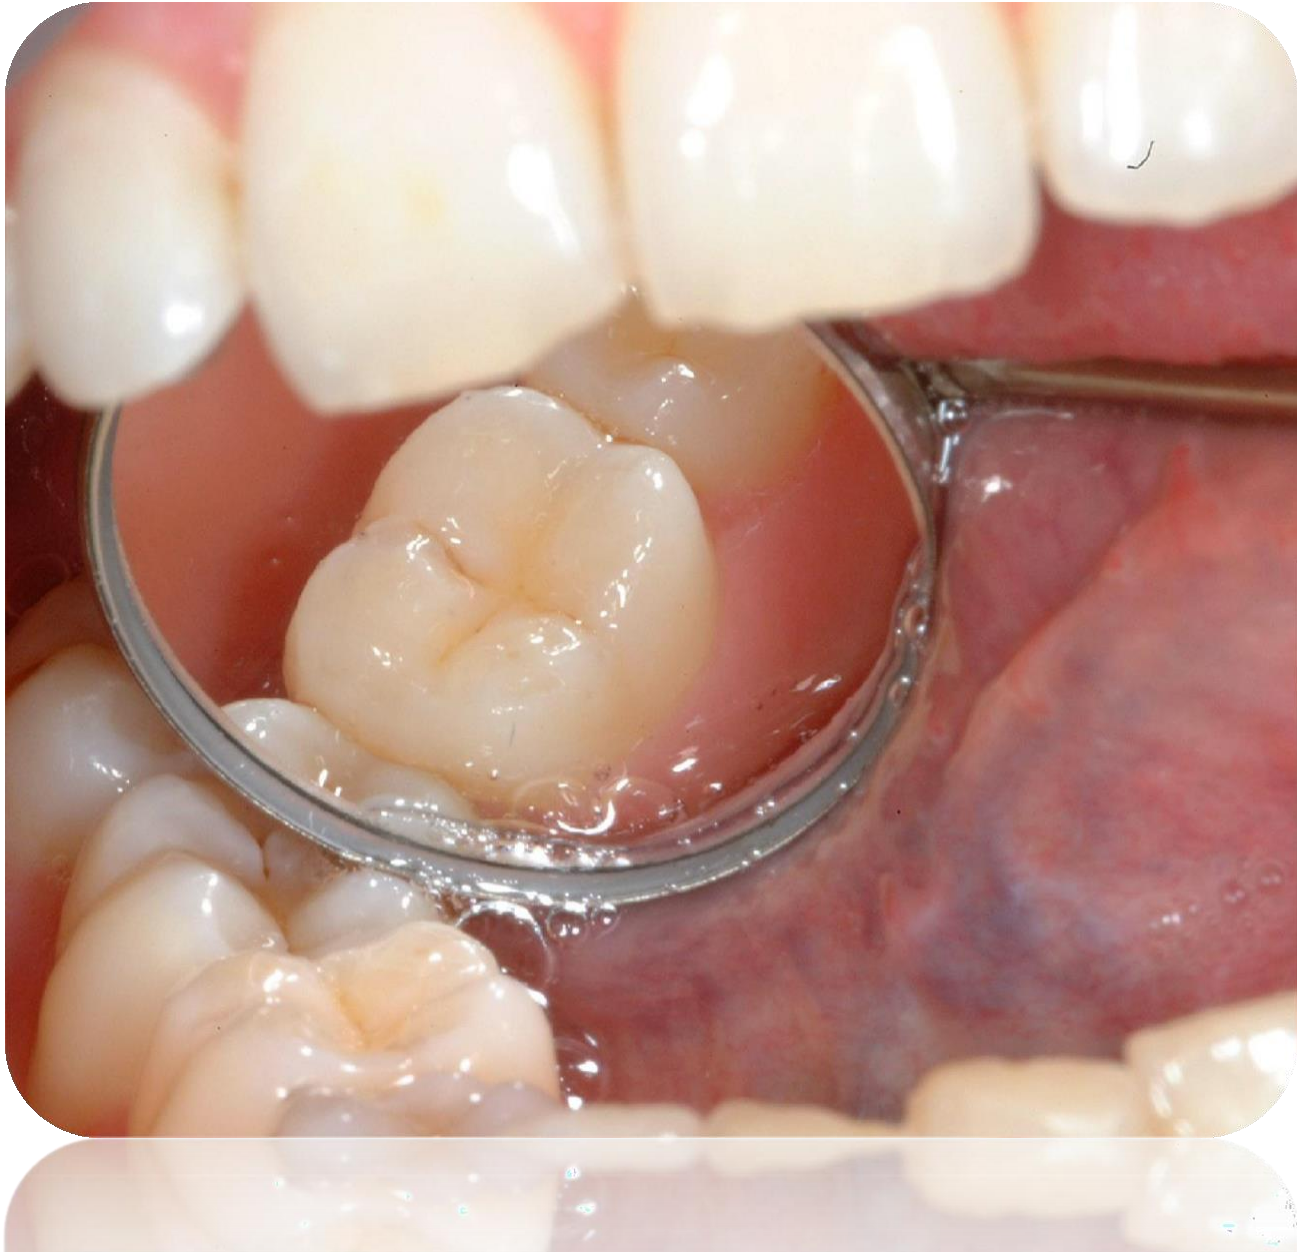
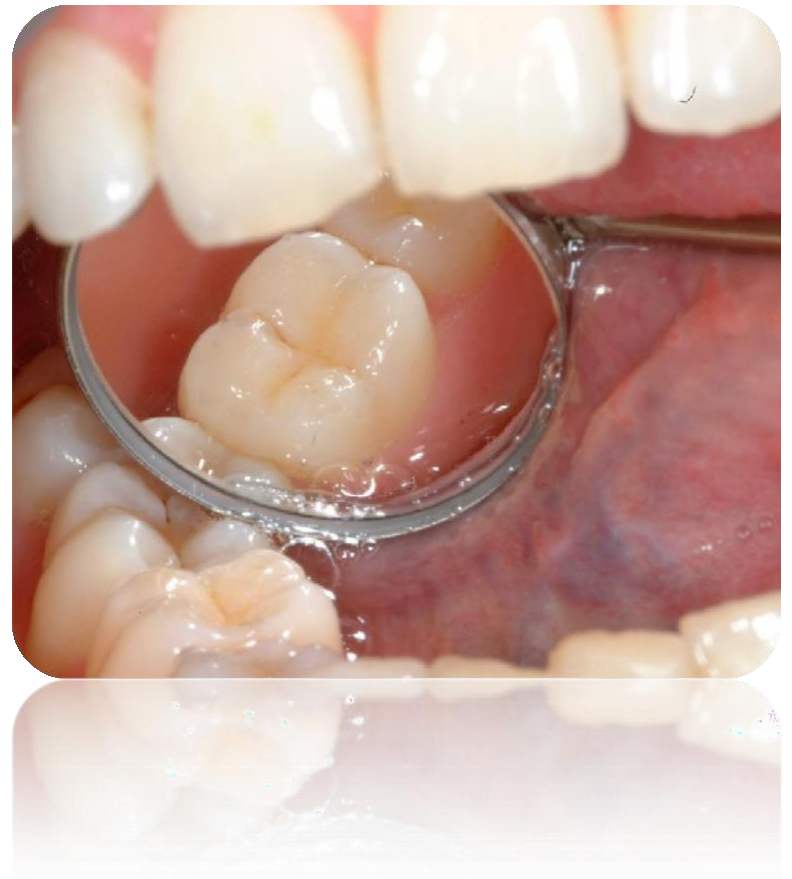
Surface code 0 – present and "sound"

- **Stained fissure/enamel caries**
- **Stained pits or fissures in the enamel not associated with a carious lesion into dentine are coded as sound.**

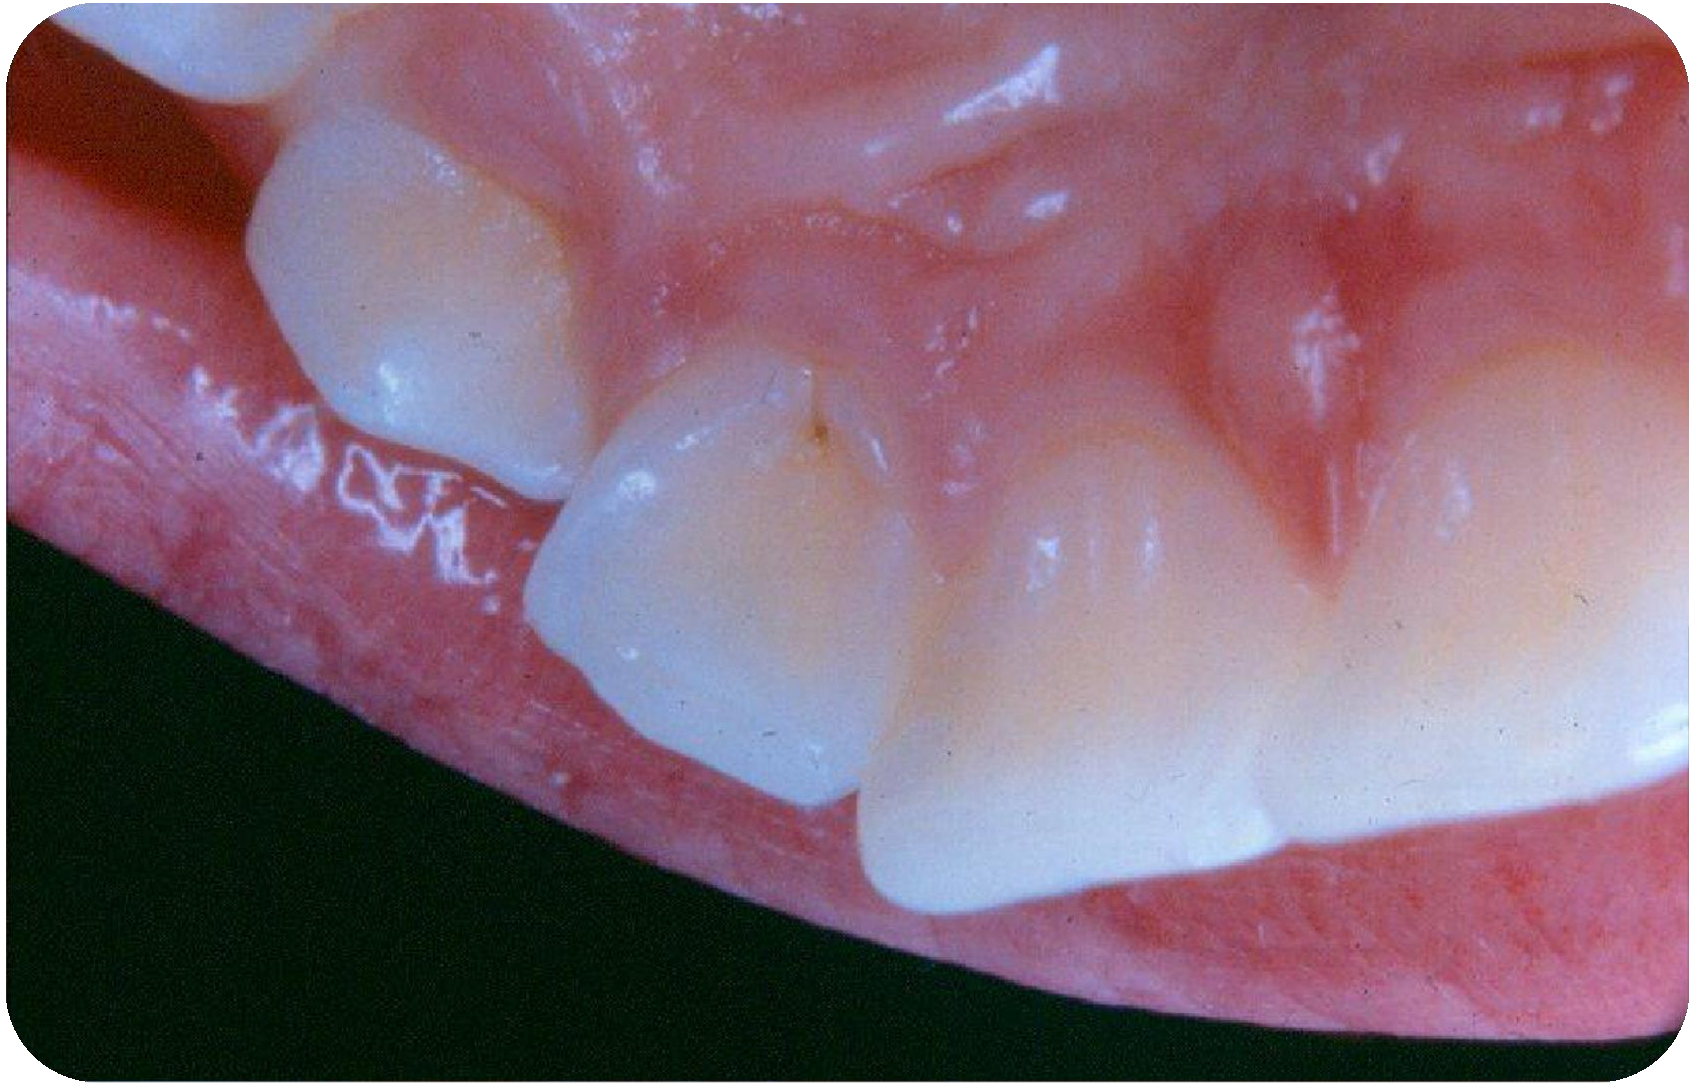
Surface code 0 – present and "sound"

- **UL2 – lingual surface has stained pit.**
- **No visible evidence of caries into dentine**
- **Surface scored as sound.**

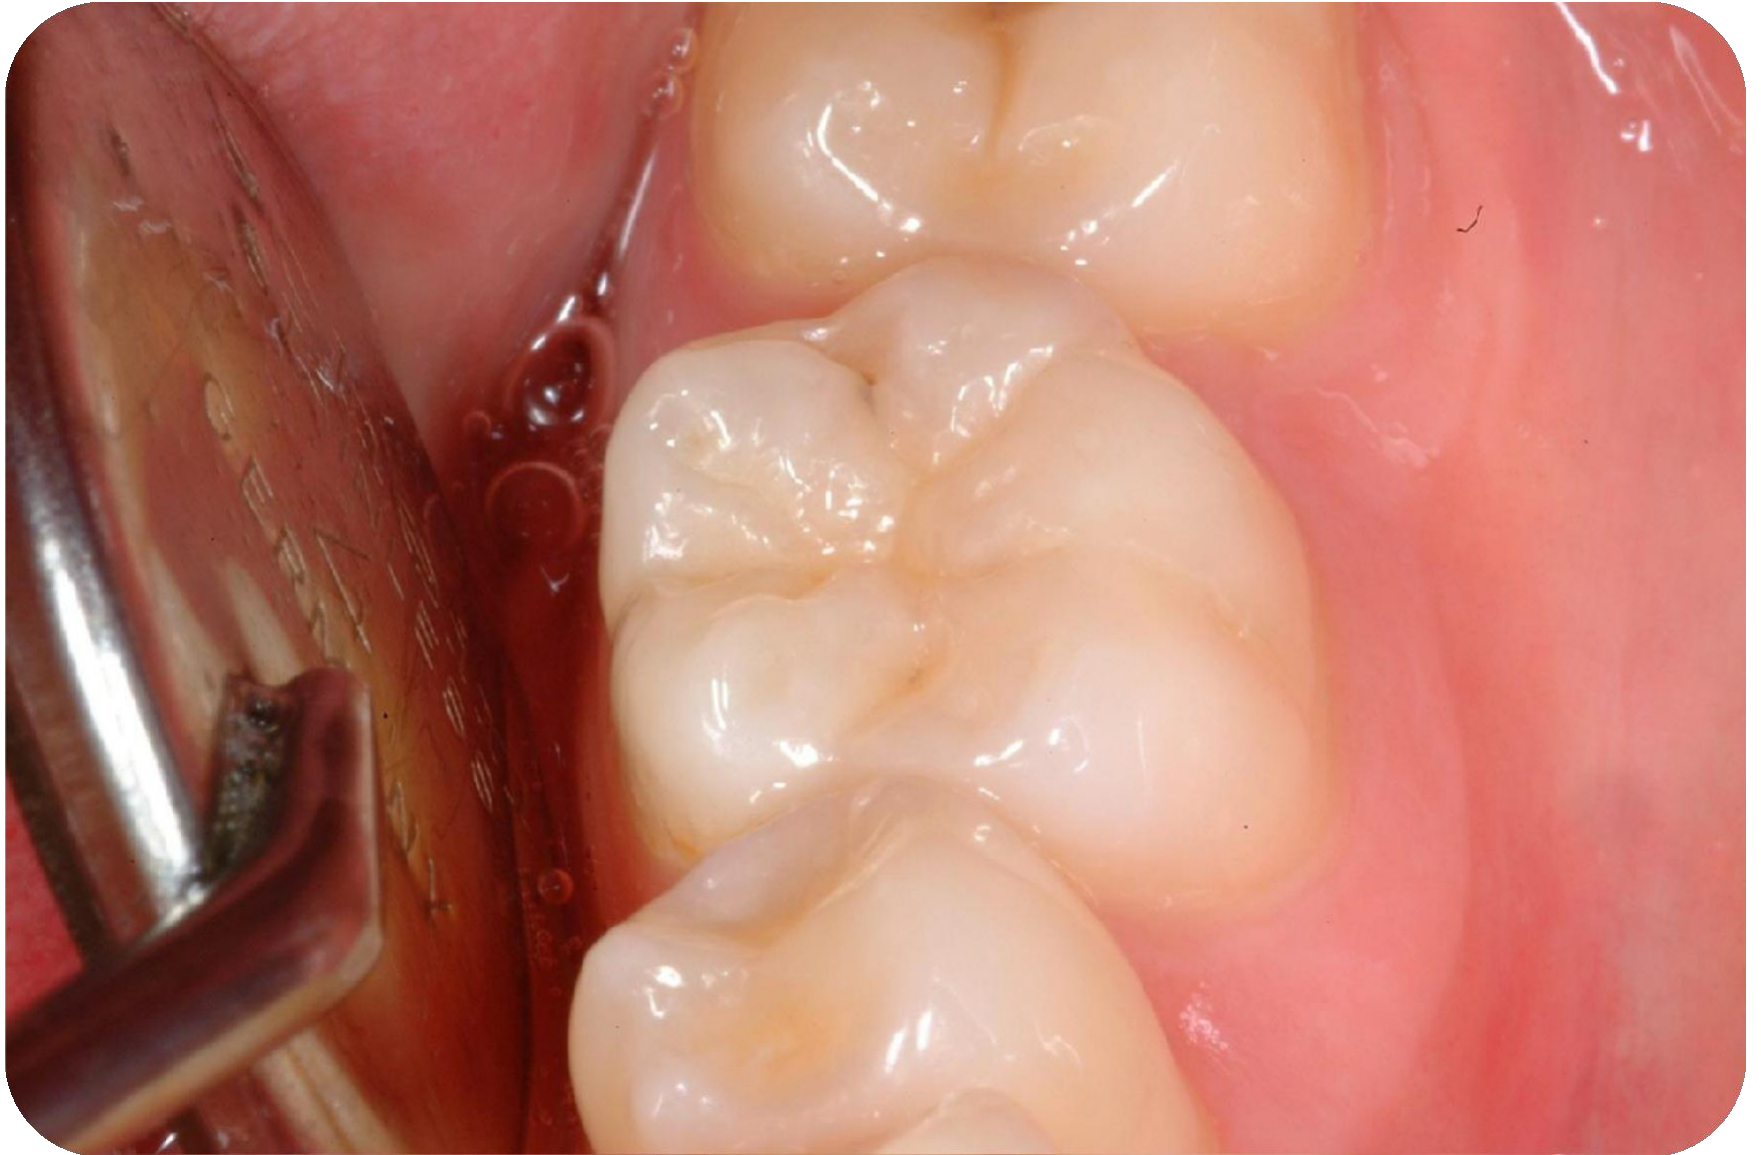
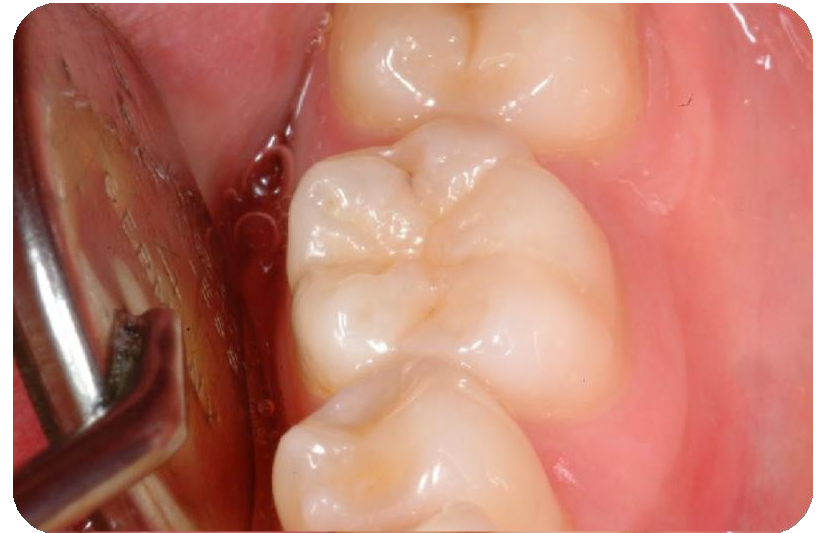
Surface code 0 – present and "sound"

- **Distal fissure of molar has a small carious lesion in enamel**
- **No visual evidence of dentine involvement**
- **Scored as sound**

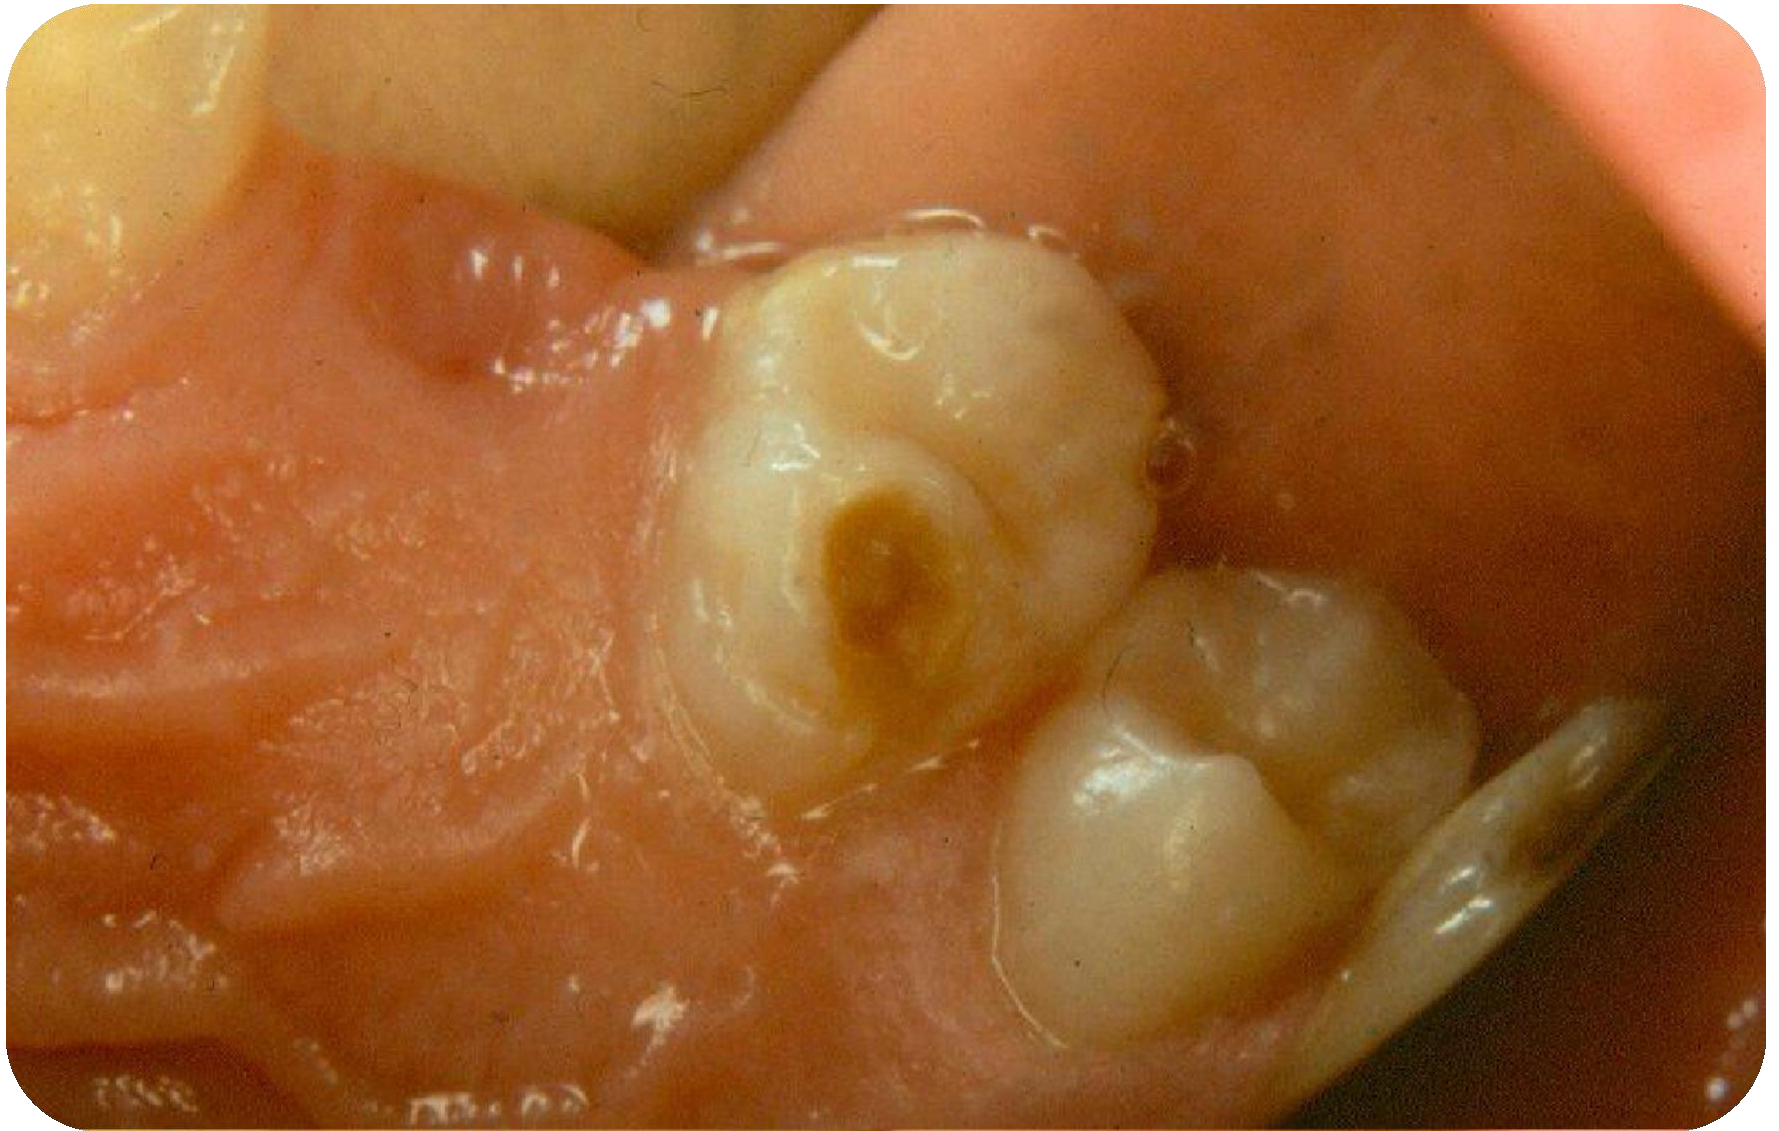
Surface code 0 – present and "sound"

- **UL4 –lingual surface has enamel loss and an orange/brown lesion.**
- **This is hypoplasia, a developmental defect of the enamel.**
- **Surface is scored sound.**

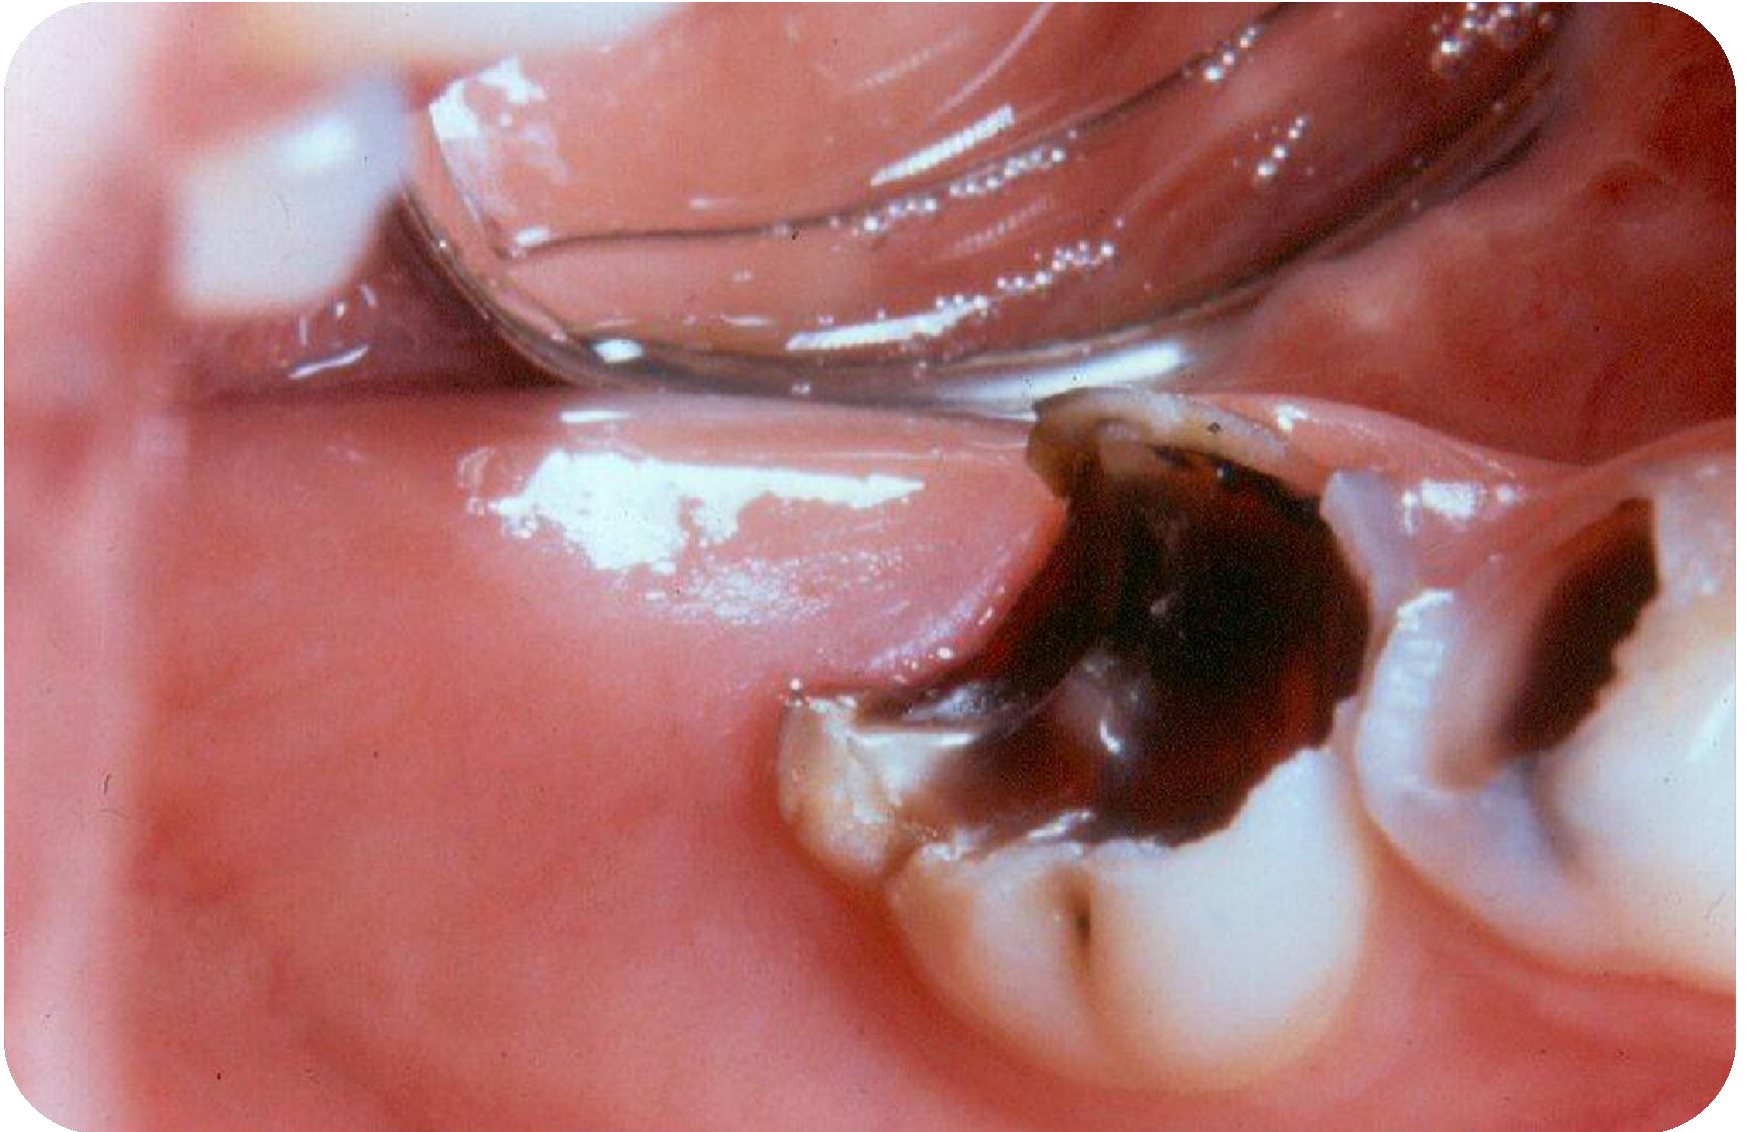
Surface code 1 – arrested dentinal decay

- URE –occlusal surface has arrested dentinal caries
- Distal, lingual and buccal surfaces would also be coded as 1.
