BASCD Trainers' Pack for Caries Prevalence Studies

Updated: June 2014

*for UK Training & Calibration
exercise for the Deciduous Dentition*

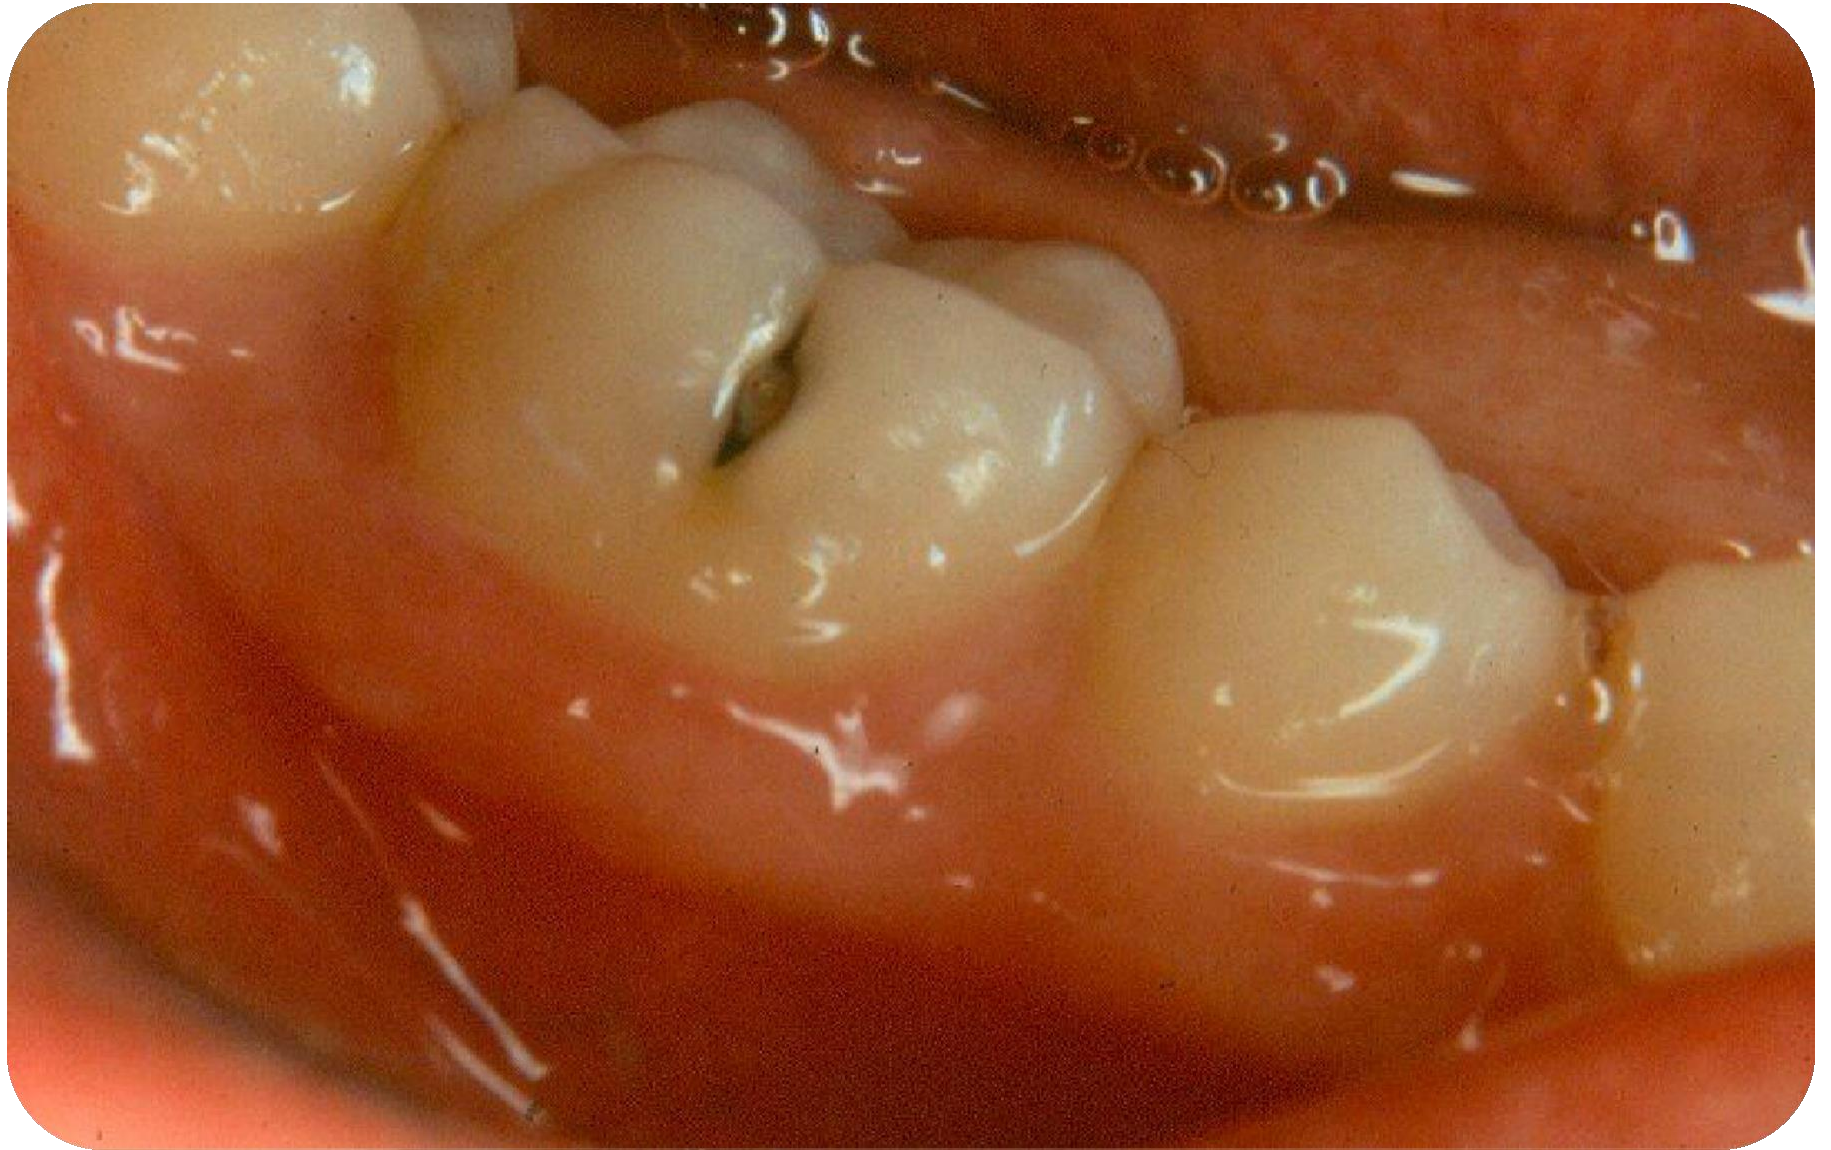
Surface code 2 – decayed into dentine

- LR6 –buccal surface has a visible carious lesion within fissure
- Surface is cavitated into dentine
- Creamy shadowing beneath enamel (mesial aspect)
- Grey shadowing beneath enamel (distal aspect)
- Both areas are undermined enamel indicating extent of carious lesion into dentine.

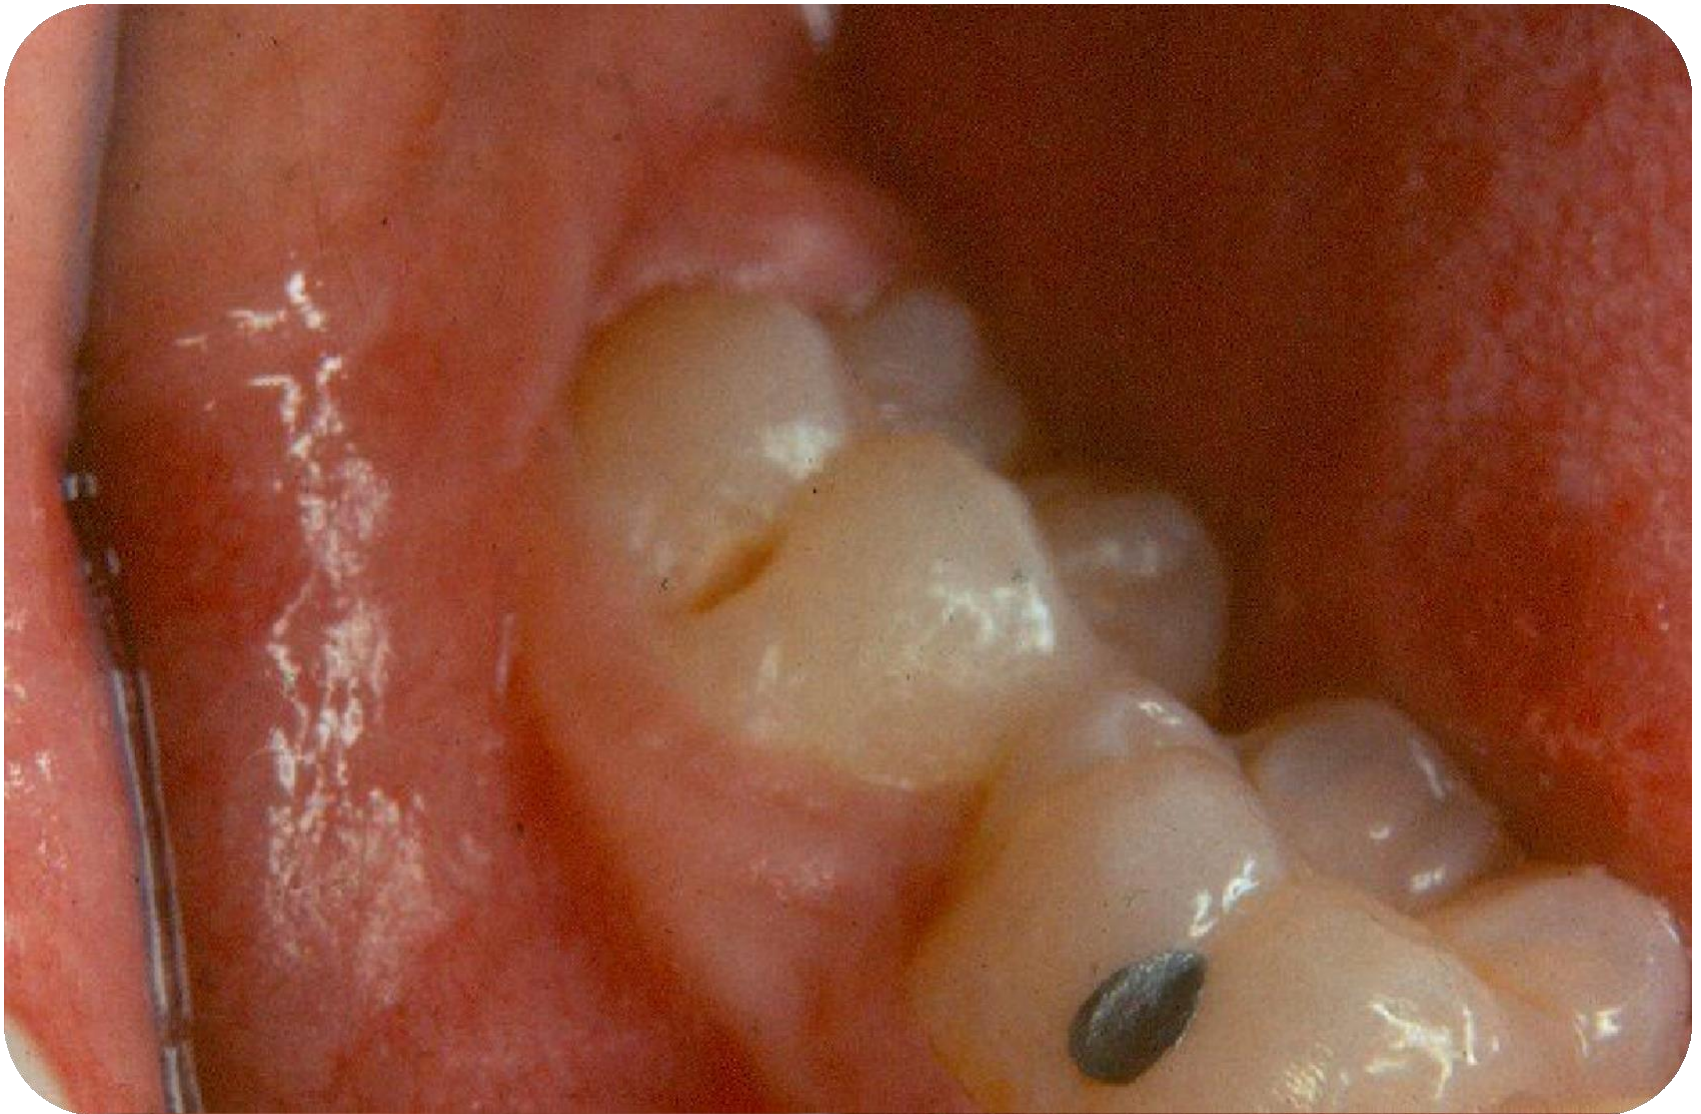
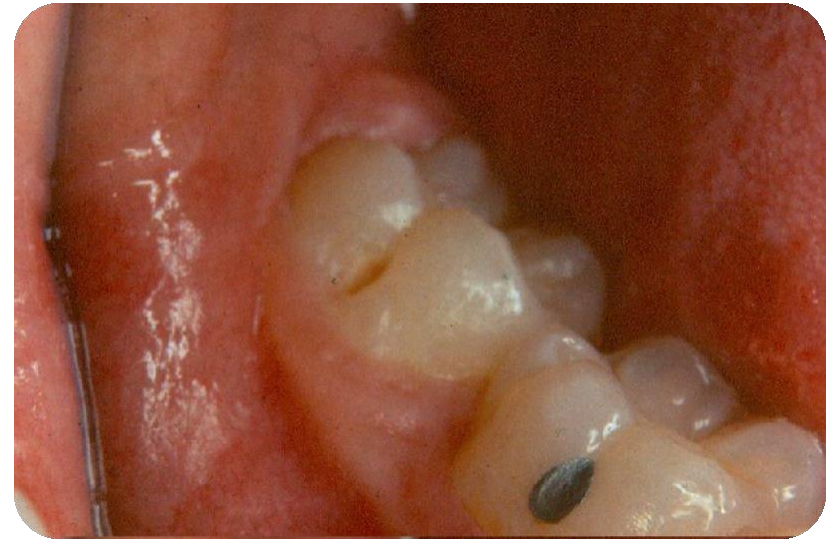
Surface code 2 – decayed into dentine

- LR7 - buccal surface has an oval lesion at the base of the fissure.
- Lesion extends into dentine and is coded 2.
- LR6 –buccal surface has intact filling in fissure with no decay or loss in adequacy of filling material
- This surface would be coded as 5 – filled with no decay

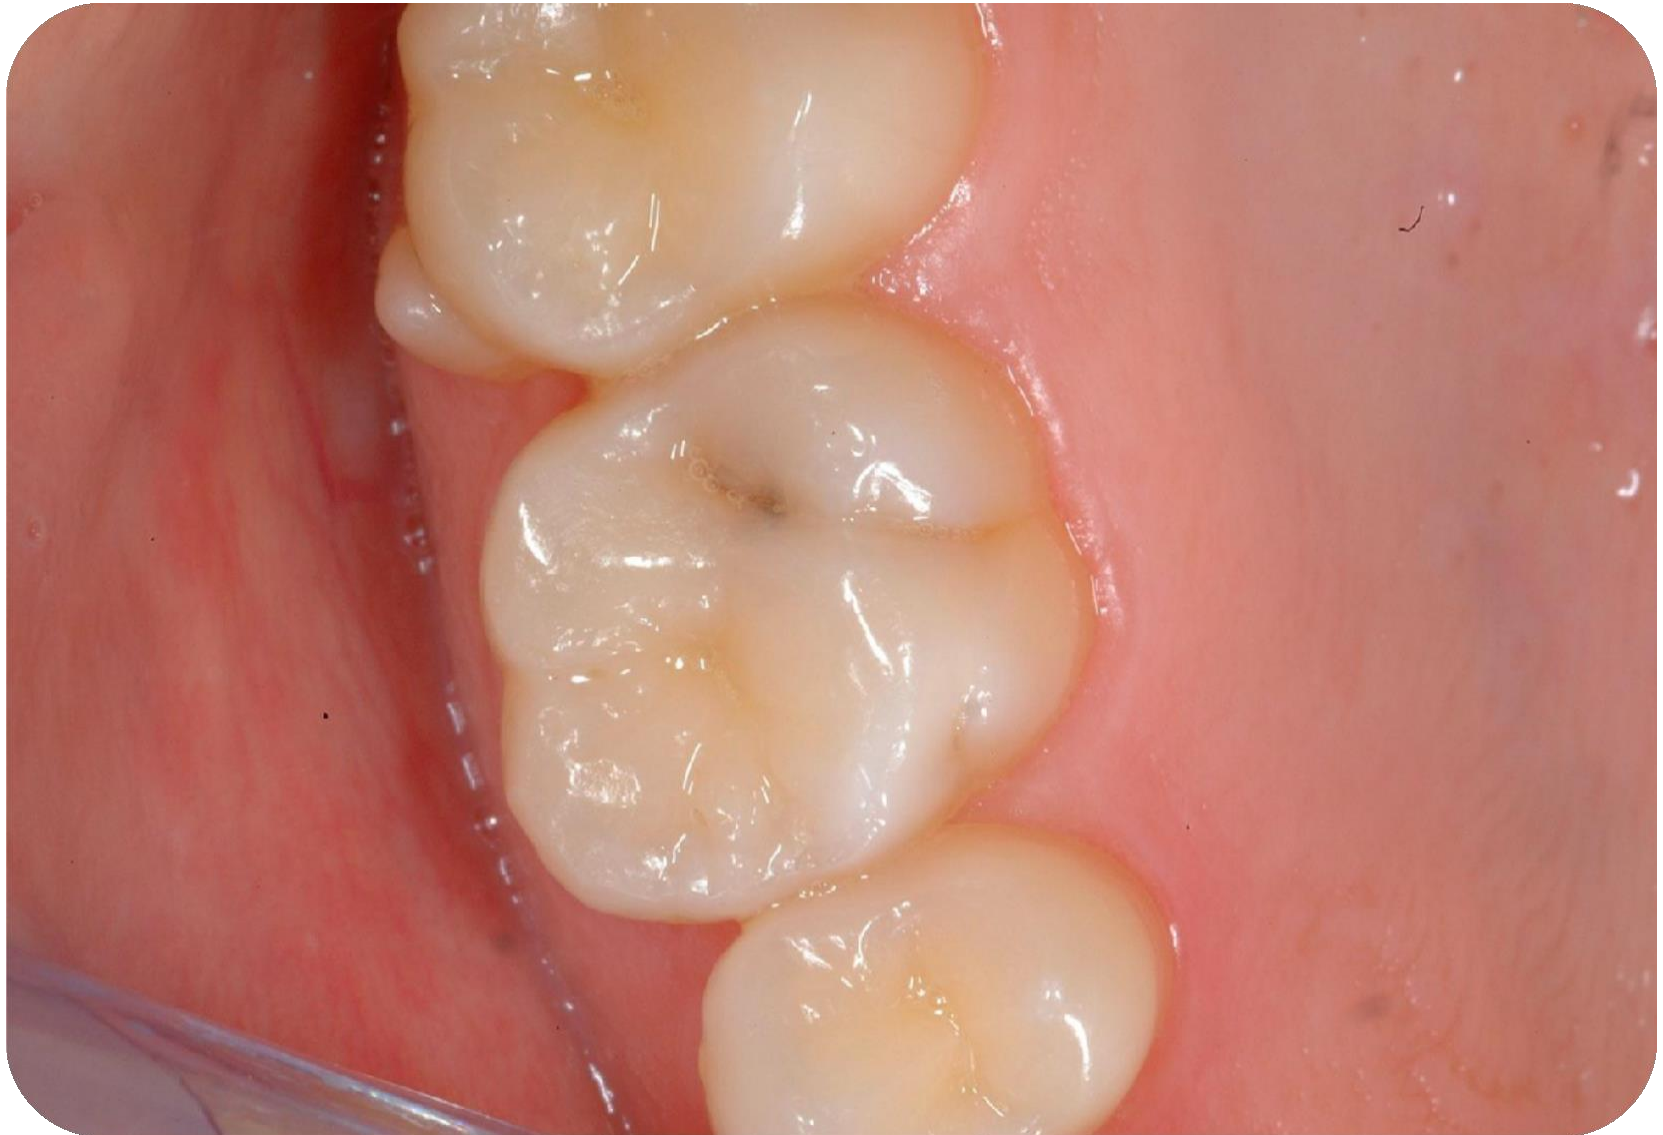
Surface code 2 – decayed into dentine

- **Distal fissure has**
 - Break in enamel
 - Widened fissure
 - Grey shadow beneath the enamel
- **Lesion scored as 2 – decayed into dentine**

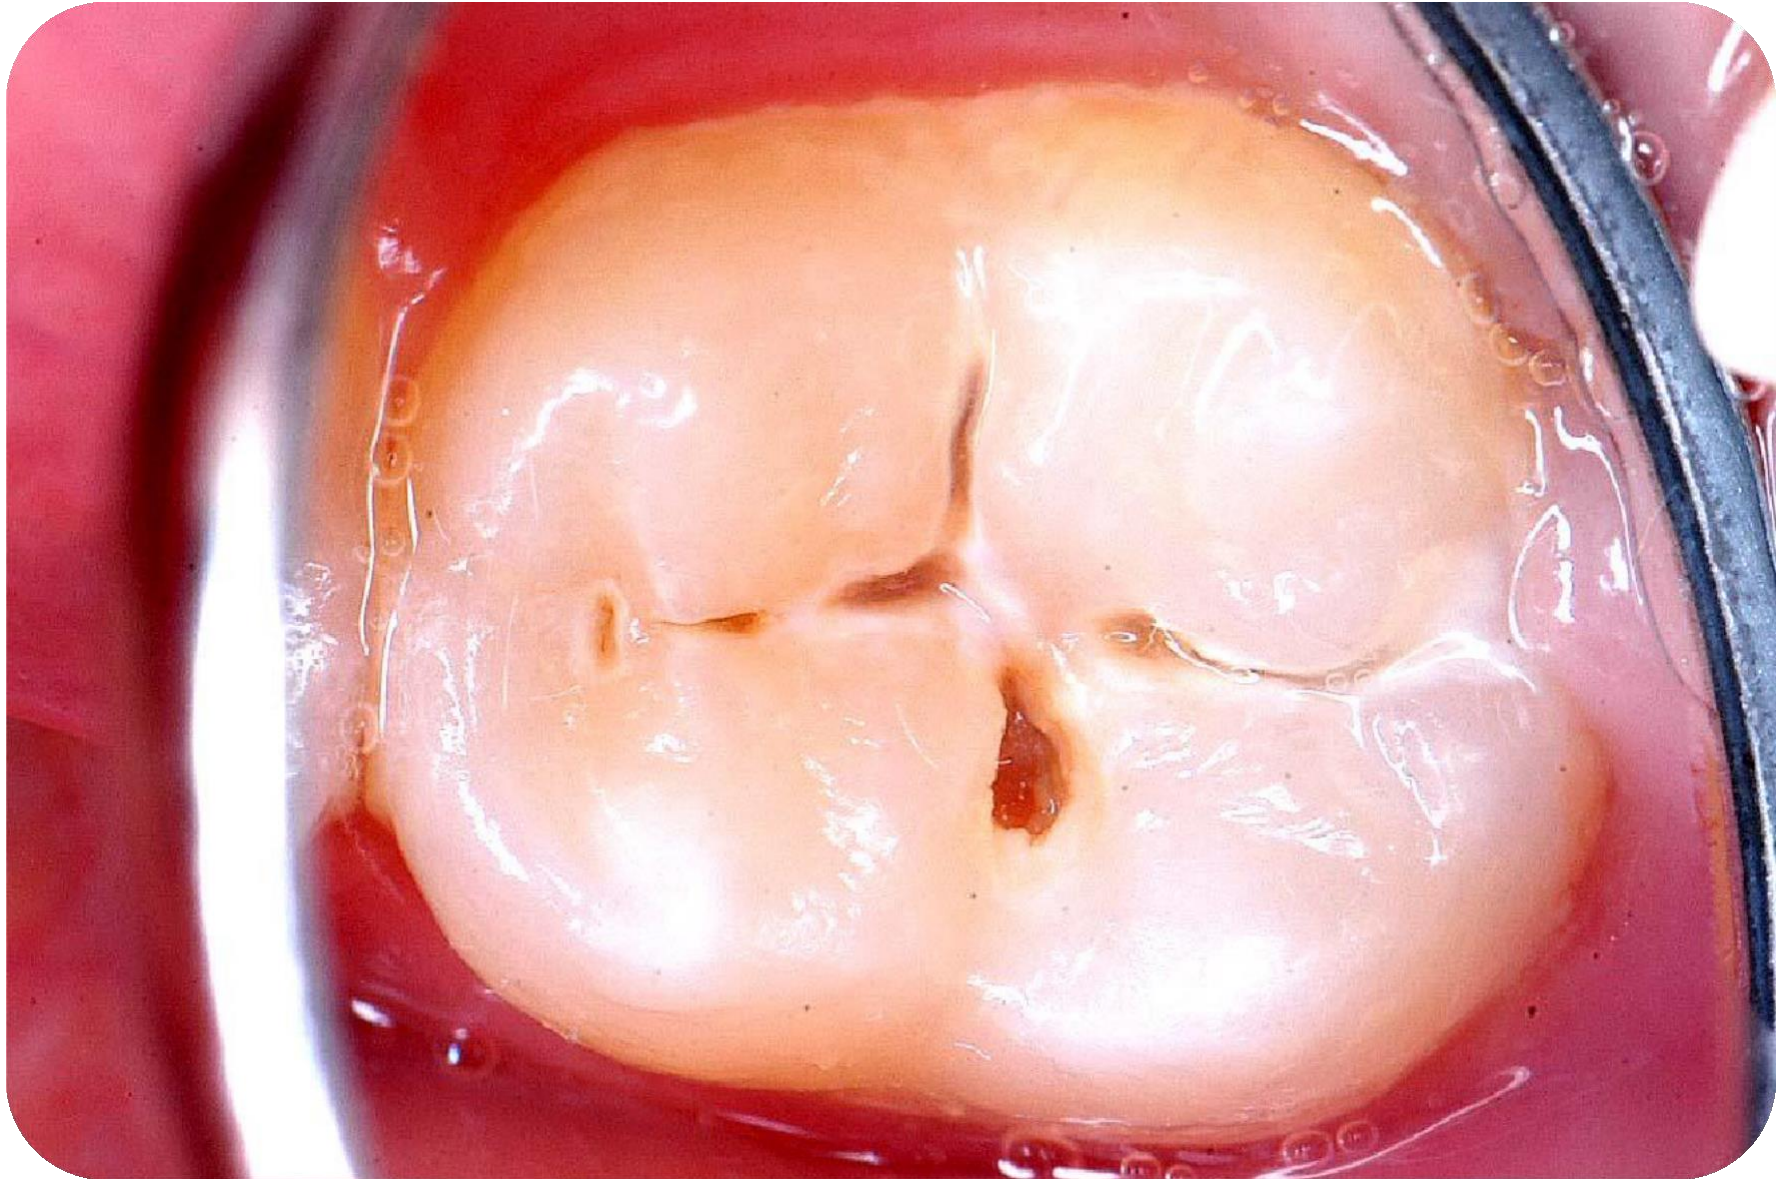
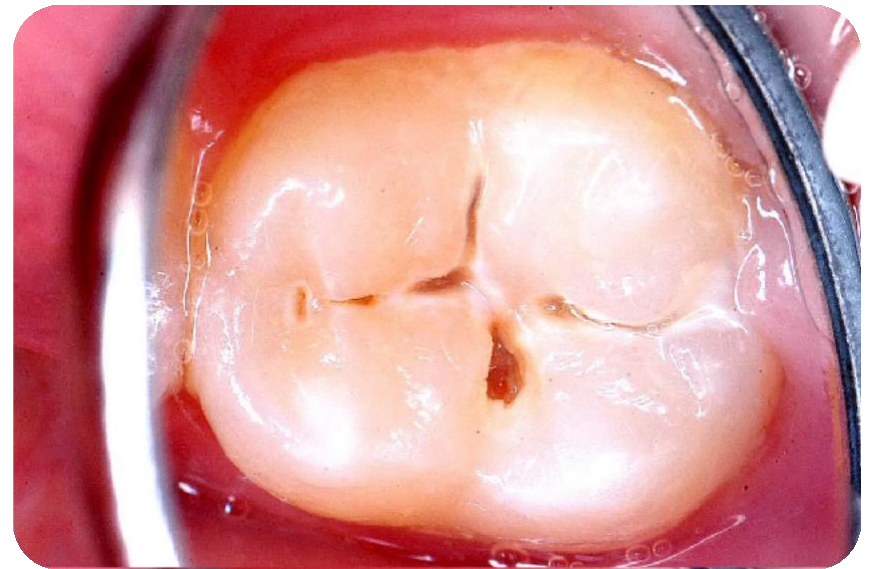
Surface code 2 – decayed into dentine

- Molar has several areas of cavitation extending into dentine

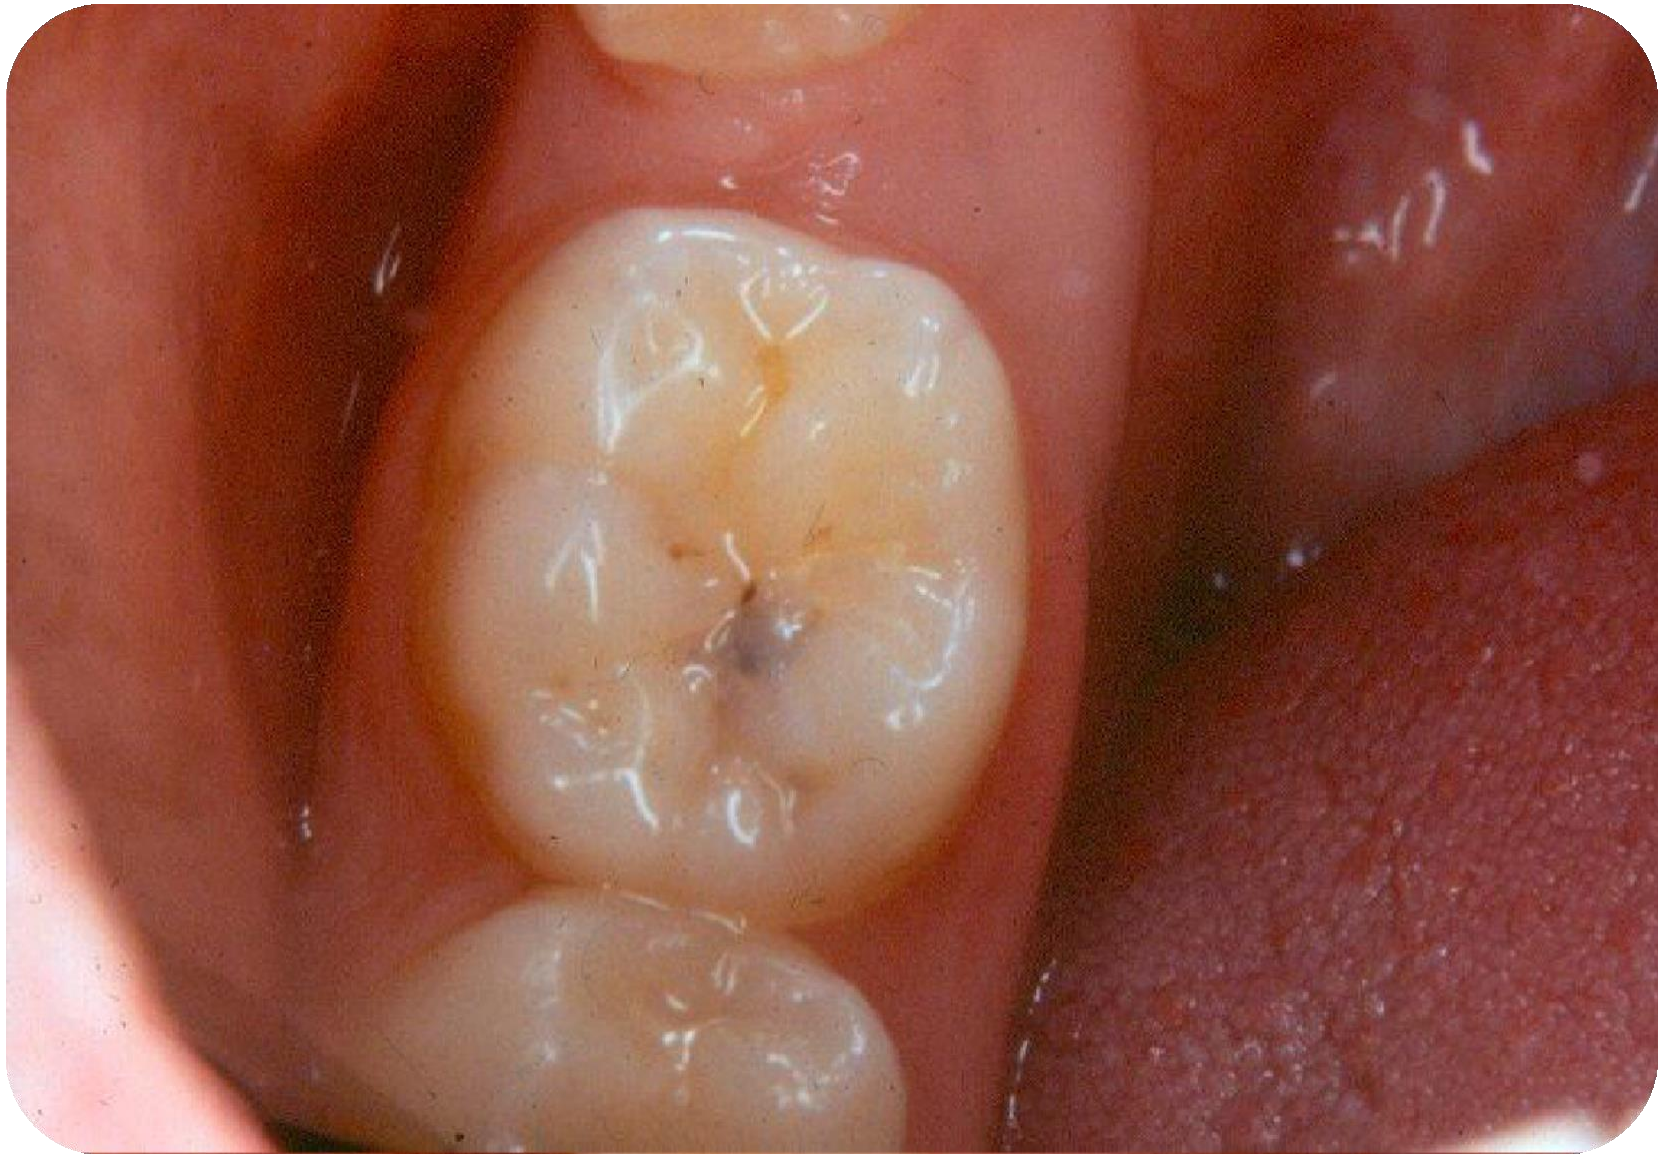
Surface code 2 – decayed into dentine

- LL6 –occlusal surface has no evident cavitation but has grey shadow beneath the enamel
- This lesion would be scored as code 2 – decayed.

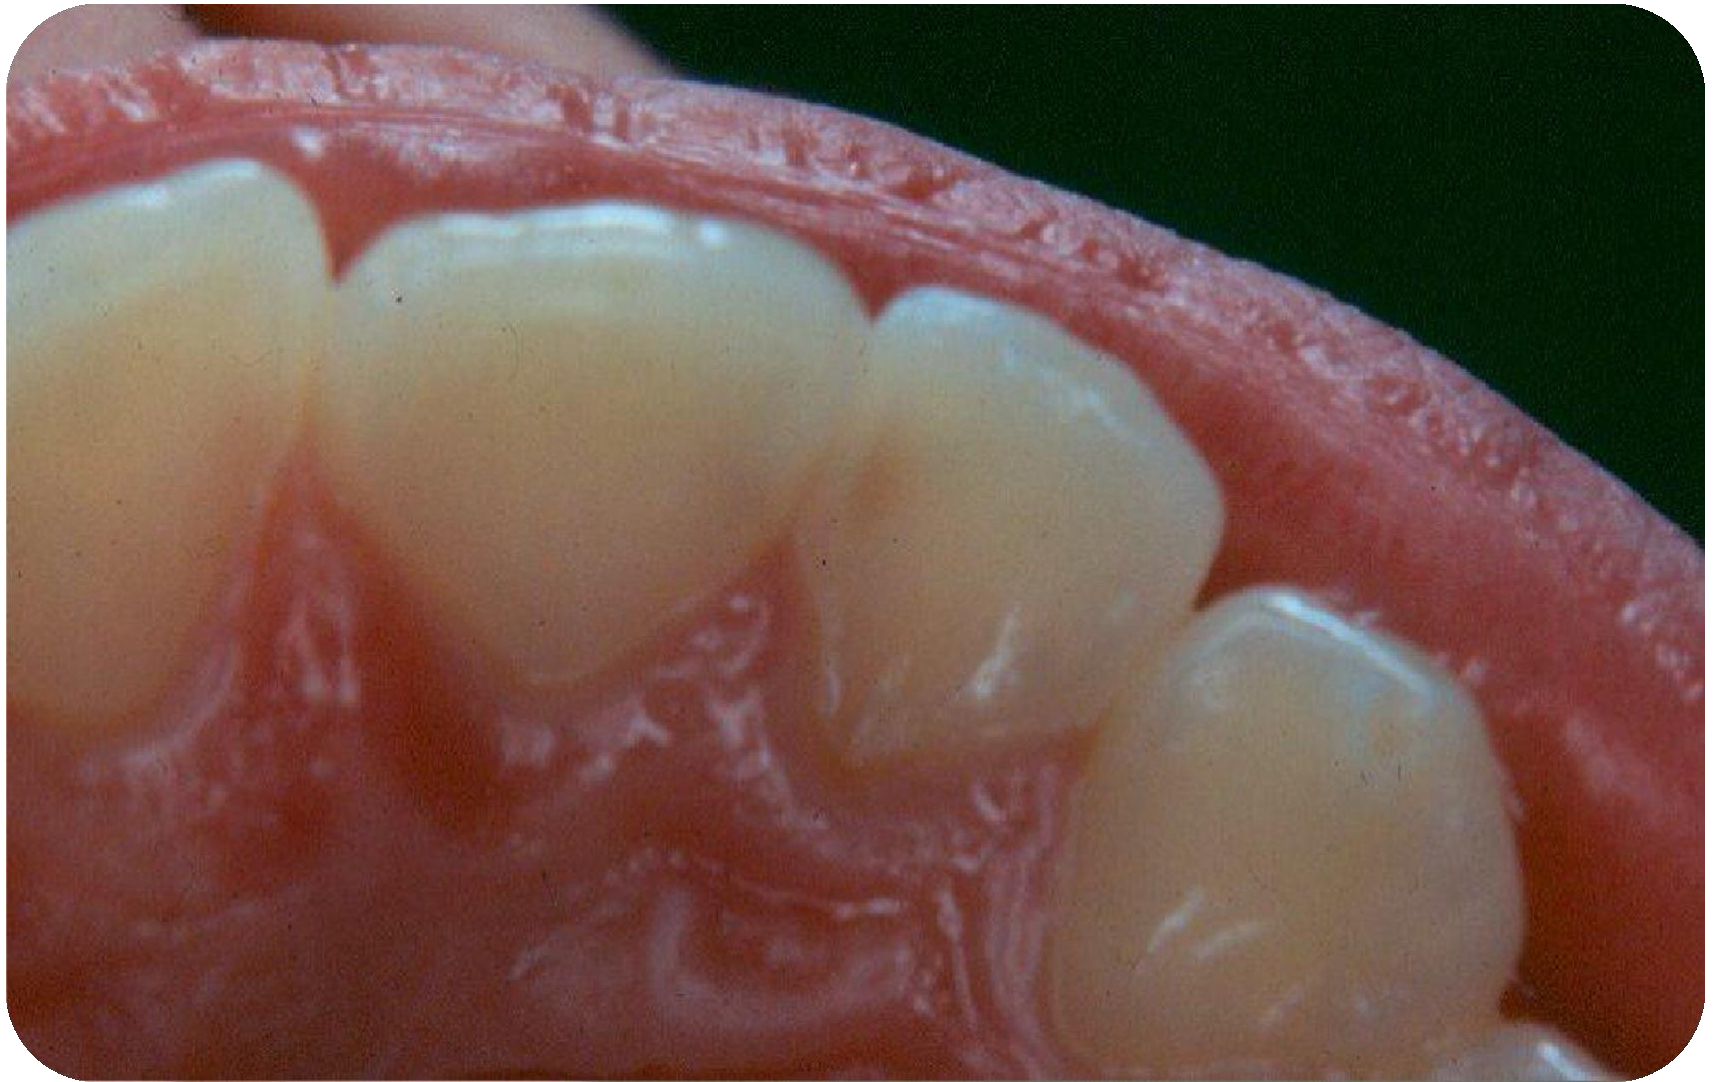
Surface code 2 – decayed into dentine

- **UL2 mesial surface –dark shadow beneath the enamel**
- **Shadowing continues beyond the ADJ and into the dentine**
- **This surface would be coded as 2.**

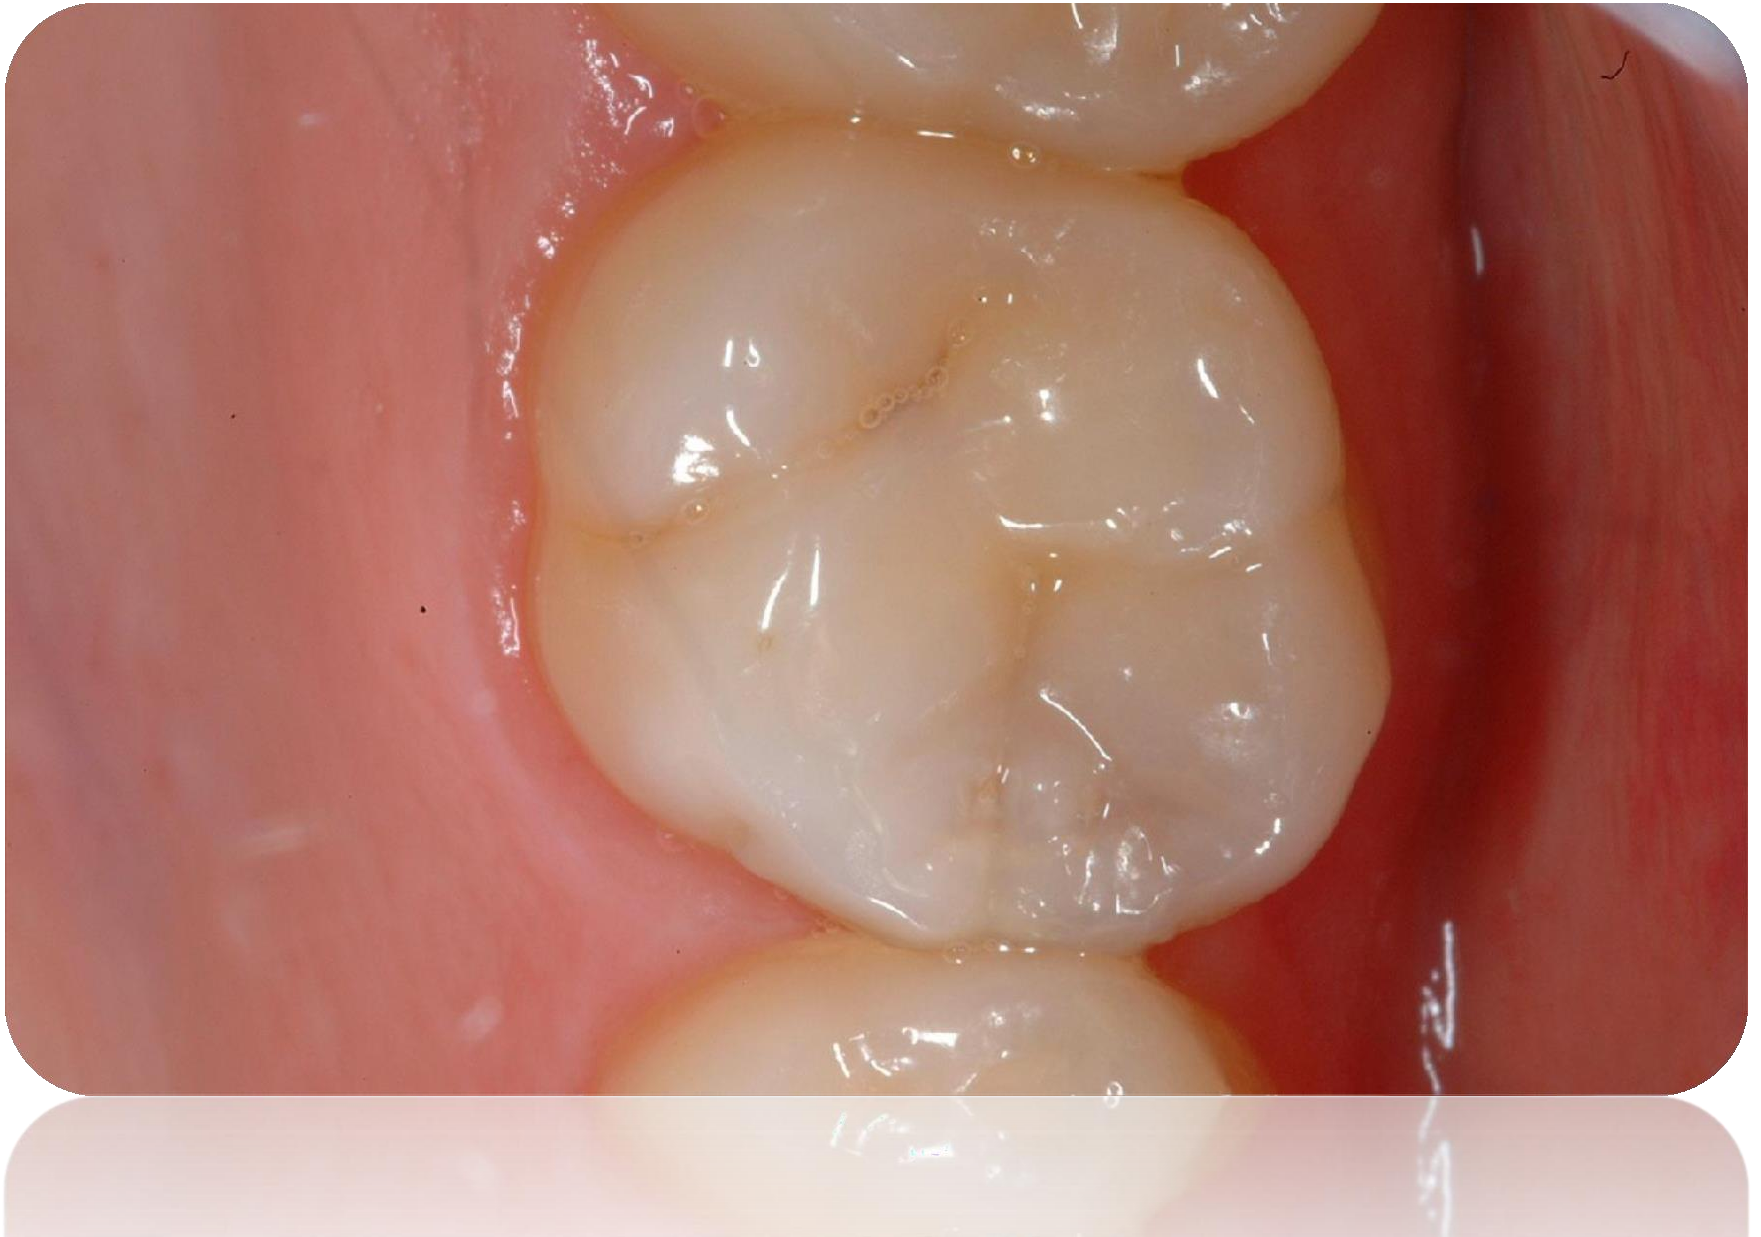
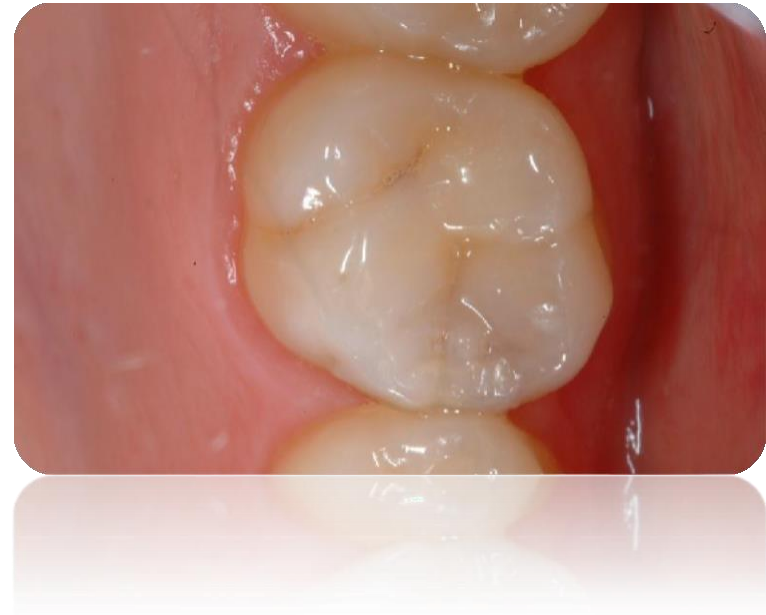
Surface code 2 – decayed into dentine - discuss

- Surface needs to be dried
- Grey opacity beneath the mesial marginal ridge
- Creamy opacity along ADJ
- Appears to be caries into dentine
- Occlusal and mesial surfaces both scored 2

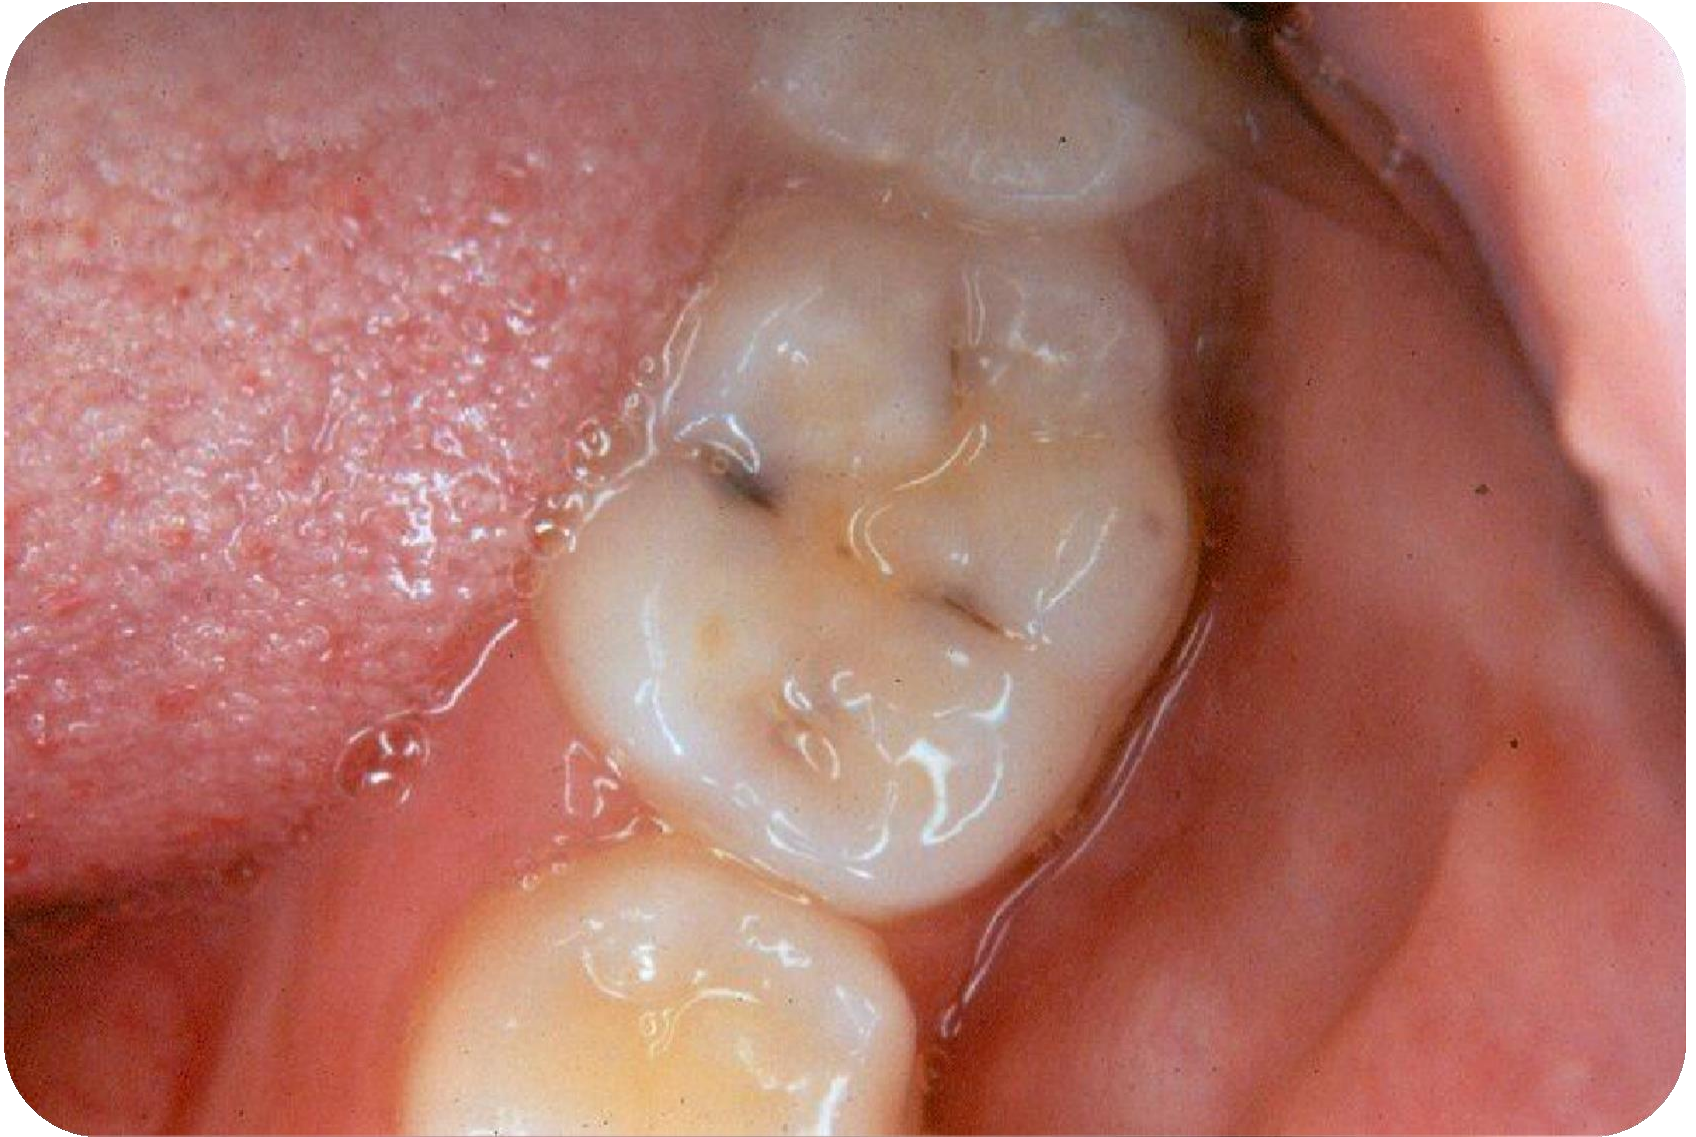
Surface code 2 – decayed into dentine

- **NB Surface is covered with saliva which can make diagnosis more difficult. Examiners are encouraged to dry surfaces with gauze, cotton wool rolls or cotton wool buds when visibility is obscured.**

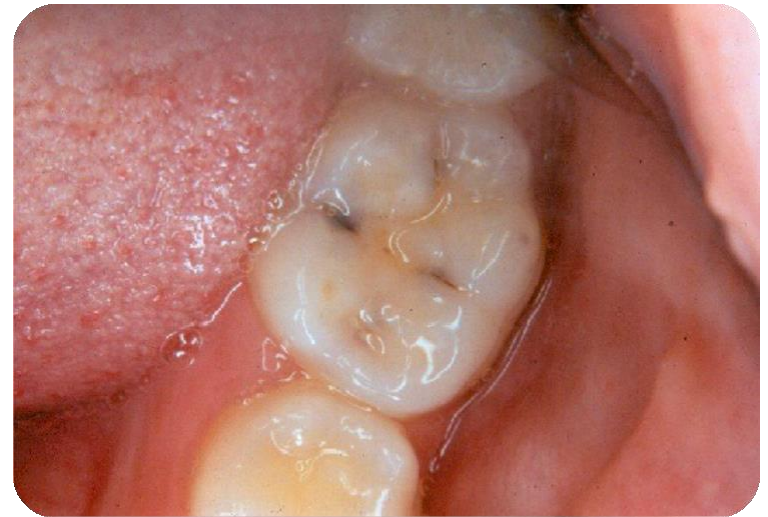
- LL6 occlusal surface –lingual aspect has deeply stained fissure and dark shadowing beneath the enamel.
- Mesial and distal aspects of the occlusal surface have lesions with cream and grey shadows beneath the enamel surface.
- Surface would be coded as caries into dentine code 2
- Smaller lesion into dentine also present on buccal aspect of the occlusal surface.

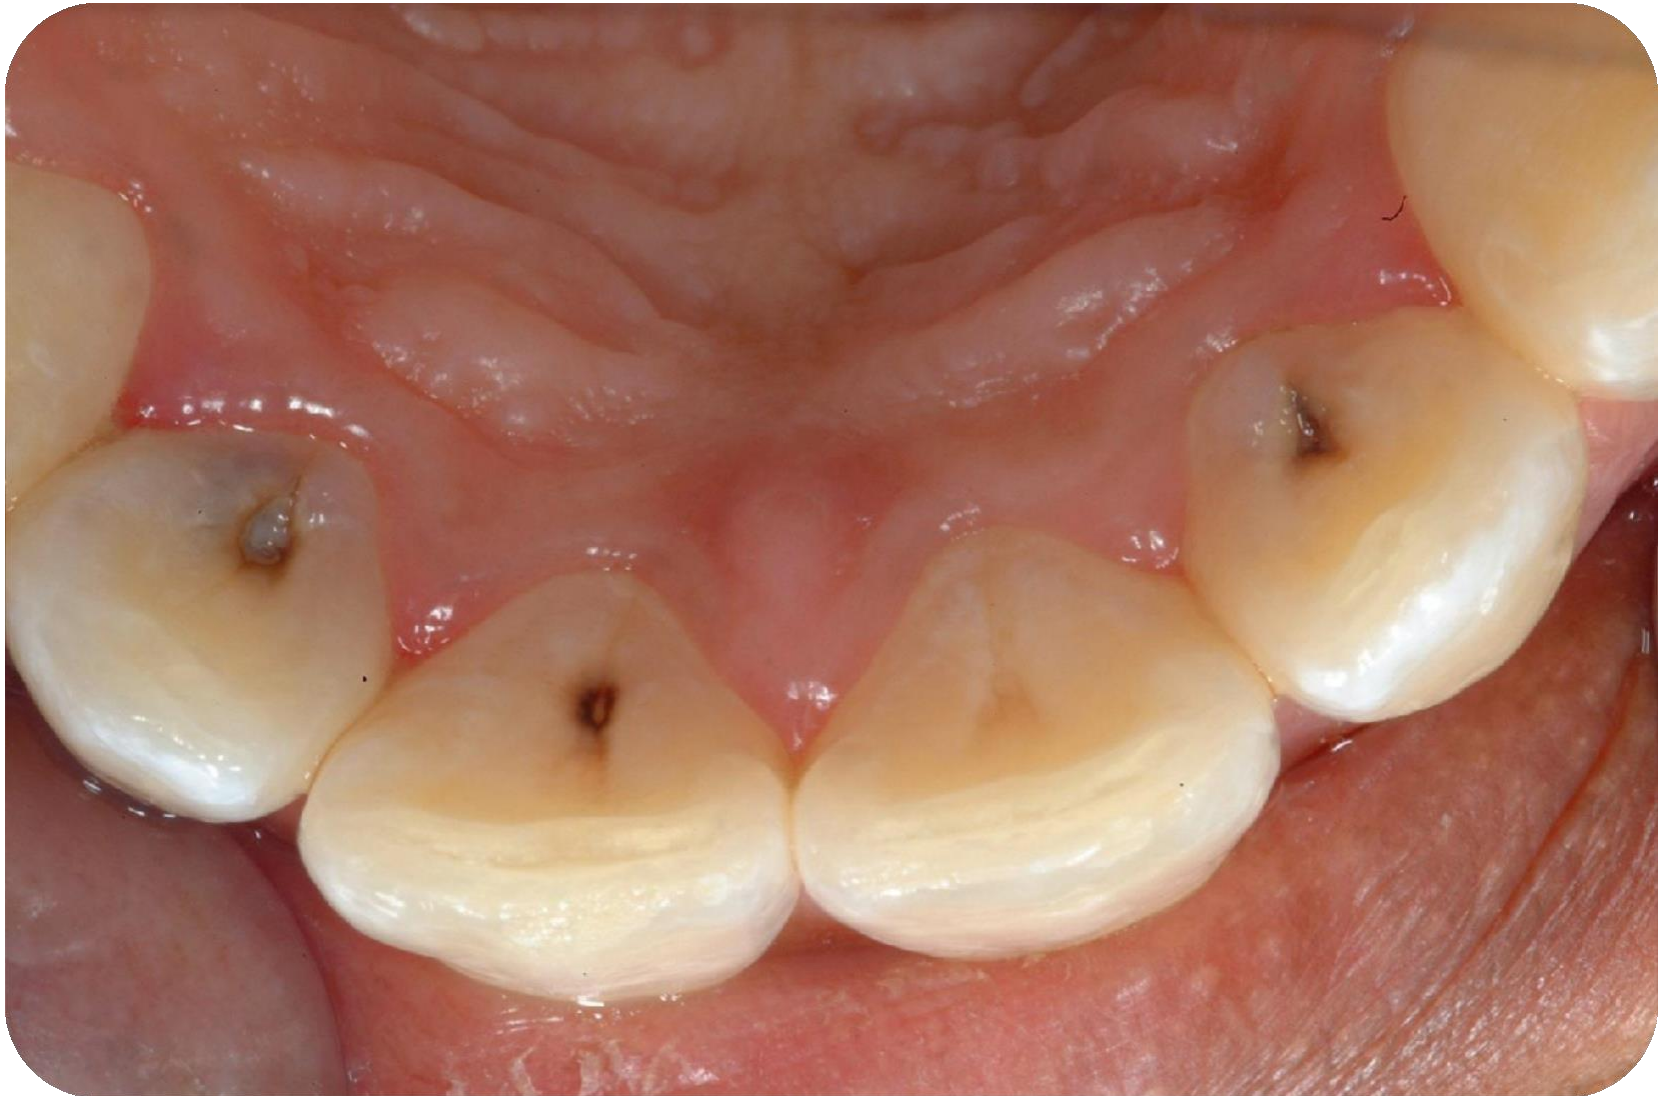
Surface code 2 – decayed into dentine

- Carious lesions involving dentine on lingual surfaces of upper lateral incisors
- Upper left central incisor has heavily stained pit
- No apparent break in enamel of UL1, no opacities beneath enamel which are present in lesions on laterals

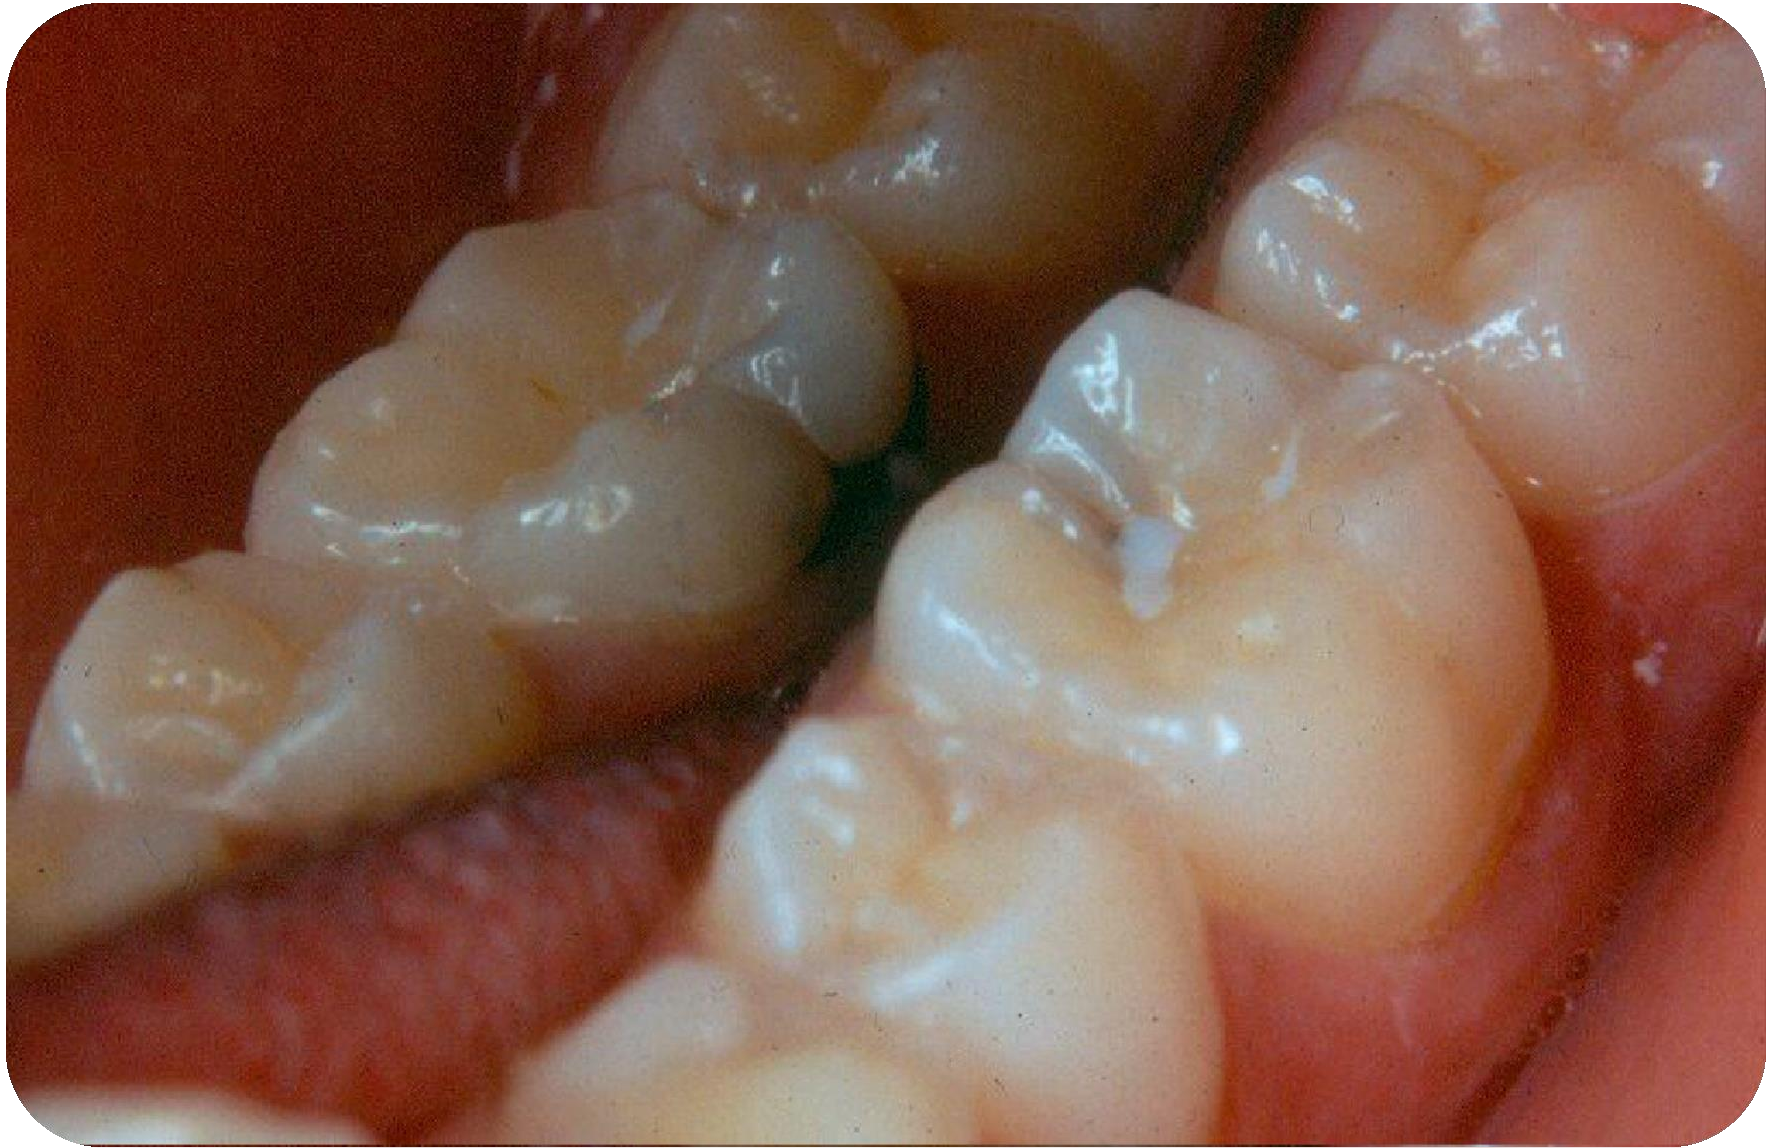
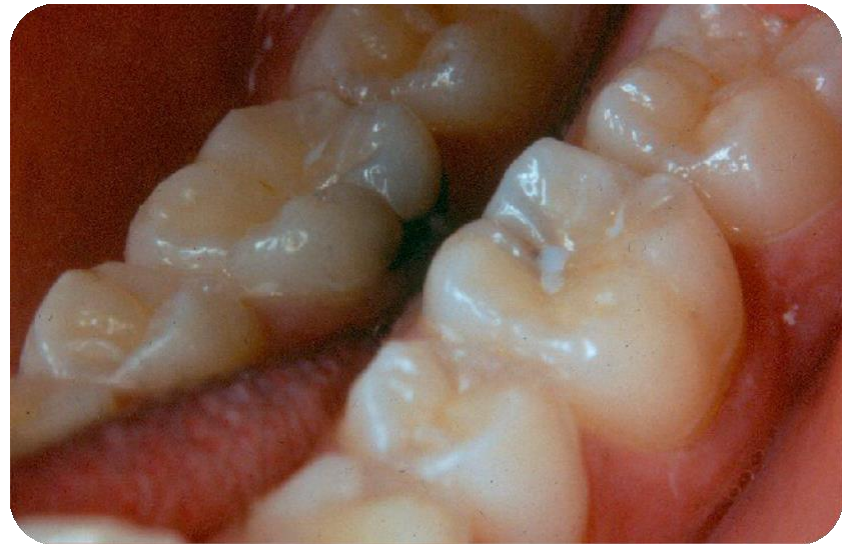
Surface code 2 – decayed into dentine

- **LL6 lingual and occlusal surfaces – look at lingual surface in mirror view first**
- **Large carious lesion within the gingival 3rd extending around base of lingual surface**
- **Presents as dark lesion cavitated into dentine with large associated area of grey shadowing beneath the enamel**

- **Grey shadowing extends to involve the occlusal surface.**
- **Occlusal surface has remnants of fissure sealant, but caries takes precedence and both lingual and occlusal scored as code 2.**
