BASCD Trainers' Pack for Caries Prevalence Studies

Updated: June 2014

*for UK Training & Calibration
exercise for the Deciduous Dentition*

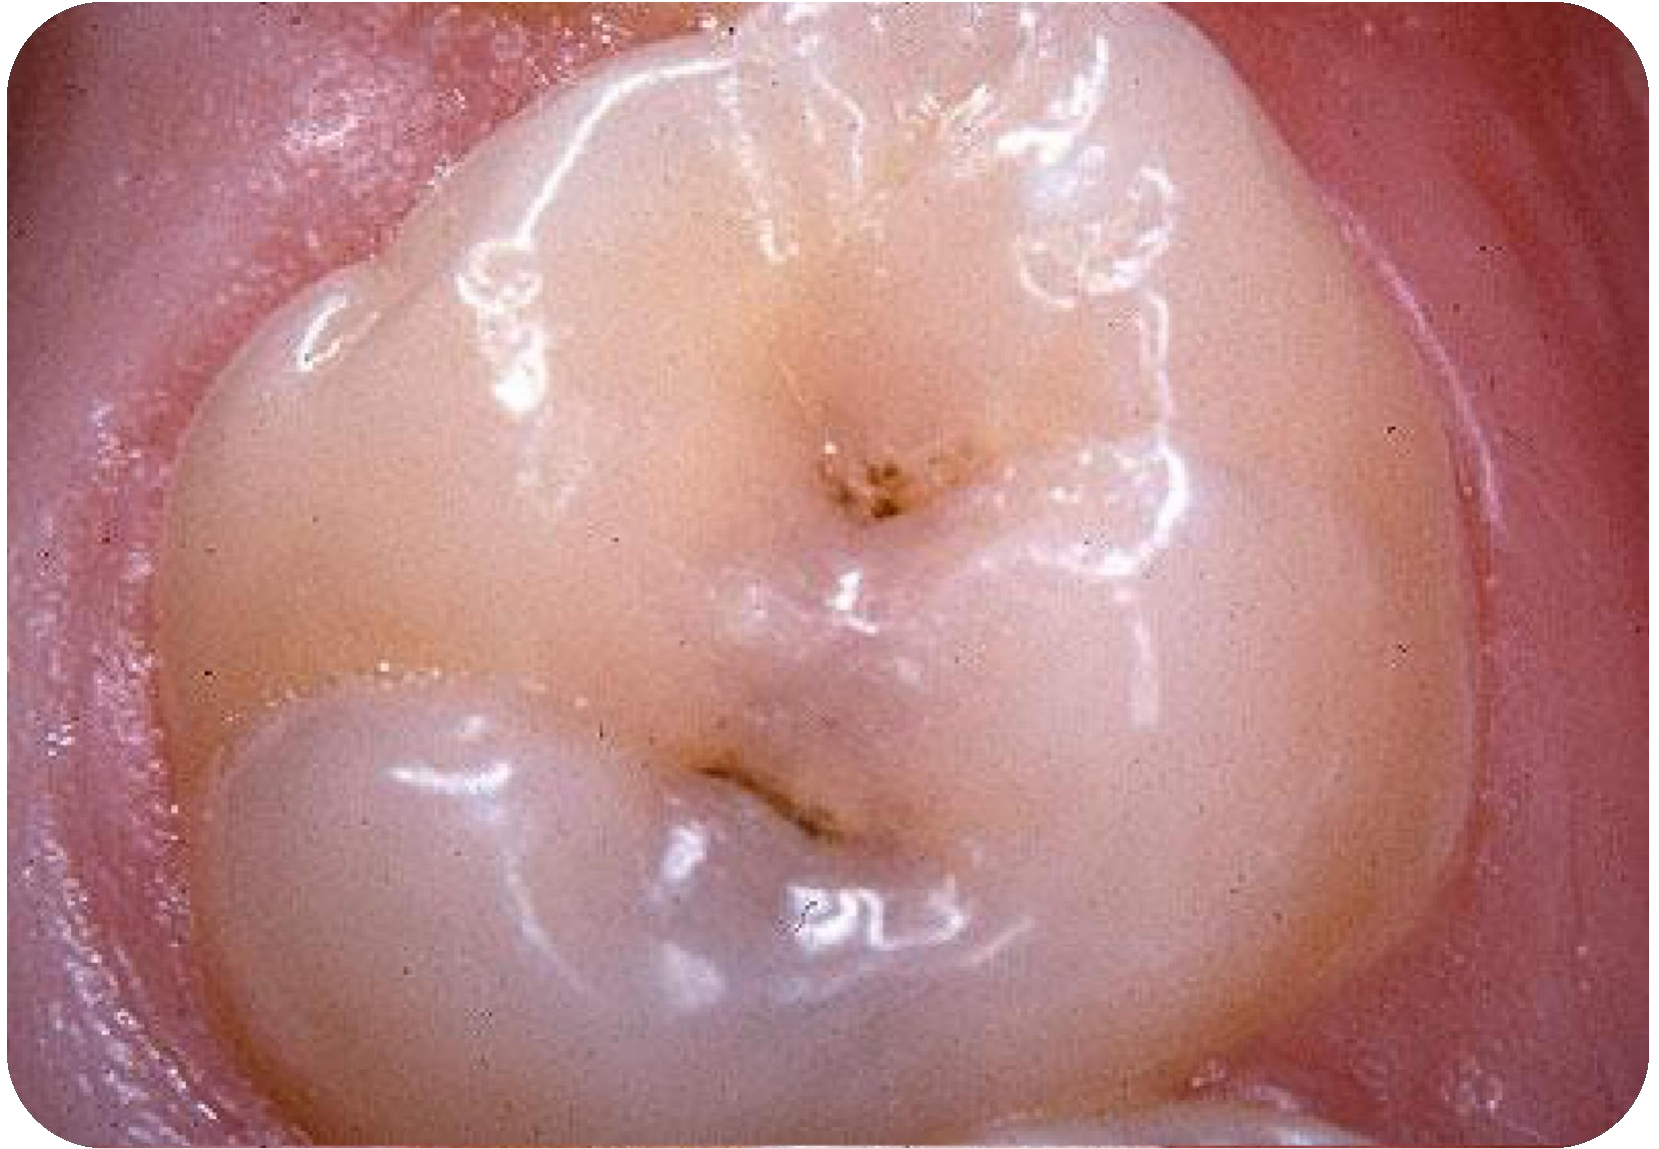
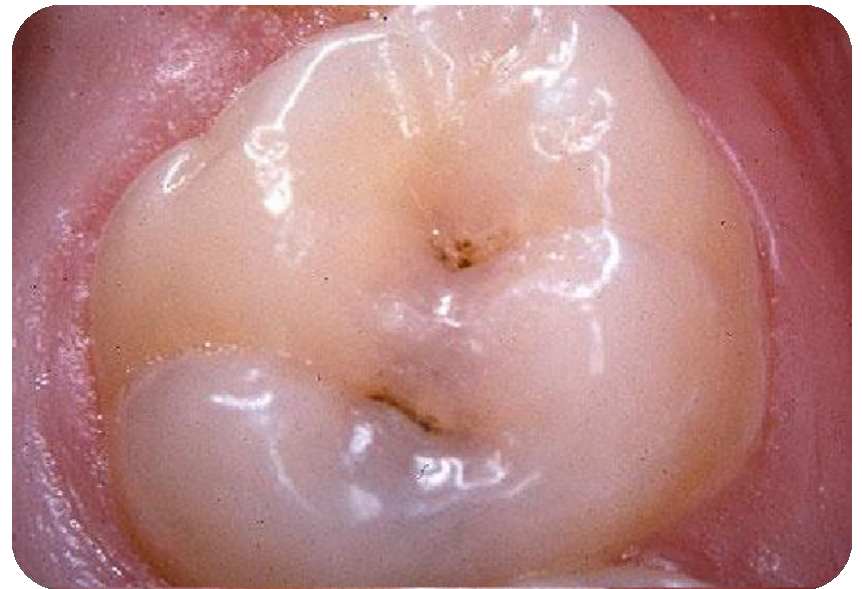
Surface code 2 – decayed into dentine

- On the occlusal surface there is a grey shadow extending across into the distal
- Both surfaces scored as code 2

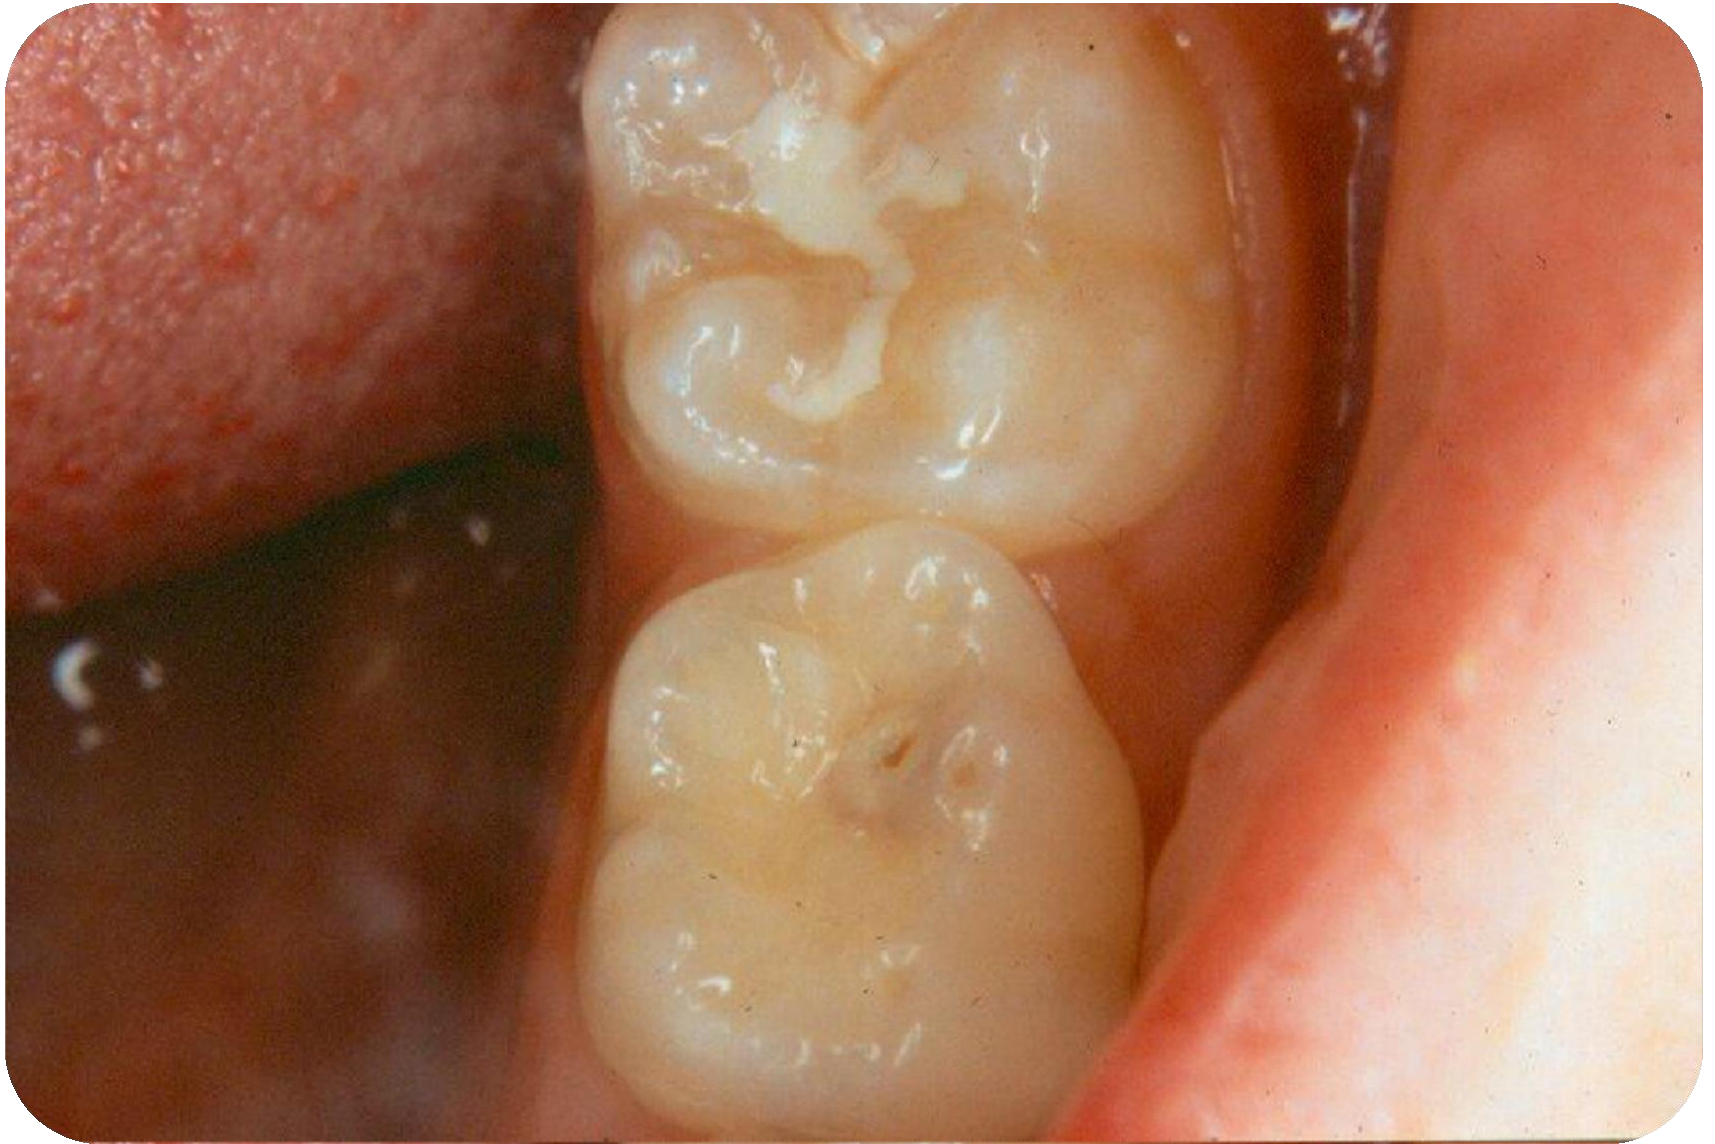
Surface code 2 – decayed into dentine

- **LLE –occlusal surface has a carious lesion into dentine**
- **Lesion presents with small cavitated area in the centre surrounded by cream and grey shadowing beneath the enamel**
- **Note that the tip of the cusp is worn and this would be regarded as normal.**

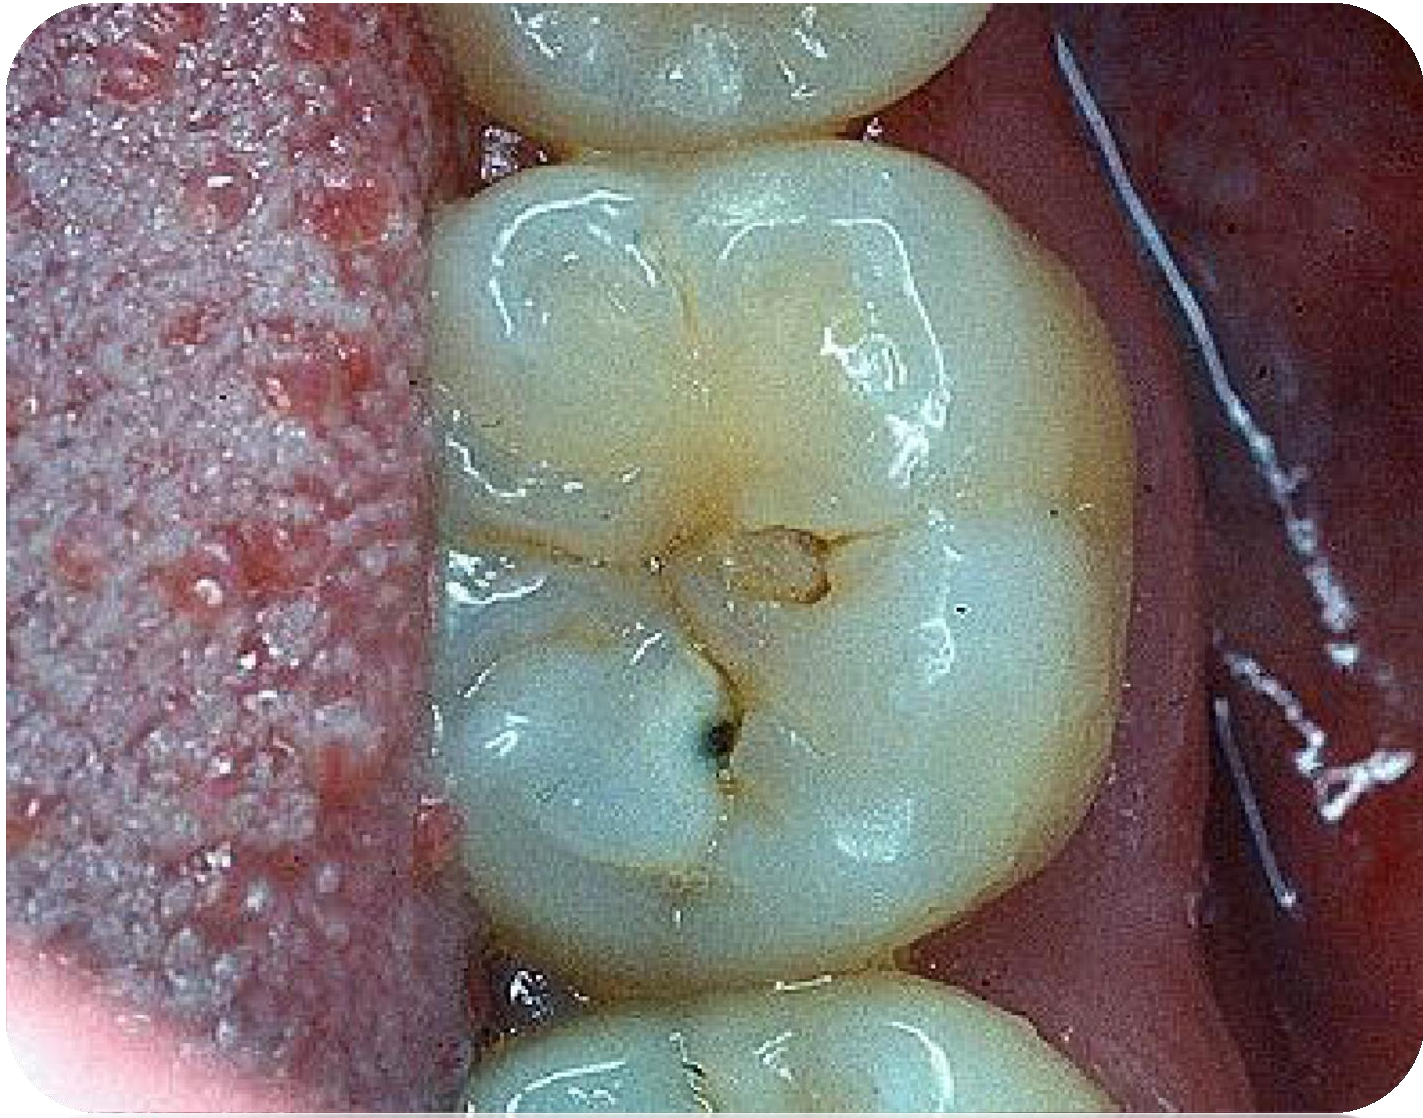
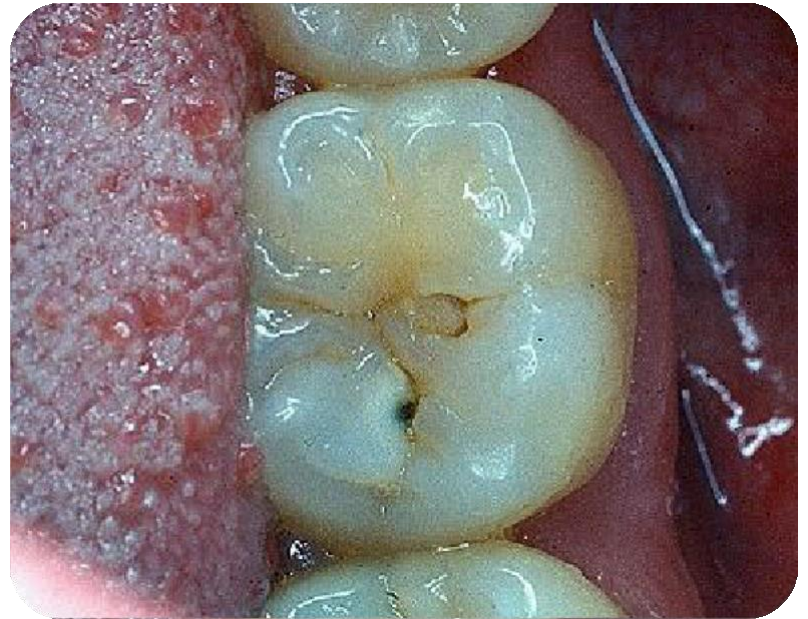
Surface code 2 – decayed into dentine

- LL6 occlusal surface has a break in the enamel extending into dentine and a creamy shadowing
- Occlusal code 2

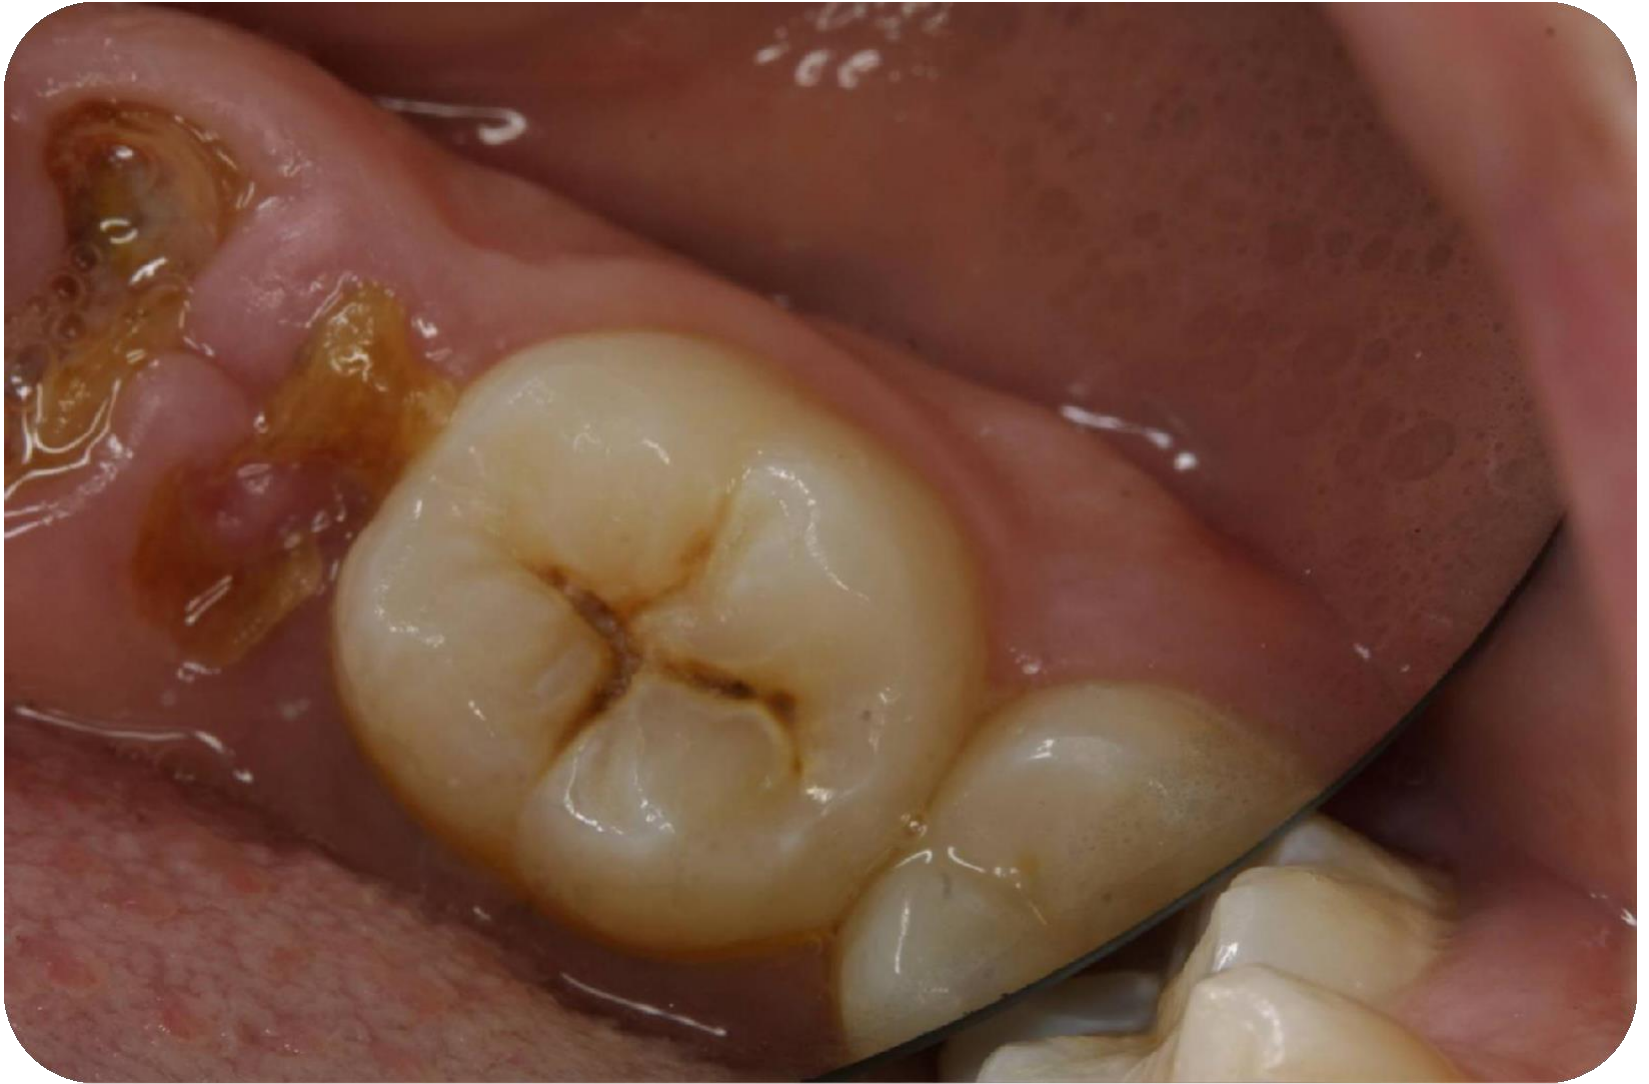
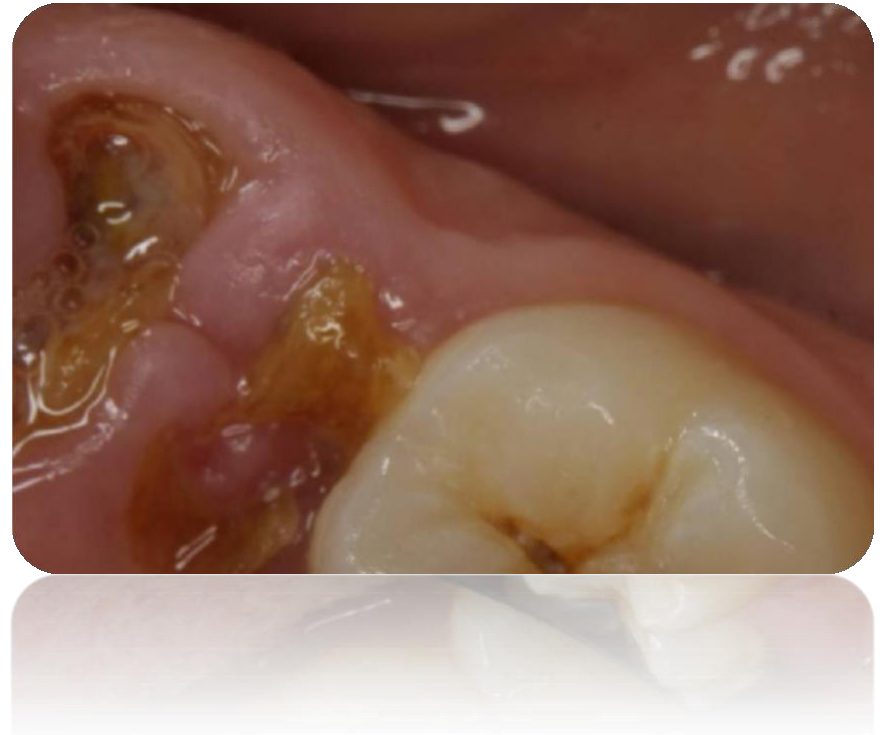
Surface code 2 – decayed into dentine

- LLE is retained roots
- LL6 has fissures which are widened due to carious breakdown
- Occlusal scored 2

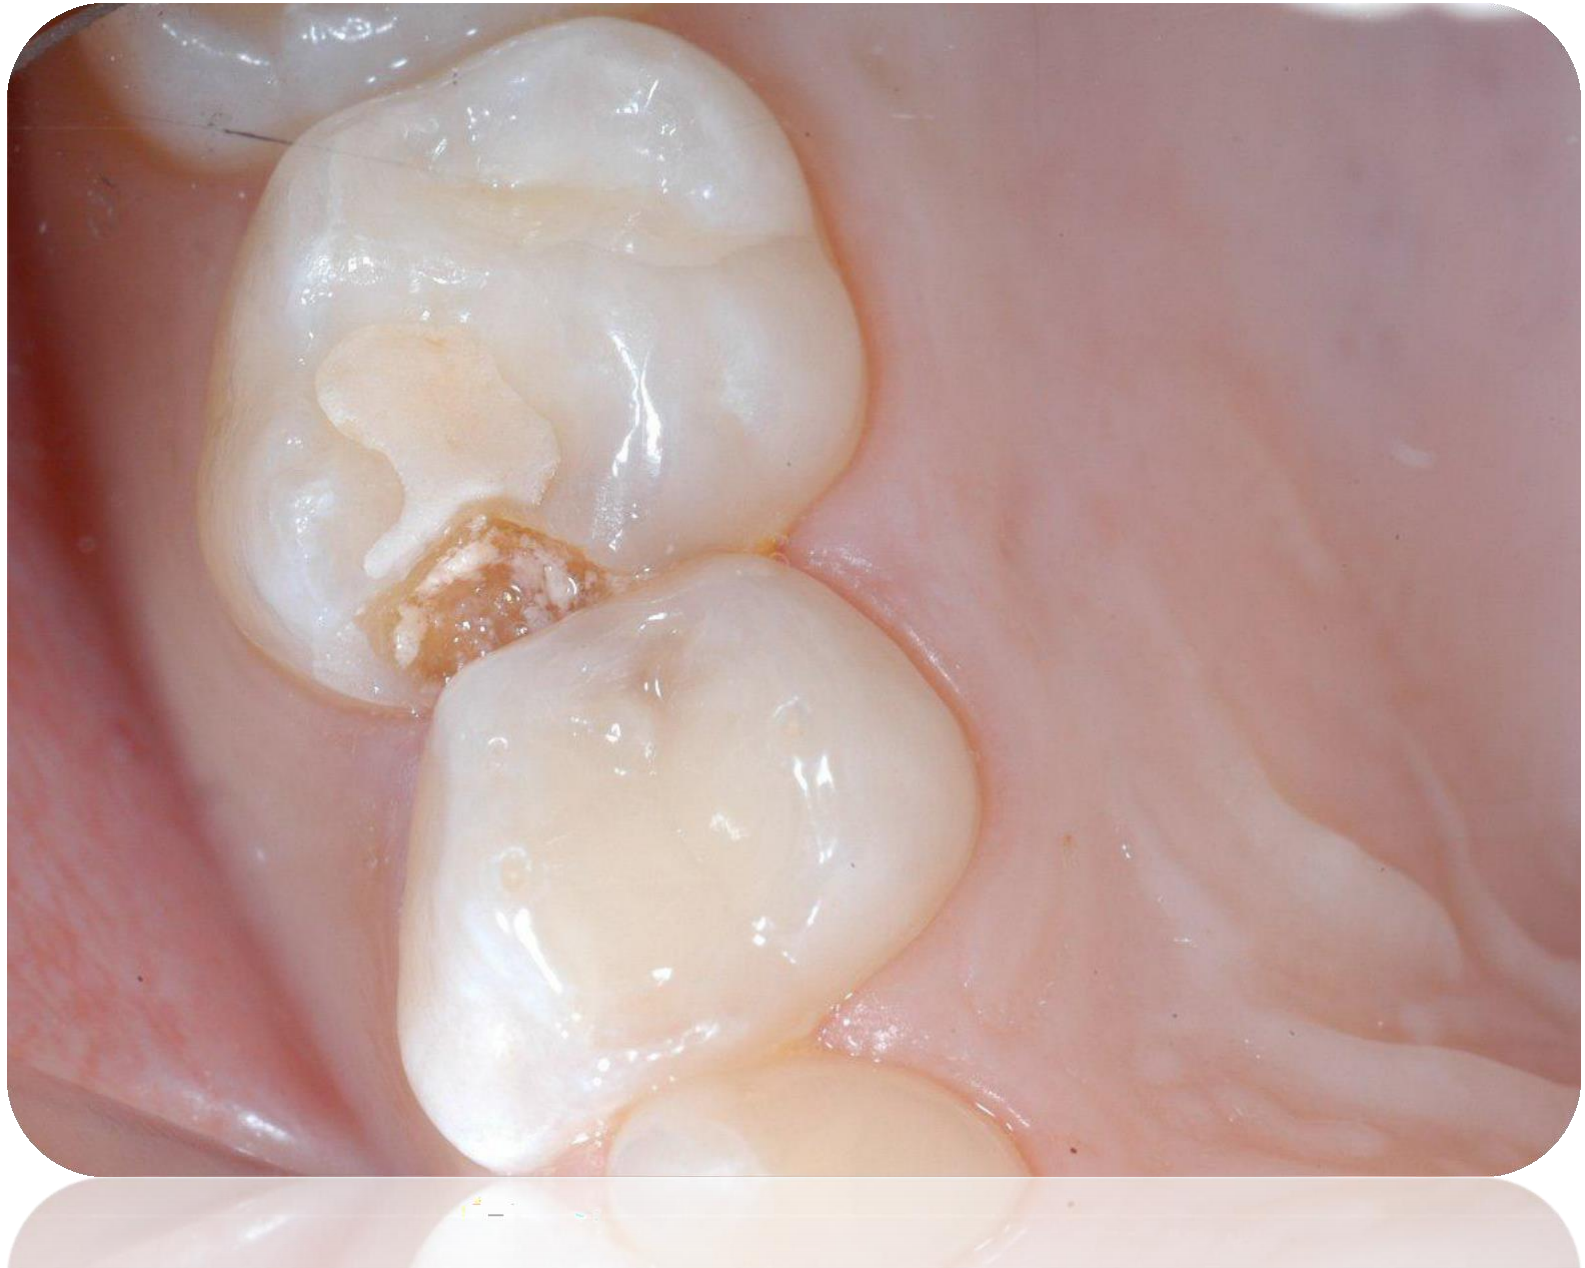
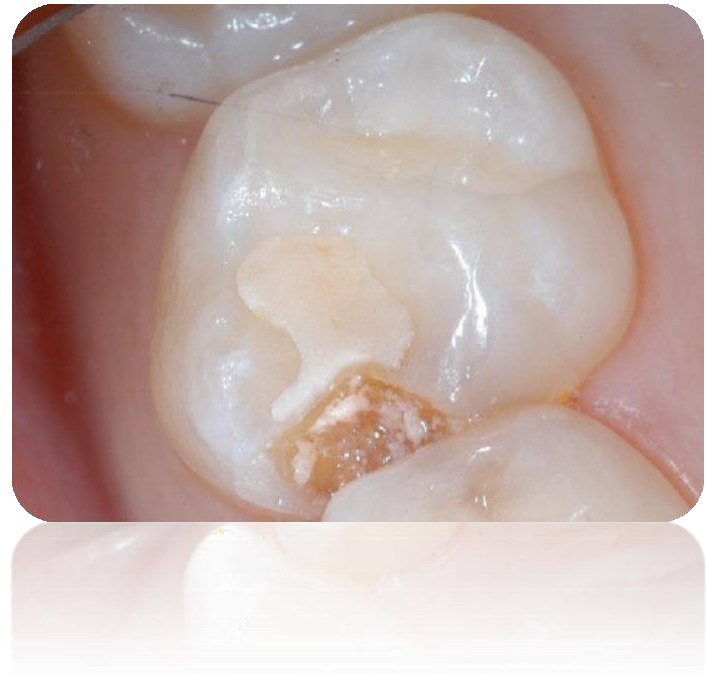
Surface code 2 – decayed into dentine

- URE - glass ionomer material on the occlusal surface
- fissure sealant + large carious lesion into dentine
- occlusal and mesial both code 2 - decayed
- URD has grey shadow within distal surface, dry and check before coding

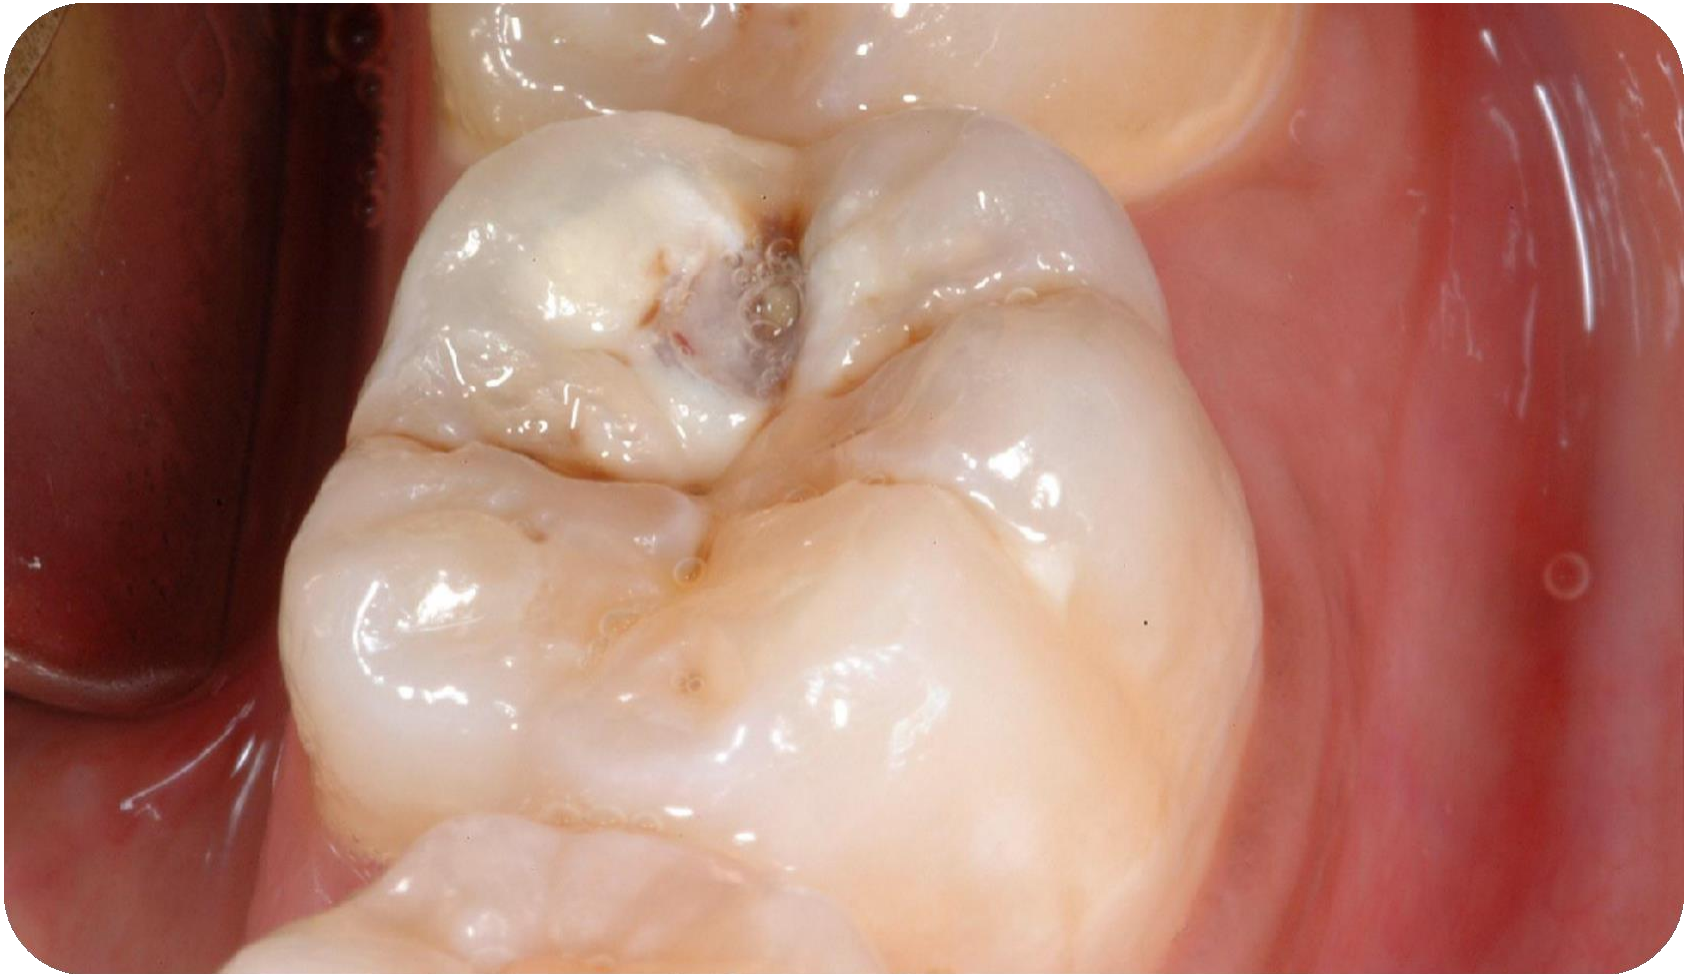
**Surface code 2 into dentine OR
code 3 decay with pulpal involvement ?- Discuss**

- Very large carious lesion into dentine
- Large area of cavitation
- Creamy opacity on lingual occlusal aspect
- Grey shadowing involving most of disto-buccal cusp

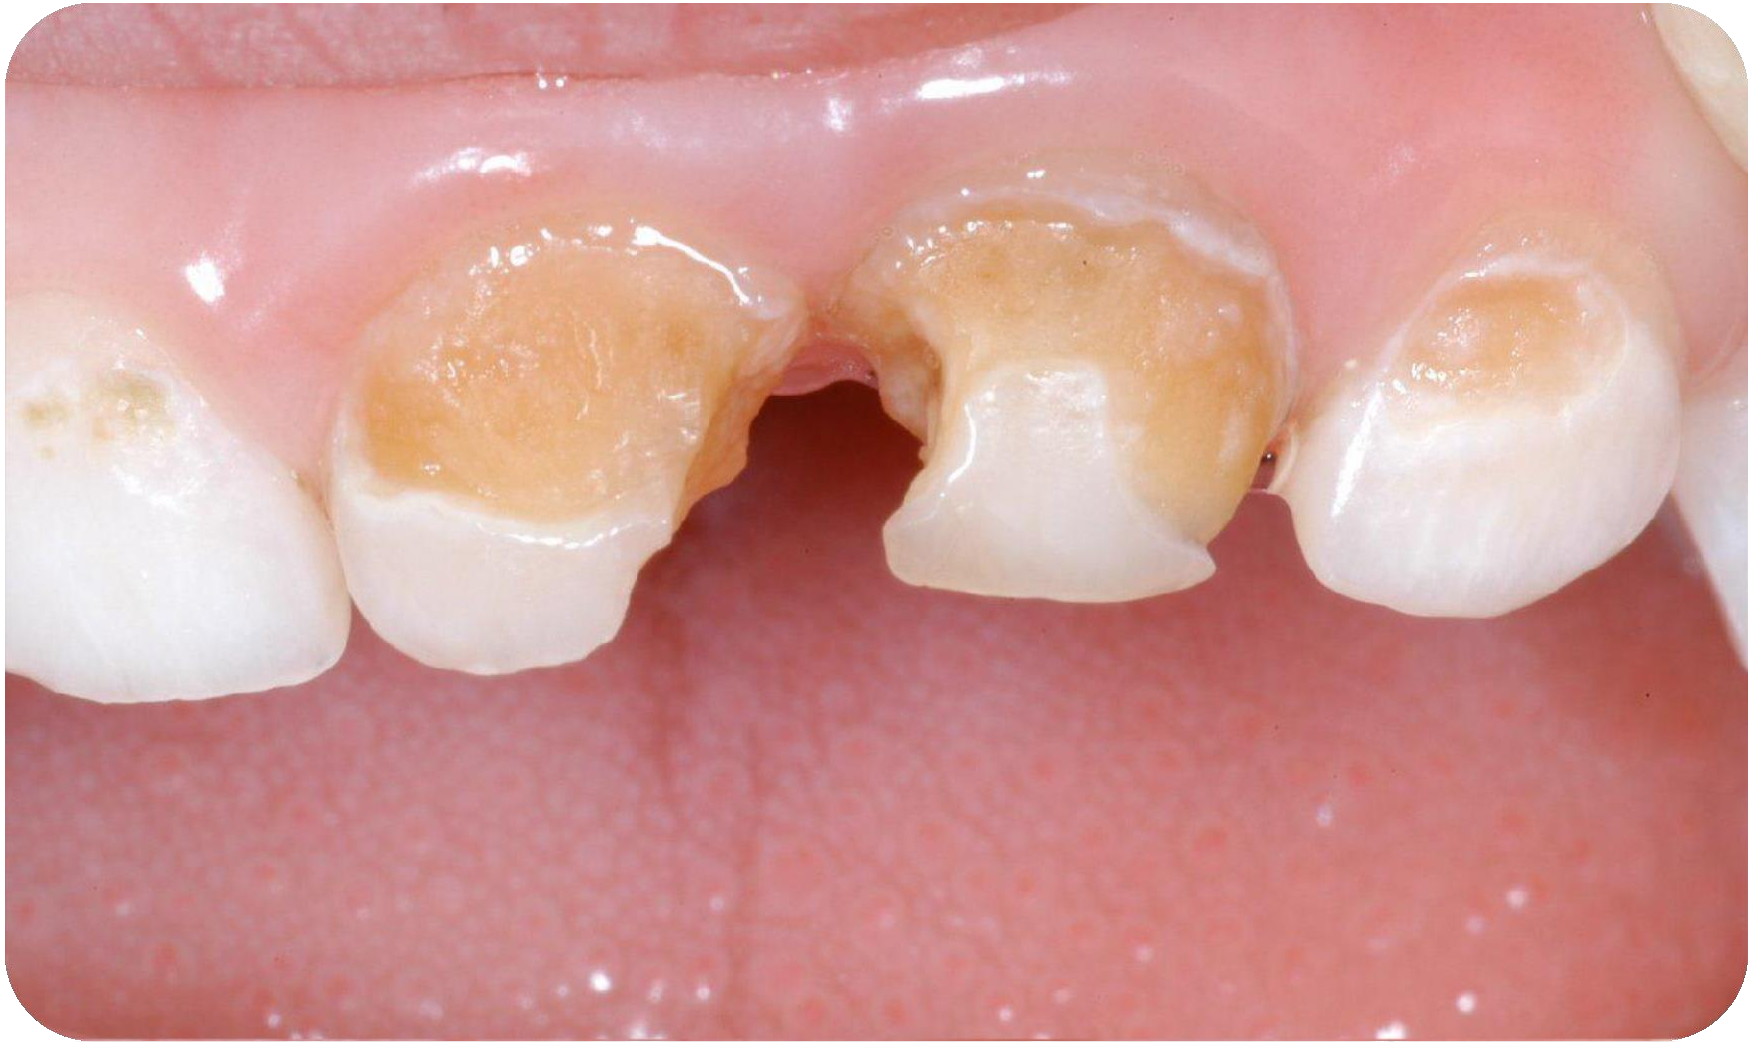
Surface code 3 – decay with pulpal involvement

- **Upper anterior deciduous teeth decayed into dentine**
- **Mesial surfaces of central incisors likely to be decayed with pulpal involvement, Code 3**

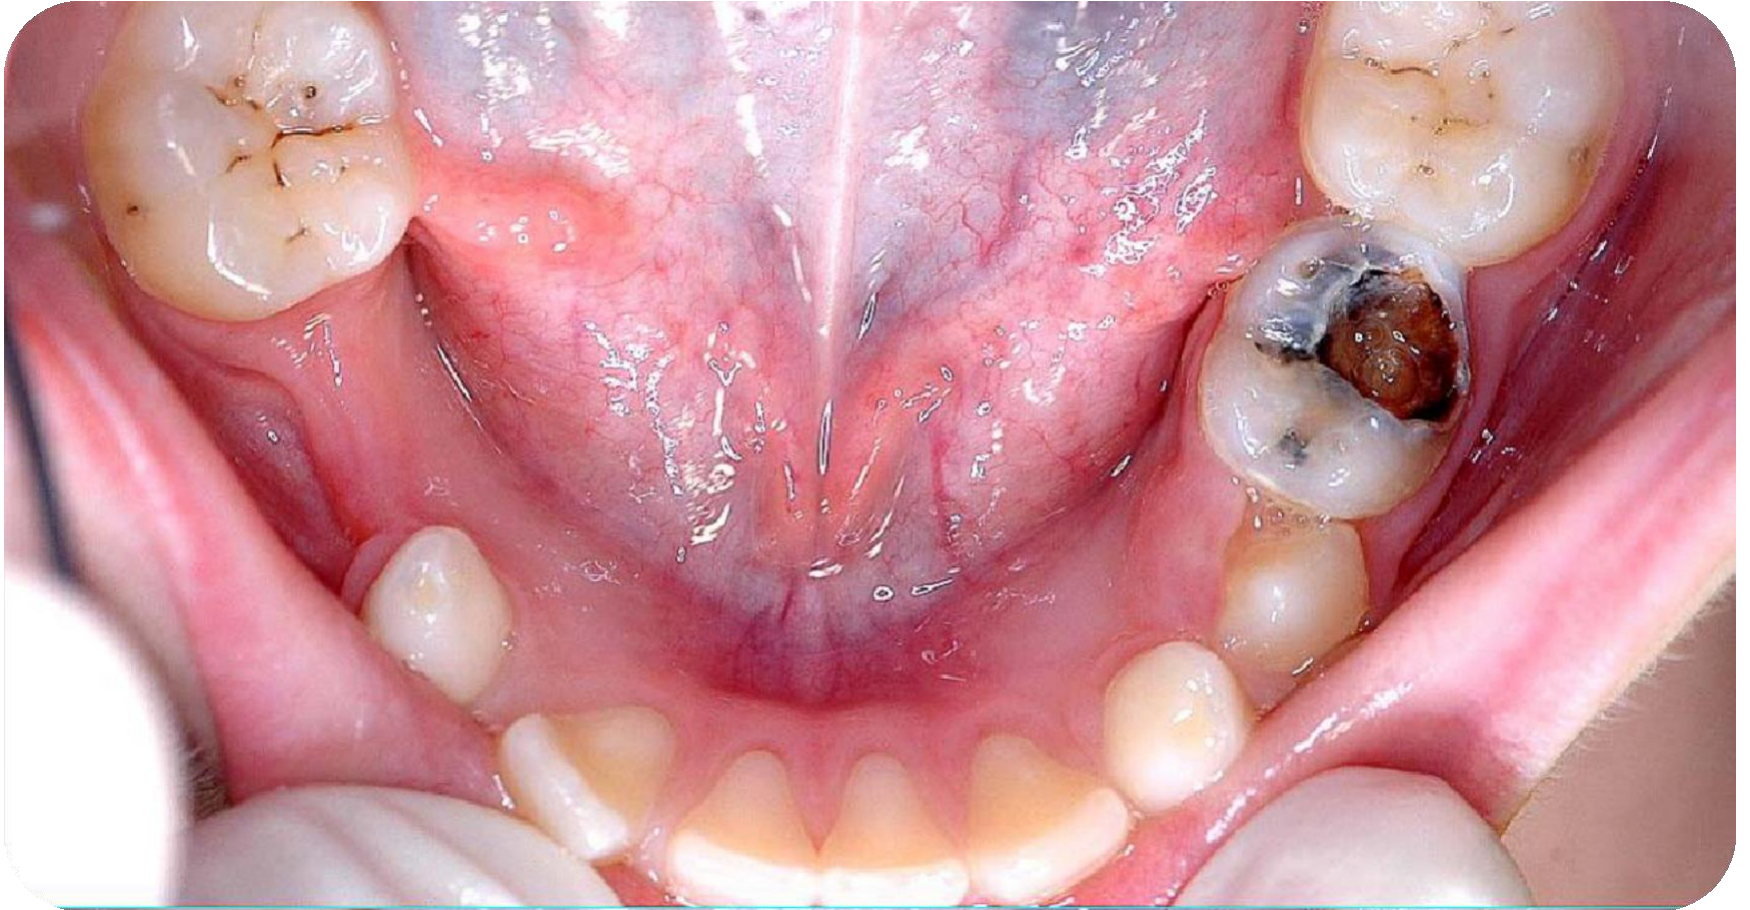
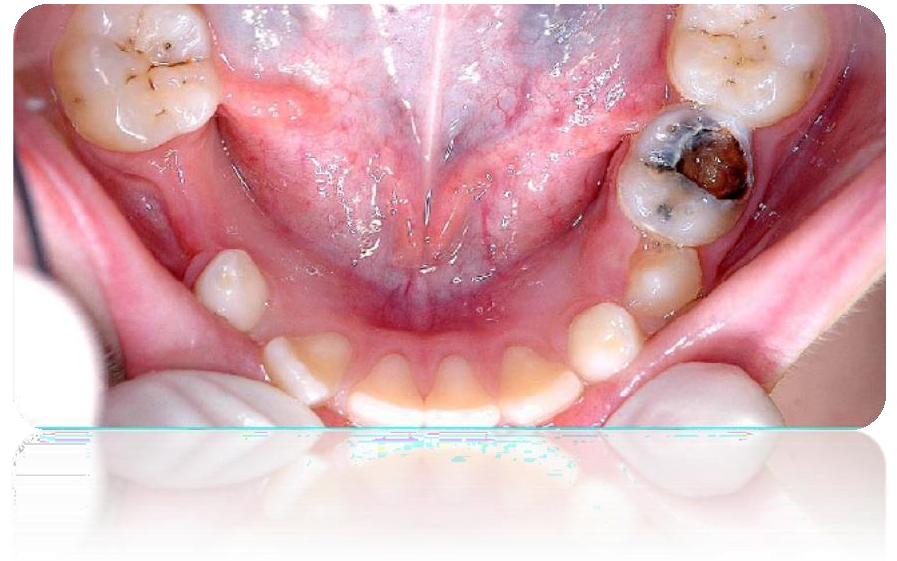
Surface code 3 – decay with pulpal involvement

- **LLE is extensively decayed**
- **Occlusal, buccal and distal code 3**

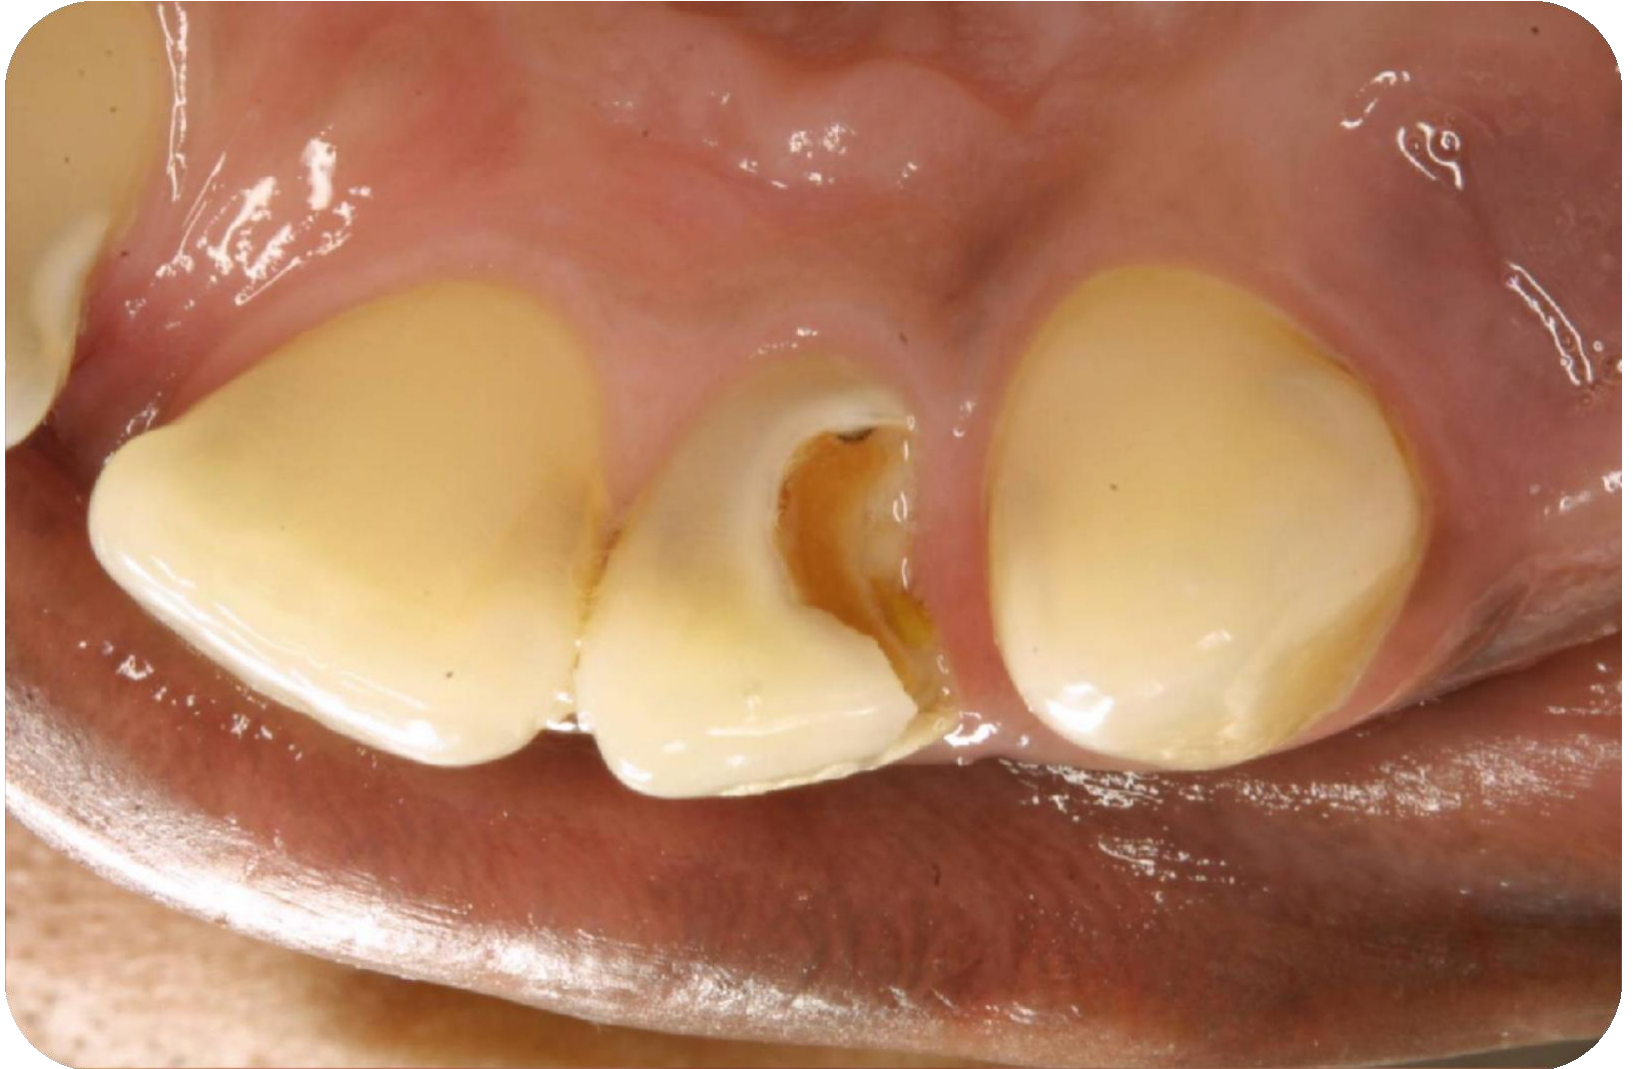
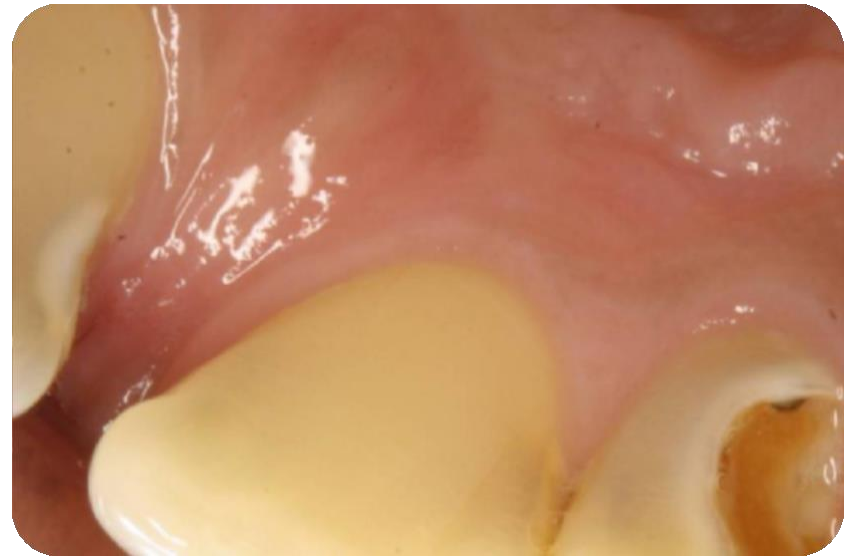
Surface code 3 – decay with pulpal involvement

- UR2 has a large carious lesion on the lingual and distal surfaces, code 3
- Caries into dentine is present on adjacent teeth

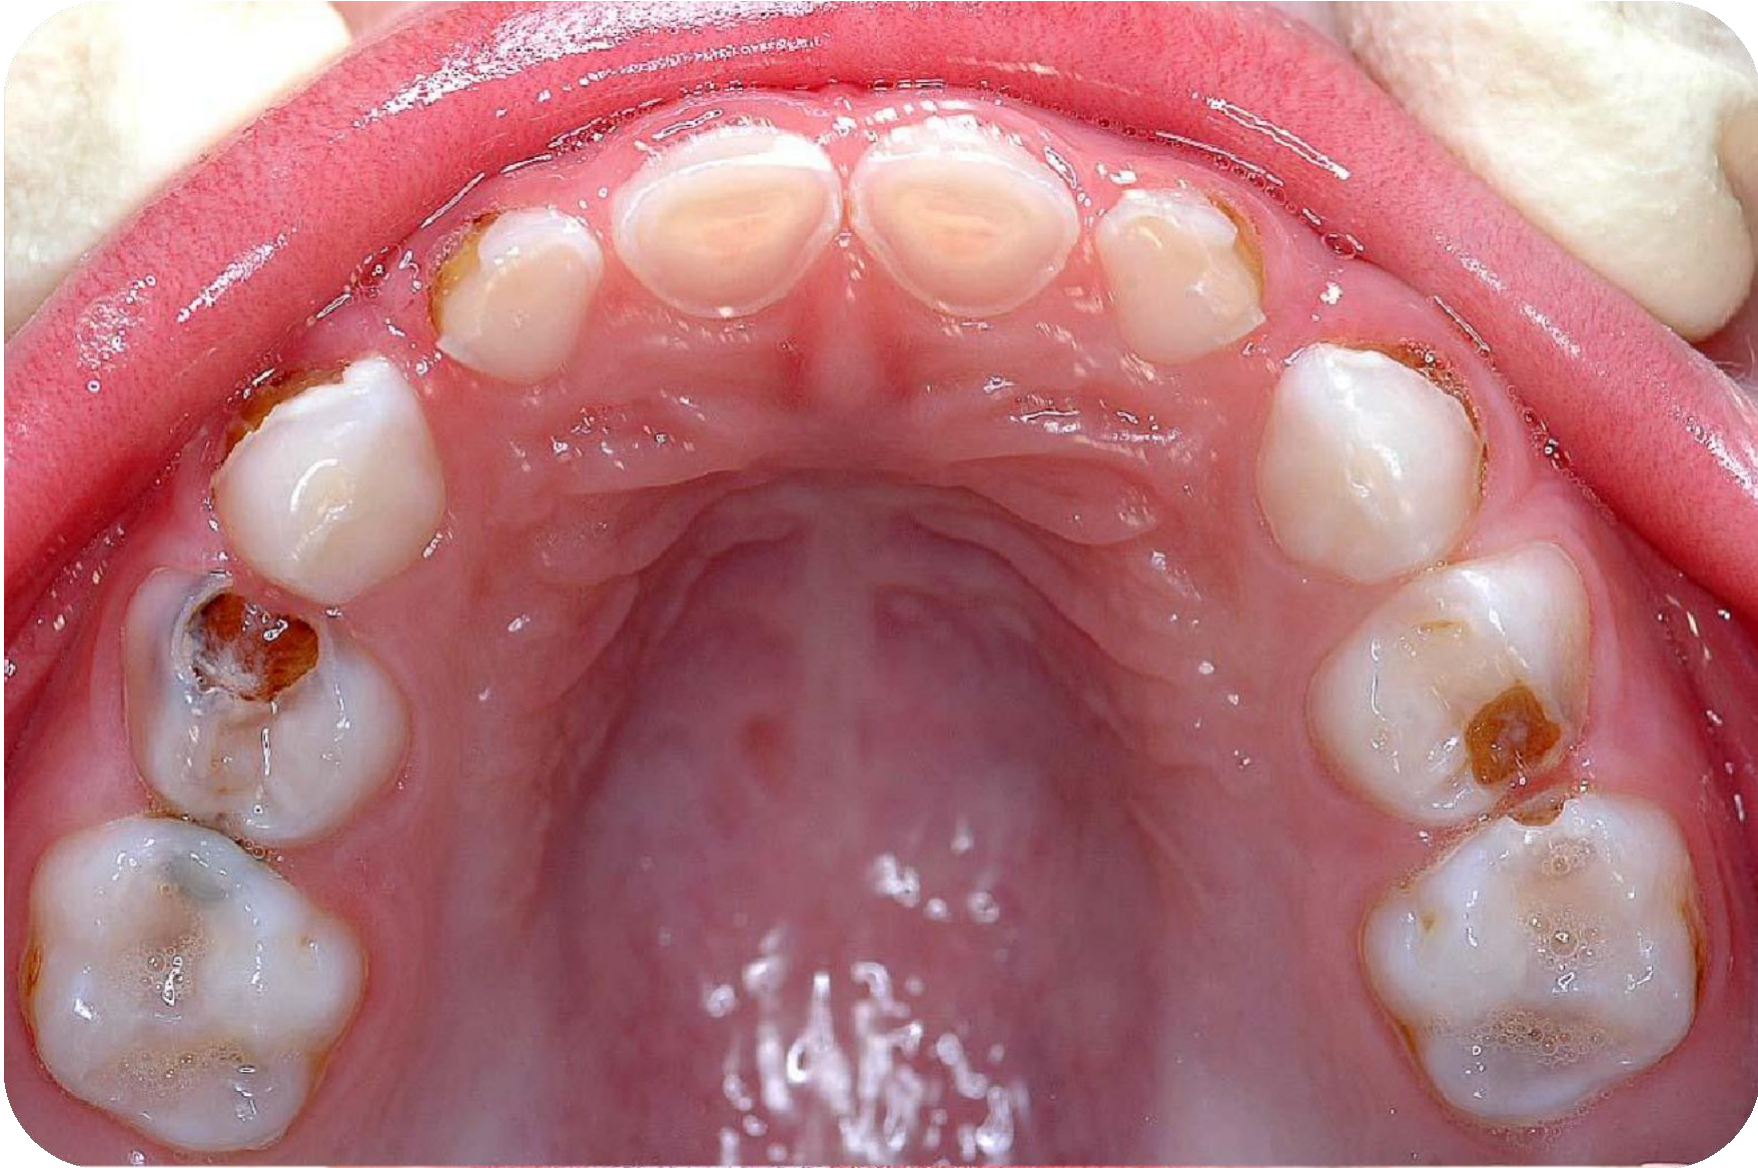
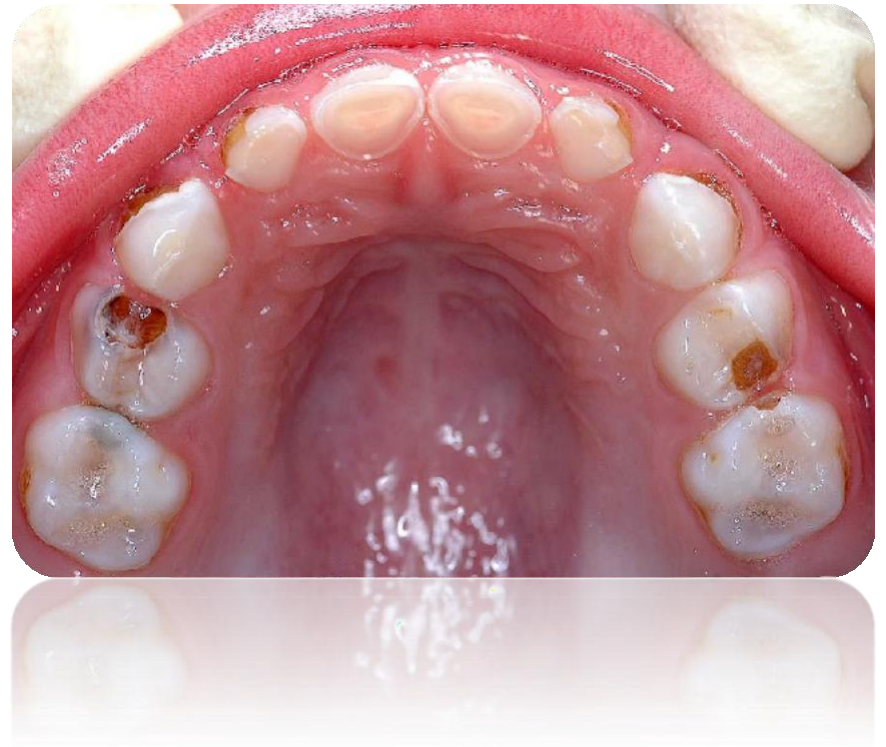
Surface code 3 – decay with pulpal involvement

- URD occlusal and mesial code 3
- Discuss the many carious lesions on other teeth
