BASCD Trainers' Pack for Caries Prevalence Studies

Updated: June 2014

*for UK Training & Calibration
exercise for the Deciduous Dentition*

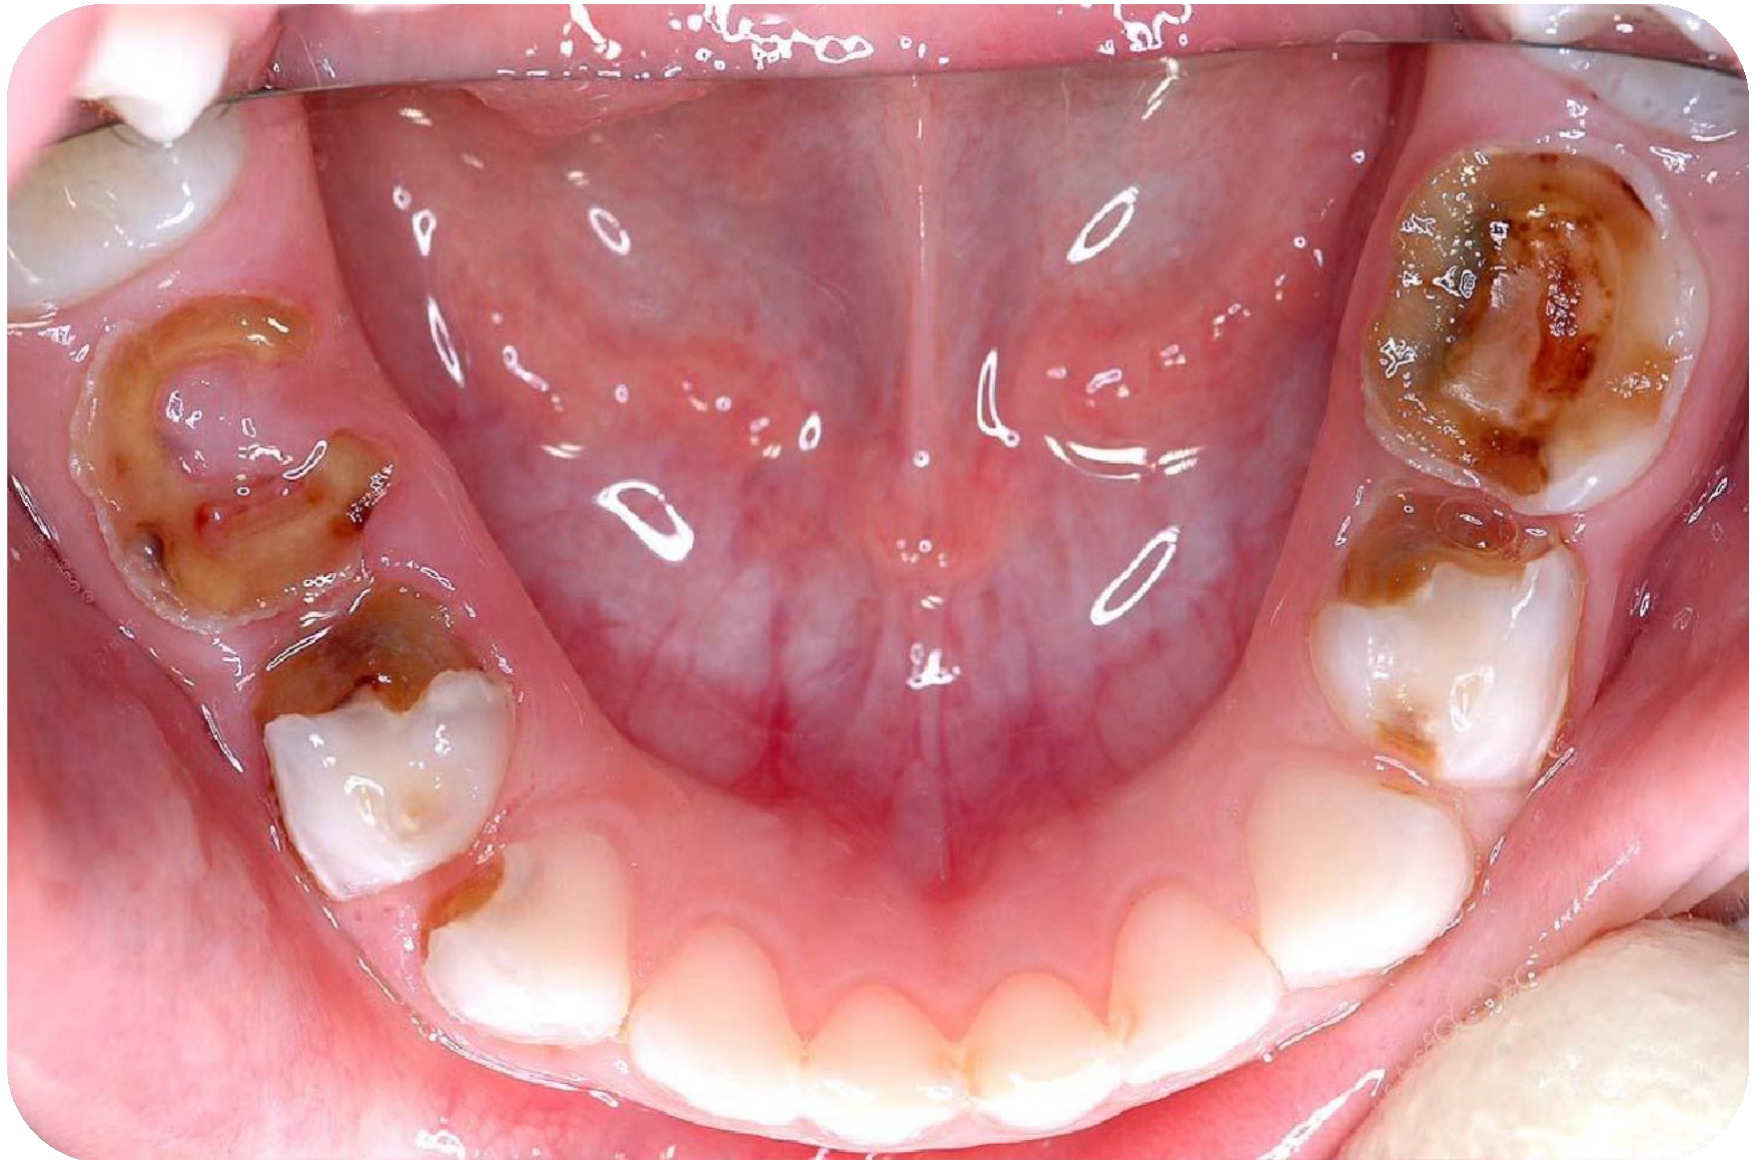
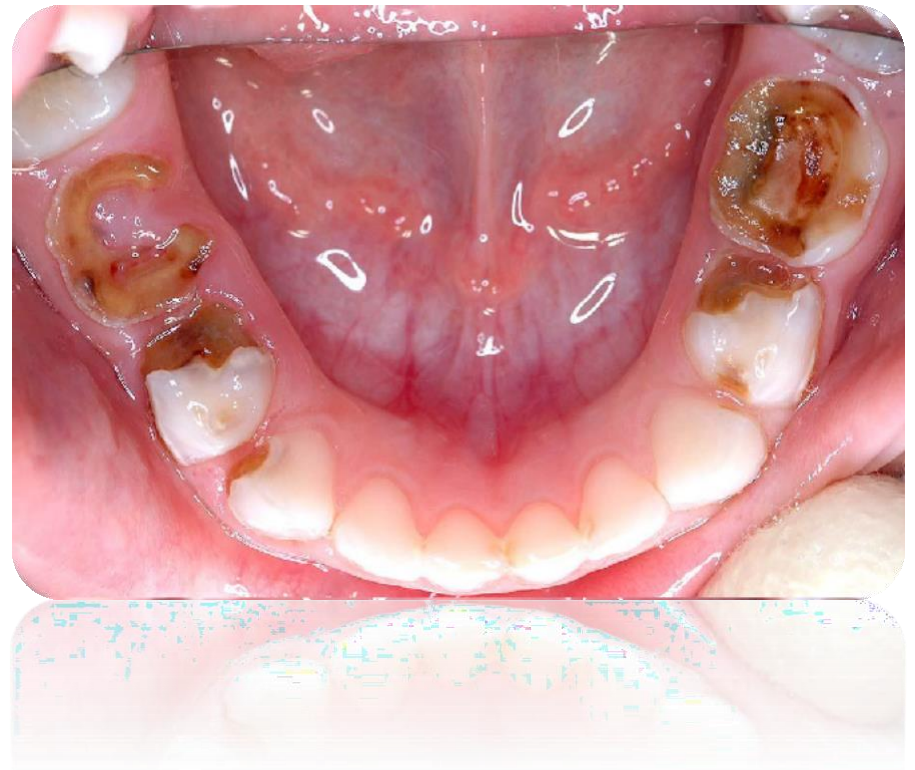
Surface code 3 – decay with pulpal involvement

- Lower molars all have lesions with pulpal involvement
- Several lower incisors have approximal caries

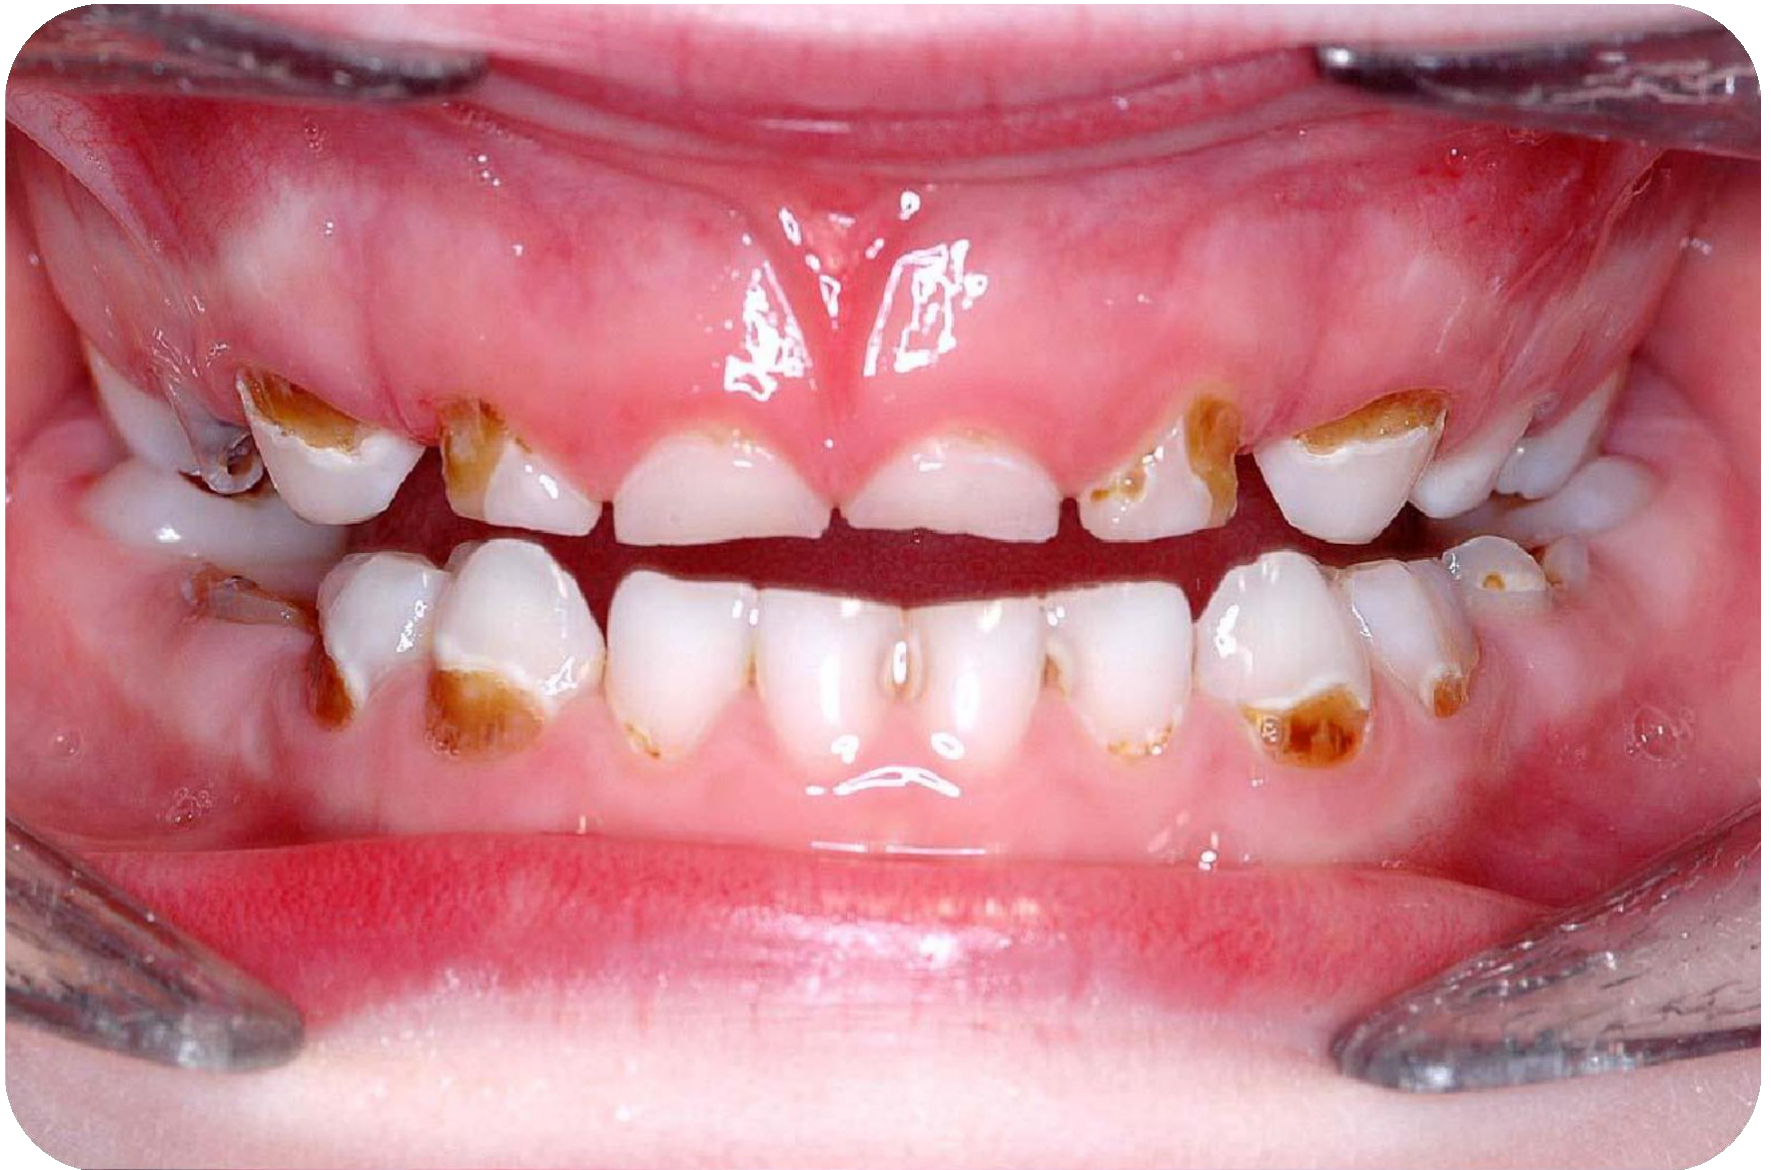
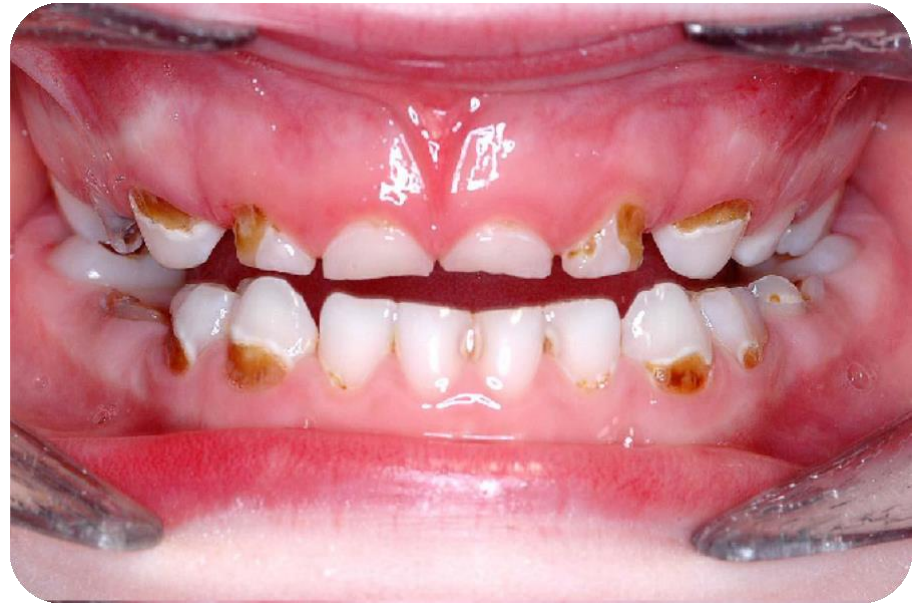
Surface code 3 – decay with pulpal involvement

- **Crown of LRE is decayed to gingival margin**
- **All other teeth (except upper As) have carious lesions into dentine**

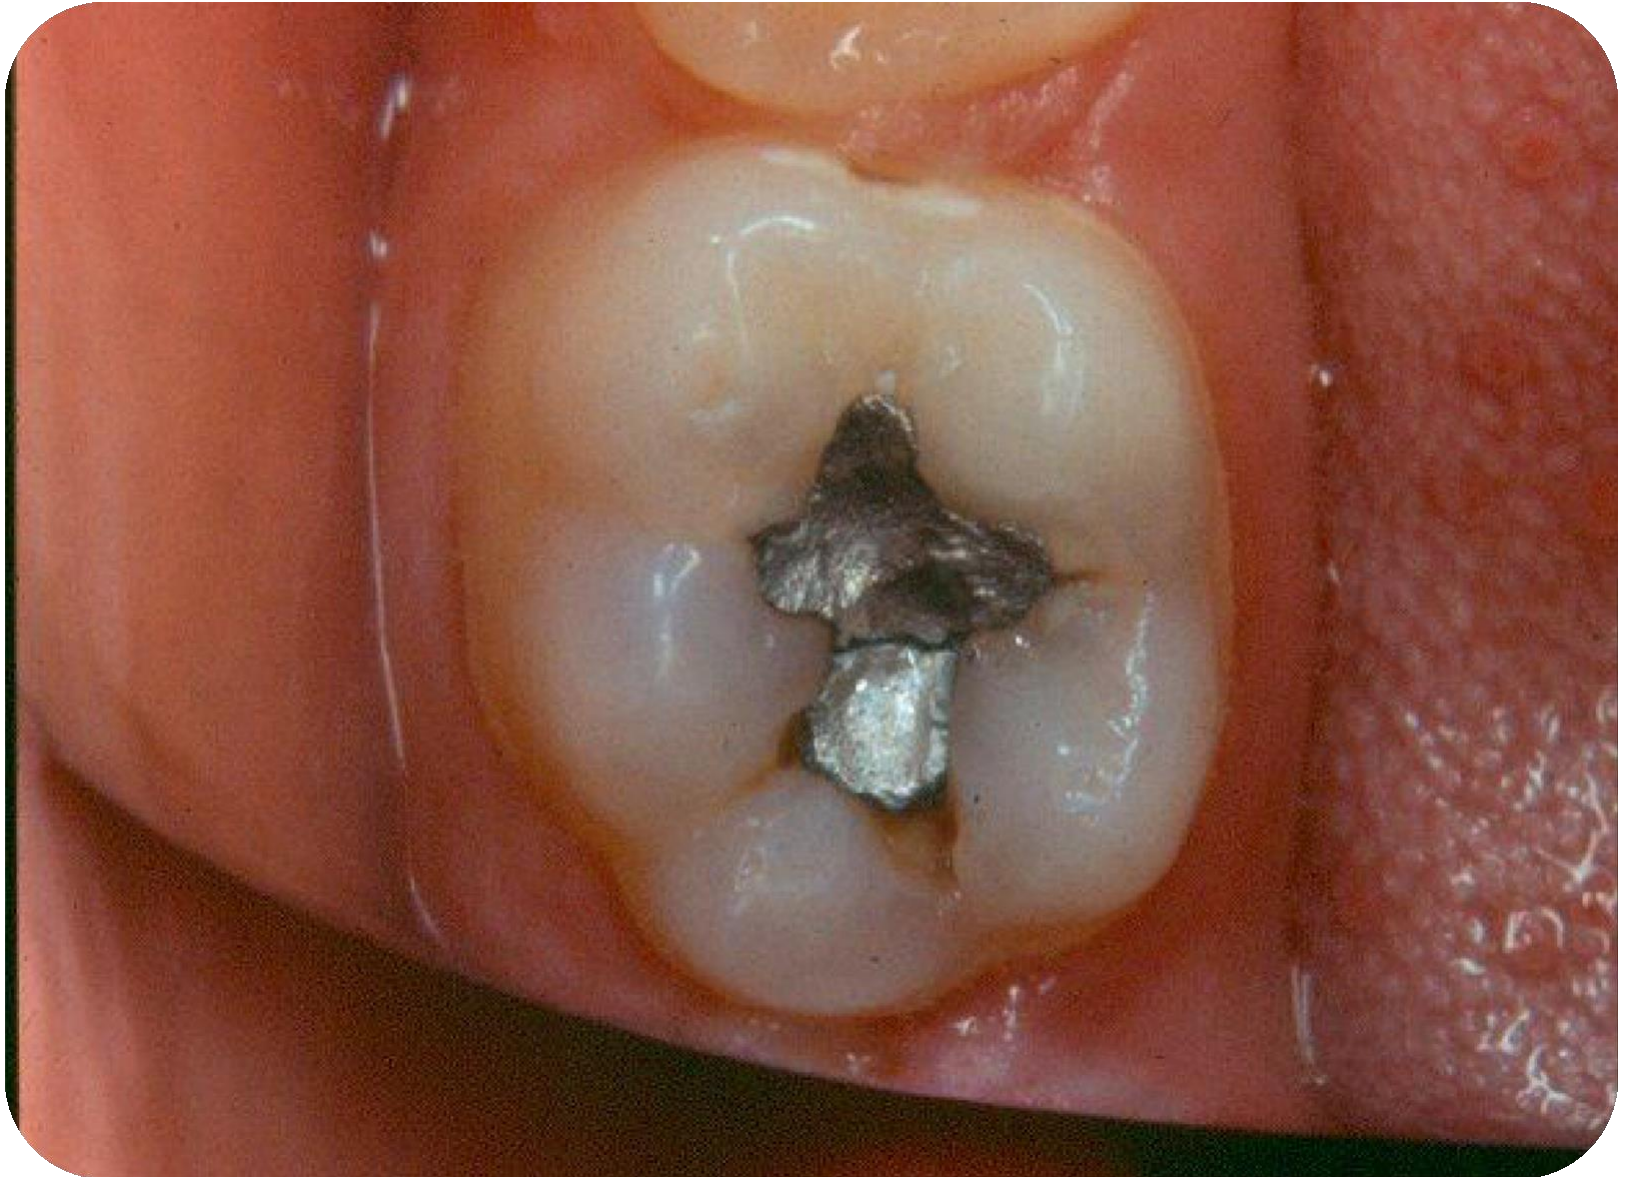
Surface code 4 – filled and decayed

- **LL6 occlusal surface has been restored with amalgam which is fractured**
- **There are 4 separate areas of secondary caries, i.e. caries associated with the filling.**
- **Two of the carious areas are in the distal and disto-buccal parts of the fissure and are characterised by cavitation into dentine.**

- **Lingual aspect of occlusal surface has caries associated with the filling**
- **This stained fissure has creamy shadowing beneath the enamel**
- **Buccal aspect of occlusal filling has a cavitated area of secondary caries.**
- **Surface is coded 4 – filled and decayed.**

NB. If no caries was present and this filling presented with the complete fracture, the surface would have been coded R, which is filled needs replacing.

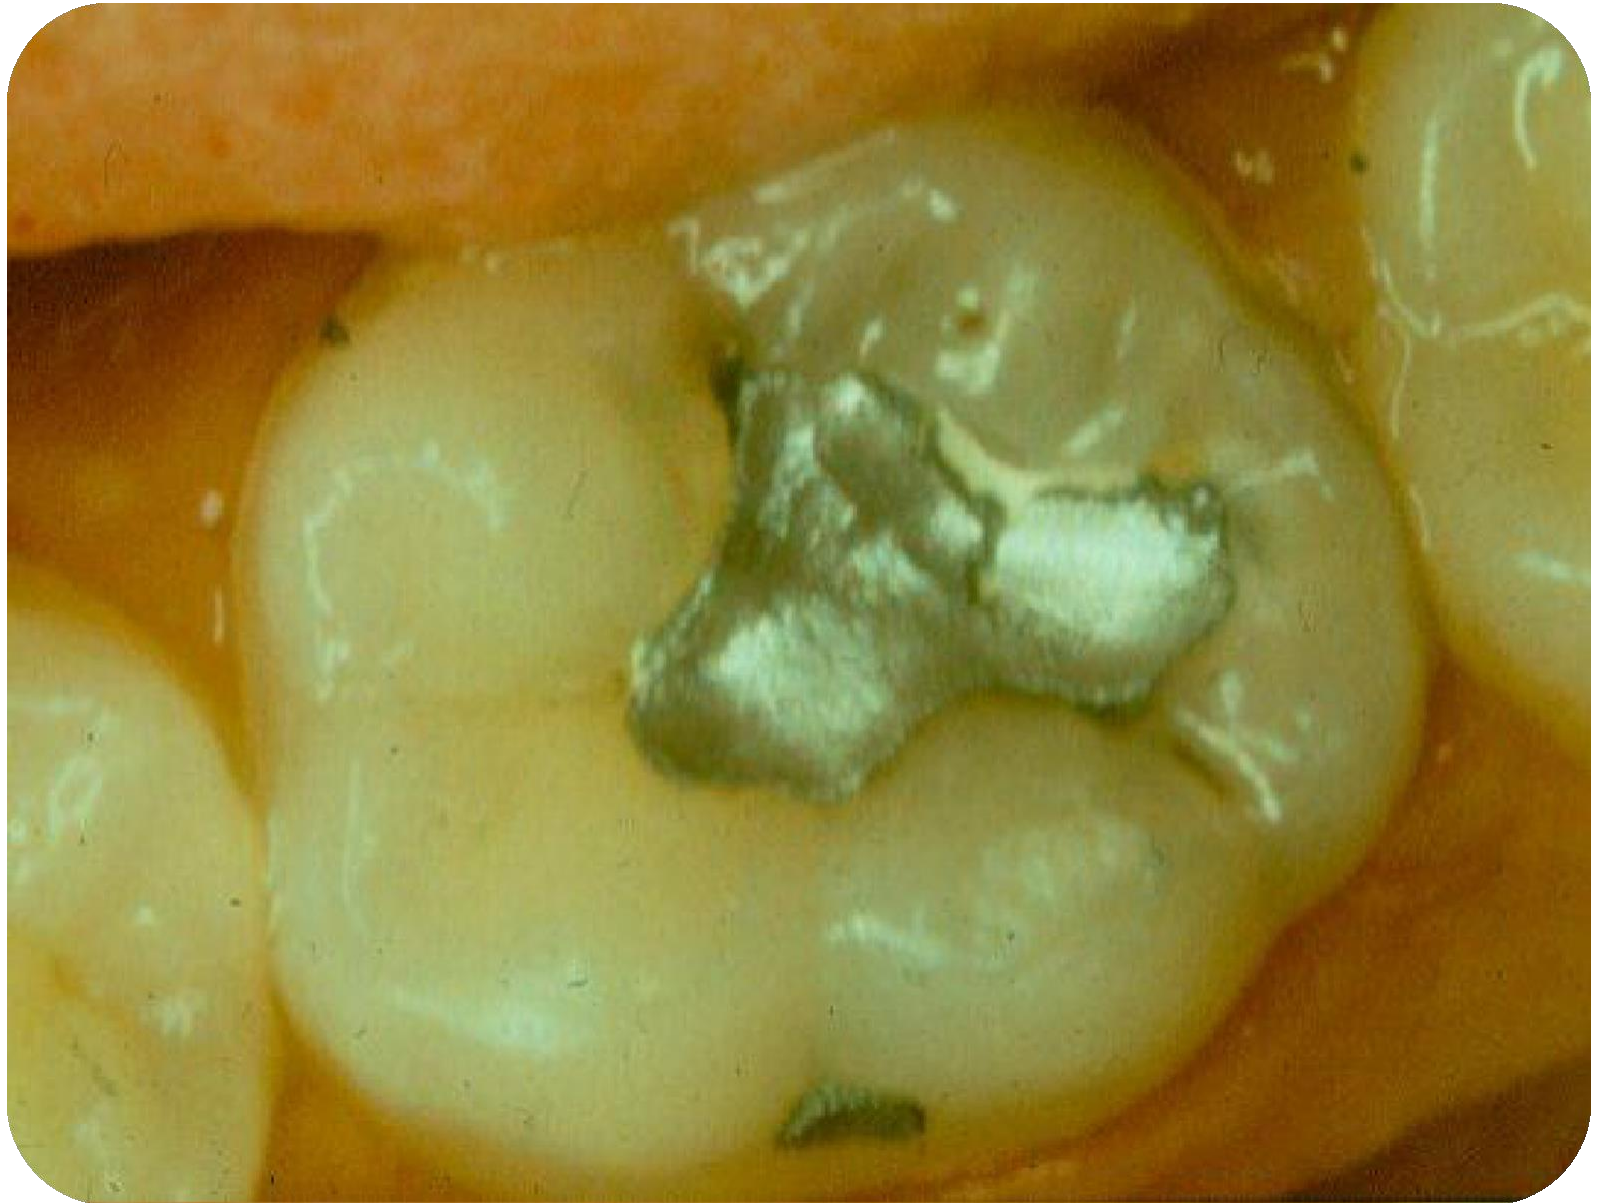
Surface code 4 – filled and decayed

- LL6 –occlusal surface is filled with amalgam.
- Amalgam is chipped and fractured to expose the cement lining.
- Lingual aspect of occlusal surface has creamy shadowing adjacent to the lost amalgam
- Secondary caries associated with the filling – code 4

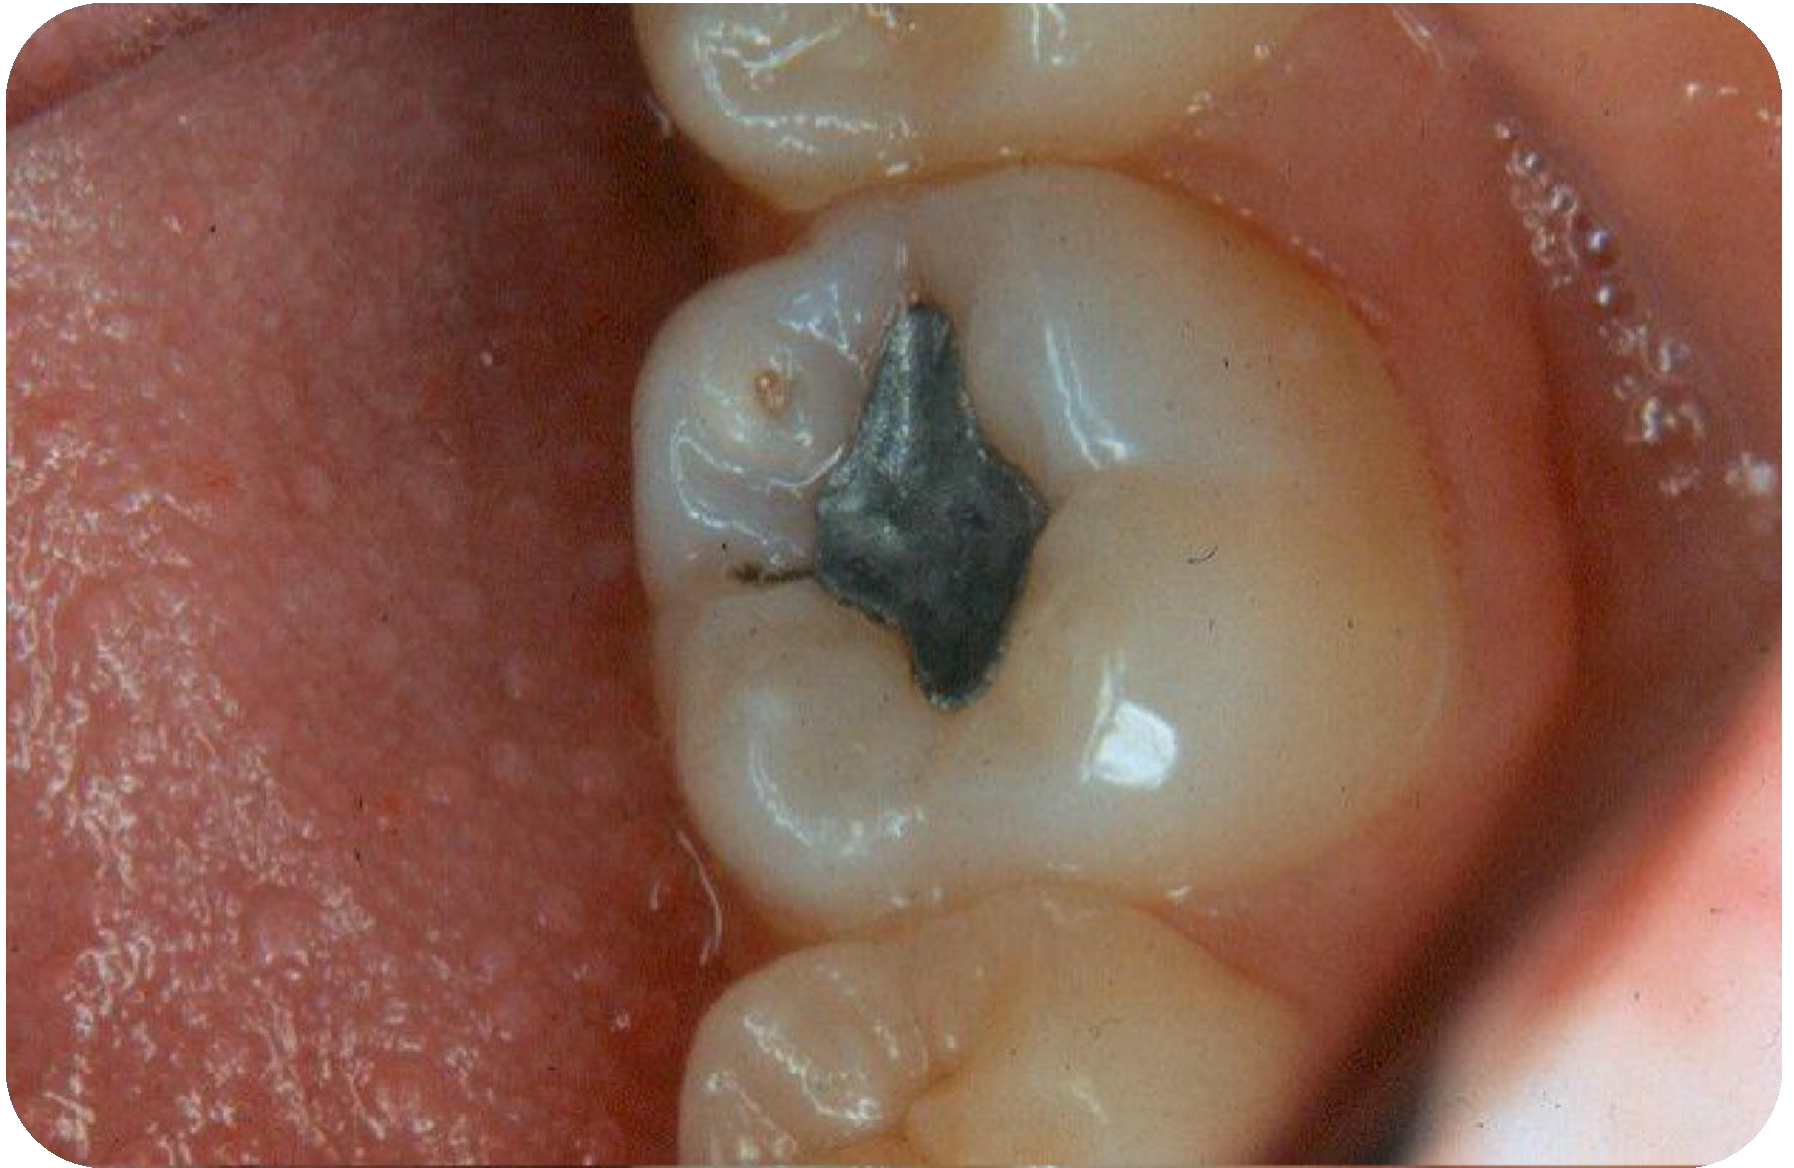
Surface code 4 – filled and decayed

- **LL6 –occlusal surface has an amalgam filling**
- **Filling is intact and there has been a separate second attack of caries on this surface**
- **There is a small cavitated area with a cream shadow beneath the enamel indicating the extent of the lesion into dentine**
- **Surface will be coded 4 – filled and decayed**

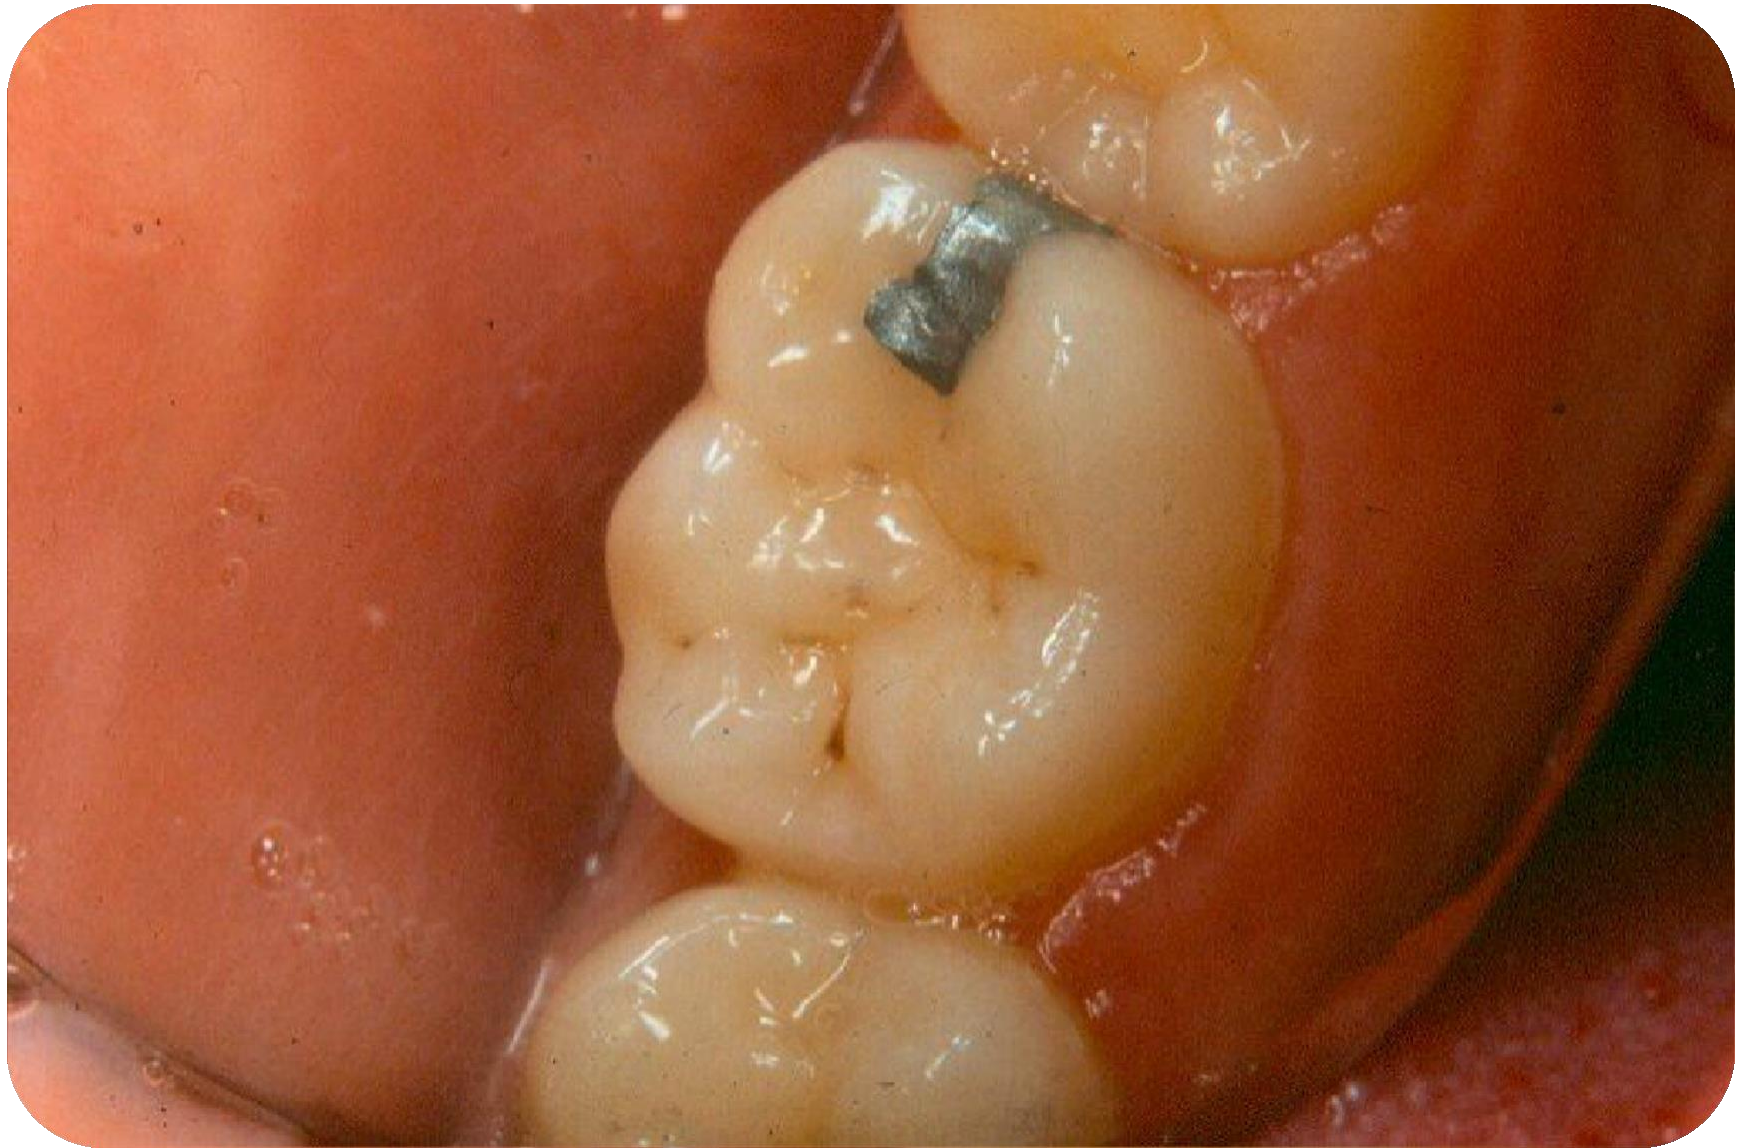
Surface code 5 – filled with no decay

- **LL6 –amalgam filling on the mesial and occlusal surfaces**
- **Filling is intact and there is no evidence of secondary caries.**
- **Occlusal fissure system has areas of staining only.**

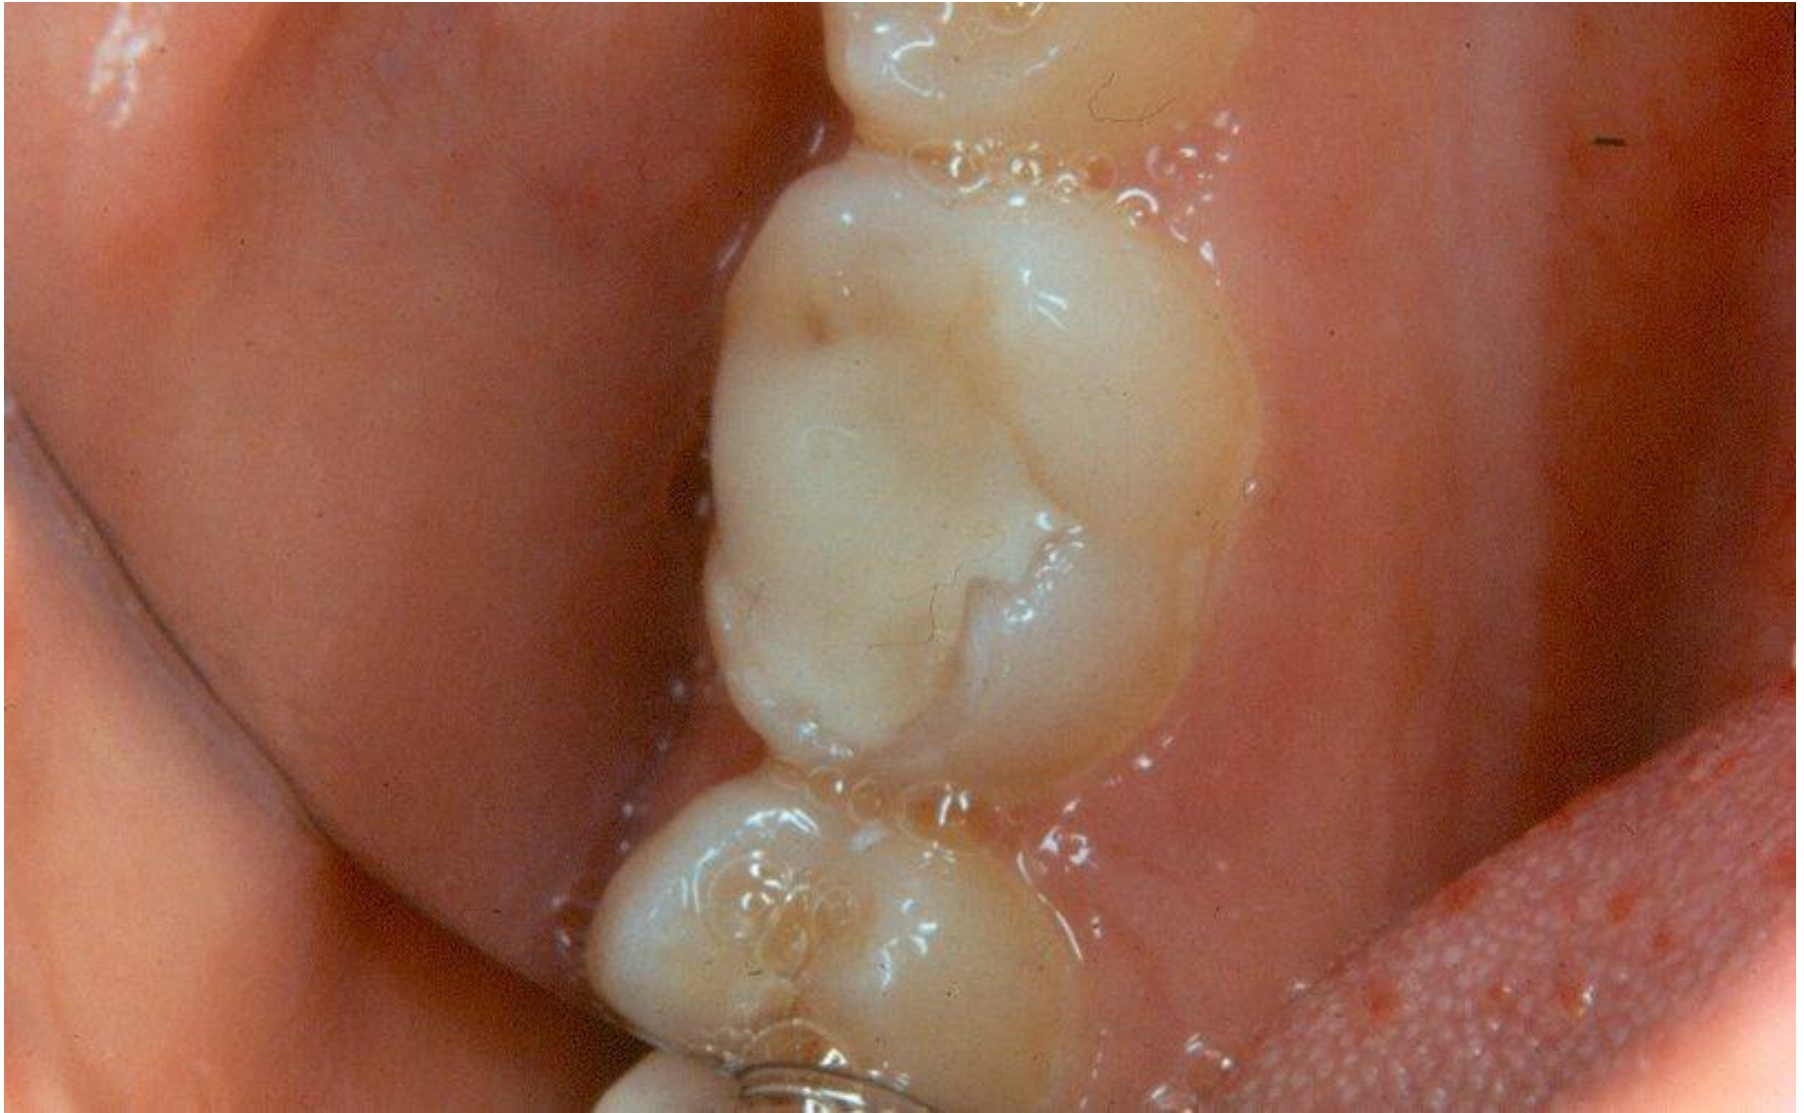
Surface code 5 – filled with no decay

- LR6 –occlusal surface has a conventional tooth coloured filling.
- No evidence of decay and filling appears intact.
- Occlusal surface will be coded 5.
- Filling extends on to buccal surface but from this view, no judgement could be made as to the state of the filling and this surface would need to be viewed and scored separately.

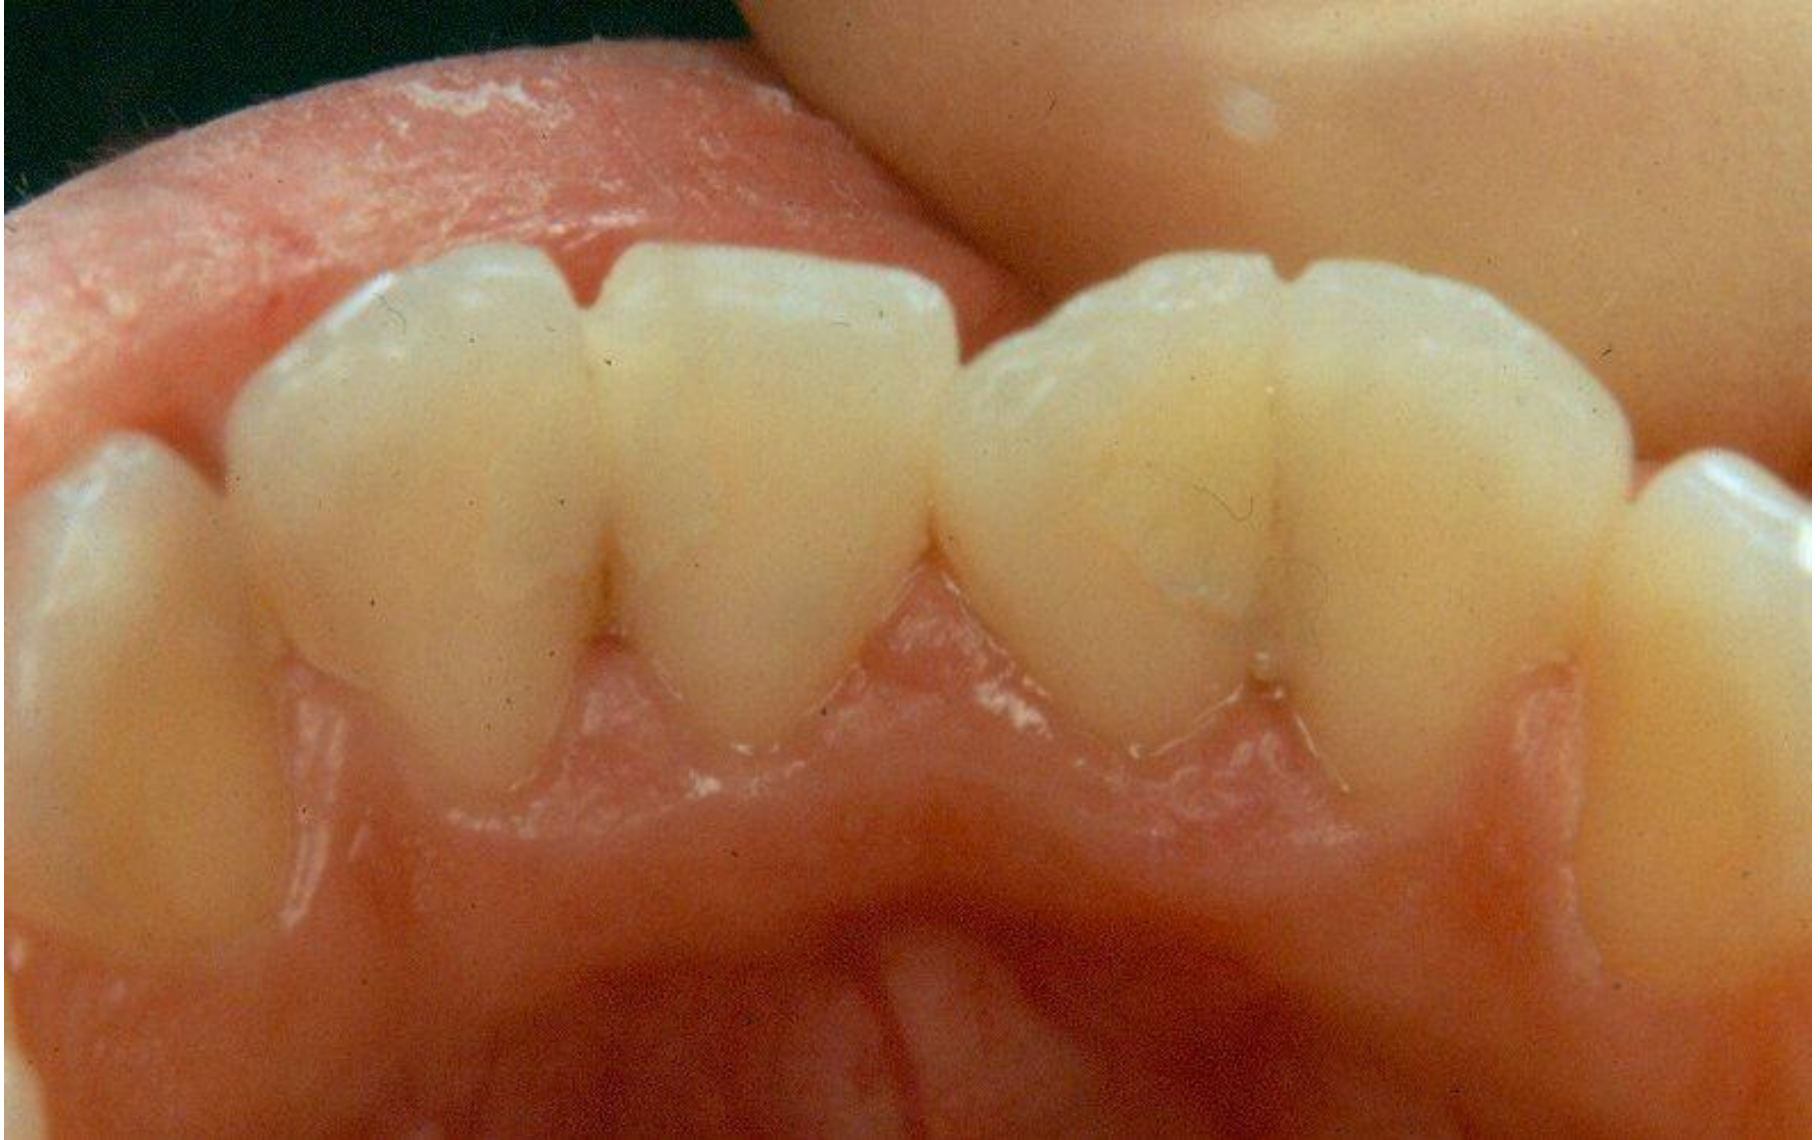
Surface code 5 – filled with no decay

- LR2, LR1, LL1 & LL2 – several intact tooth coloured fillings are present
- e.g. mesial of LL2, distal of the LL1, distal of the LR1.

NB This slide should be used to emphasise the need for a careful systematic examination to avoid missing tooth coloured fillings and the call of “3 to 3 all surfaces sound” should be discouraged.

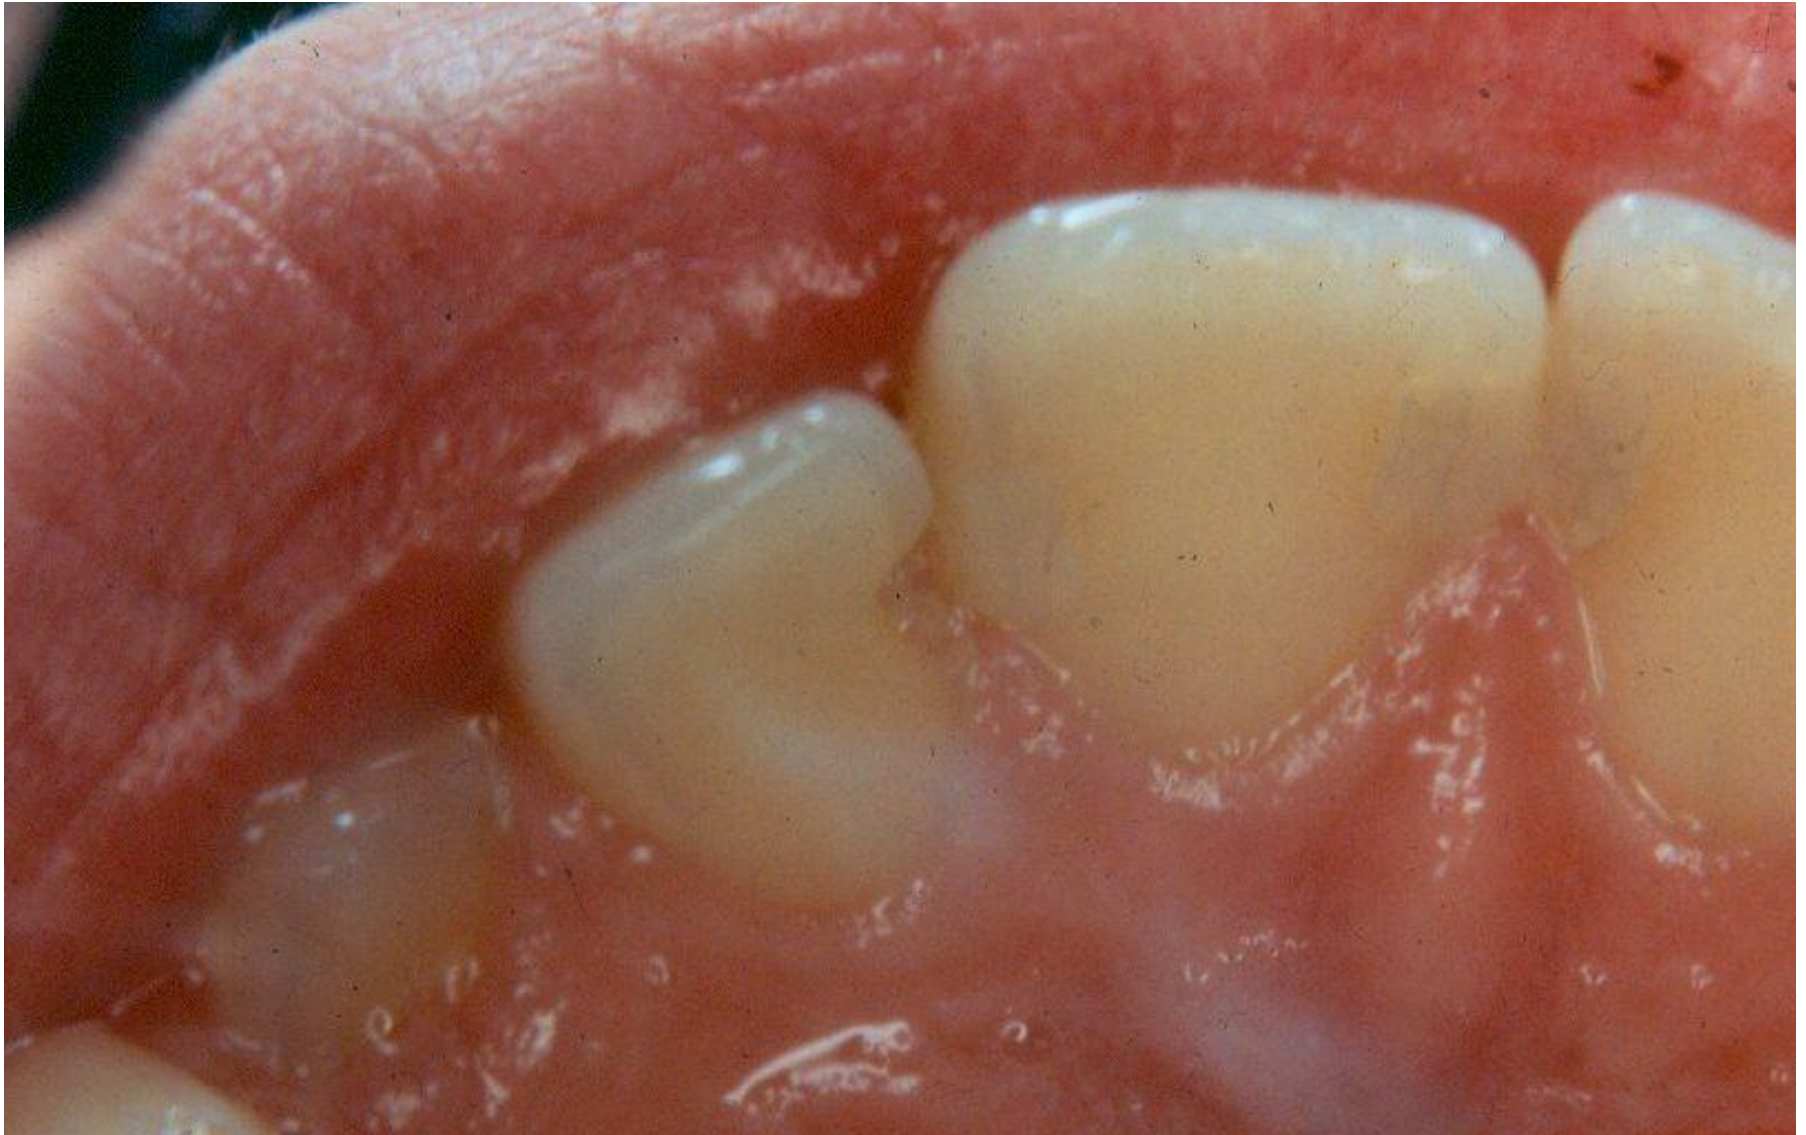
Surface code R – filled, needs replacing (not carious)

- UR2 –mesial surface has had a filling which is completely lost
- This is the most extreme form of a “defective” filling and would be scored as code R.
- Additional features on this slide:
- UR3 – all surfaces coded as sound.
- UR1 – has a composite restoration on mesial surface -careful examination is needed to avoid missing these restorations.

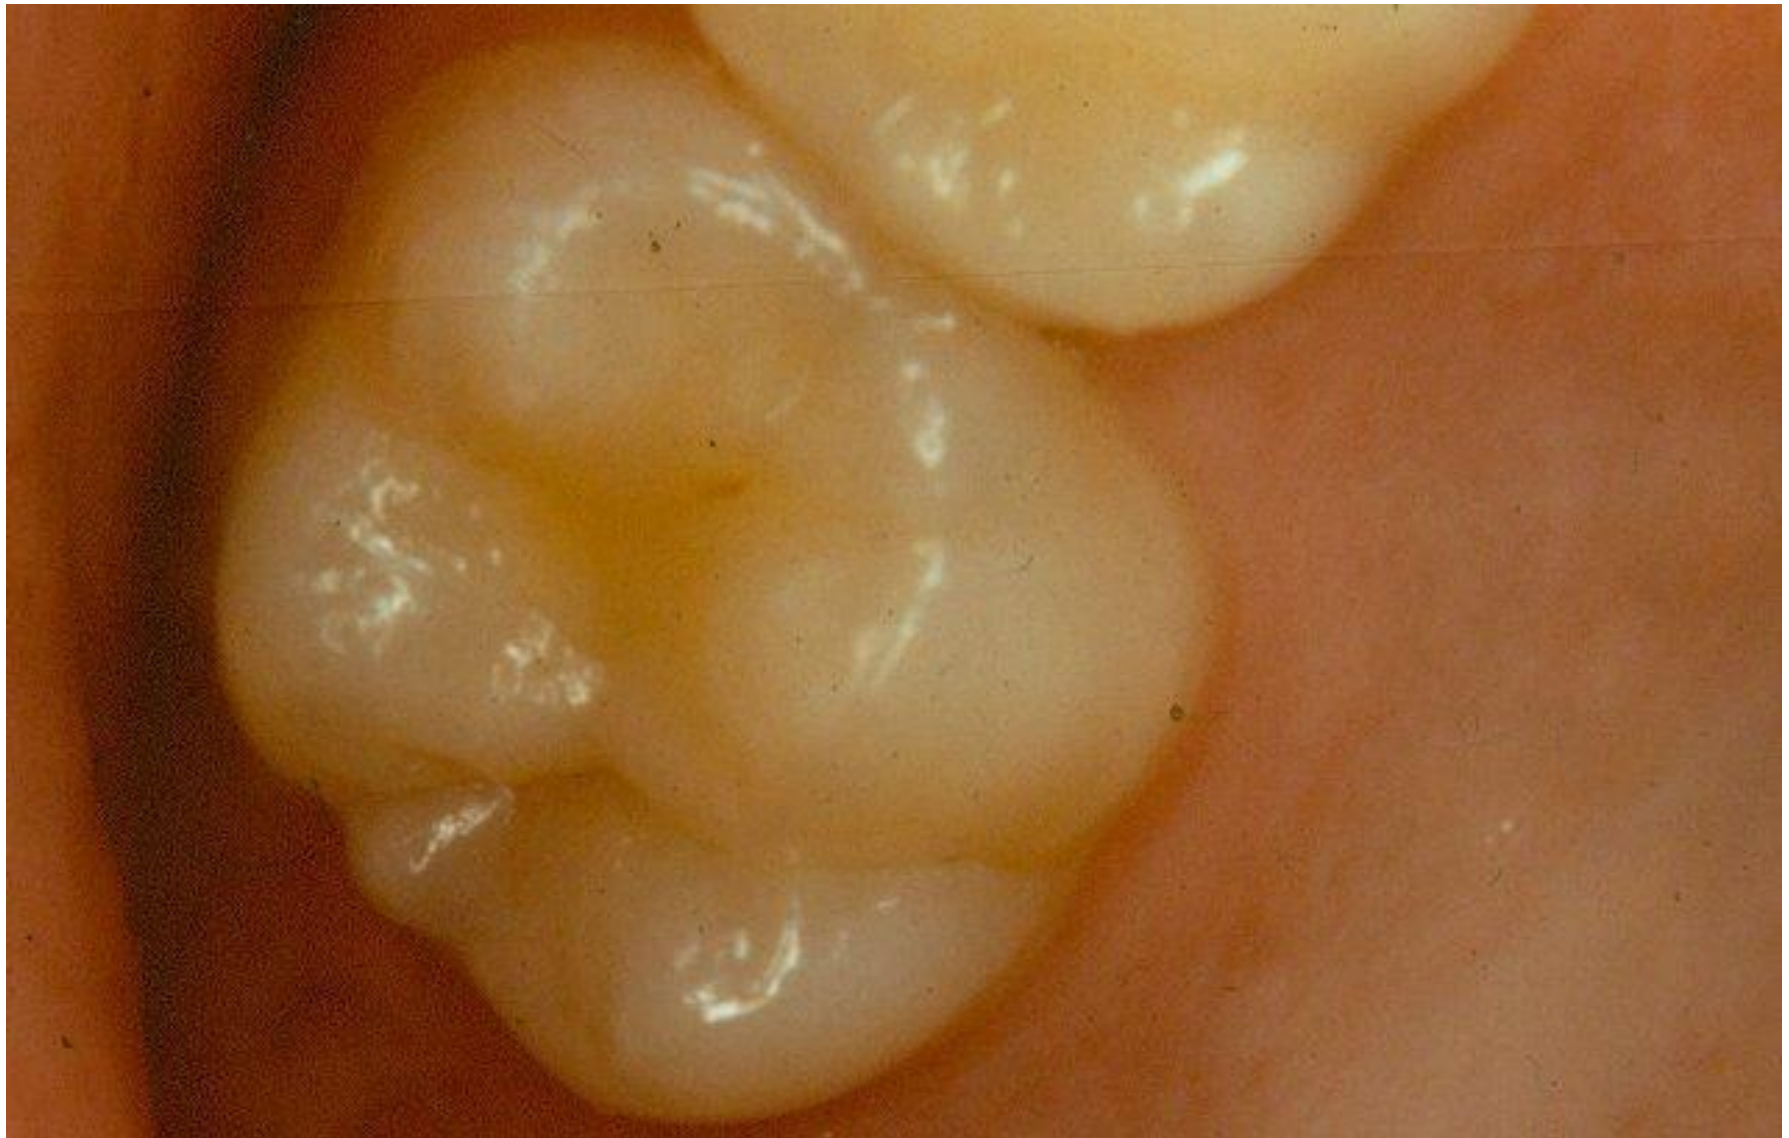
Surface code \$ - sealed surface, type unknown

- **UR6 –anterior part of the occlusal fissure has been sealed with a tinted sealant**
- **Surface would be coded \$**
- **Sealant appears to be lost from the posterior occlusal fissure.**

NB Sealants can be difficult to distinguish from enamel and diagnosis may be aided by the use of drying and/or tactile use of the ball-ended probe.
