BASCD Trainers' Pack for Caries Prevalence Studies

Updated: June 2014

*for UK Training & Calibration
exercise for the Deciduous Dentition*

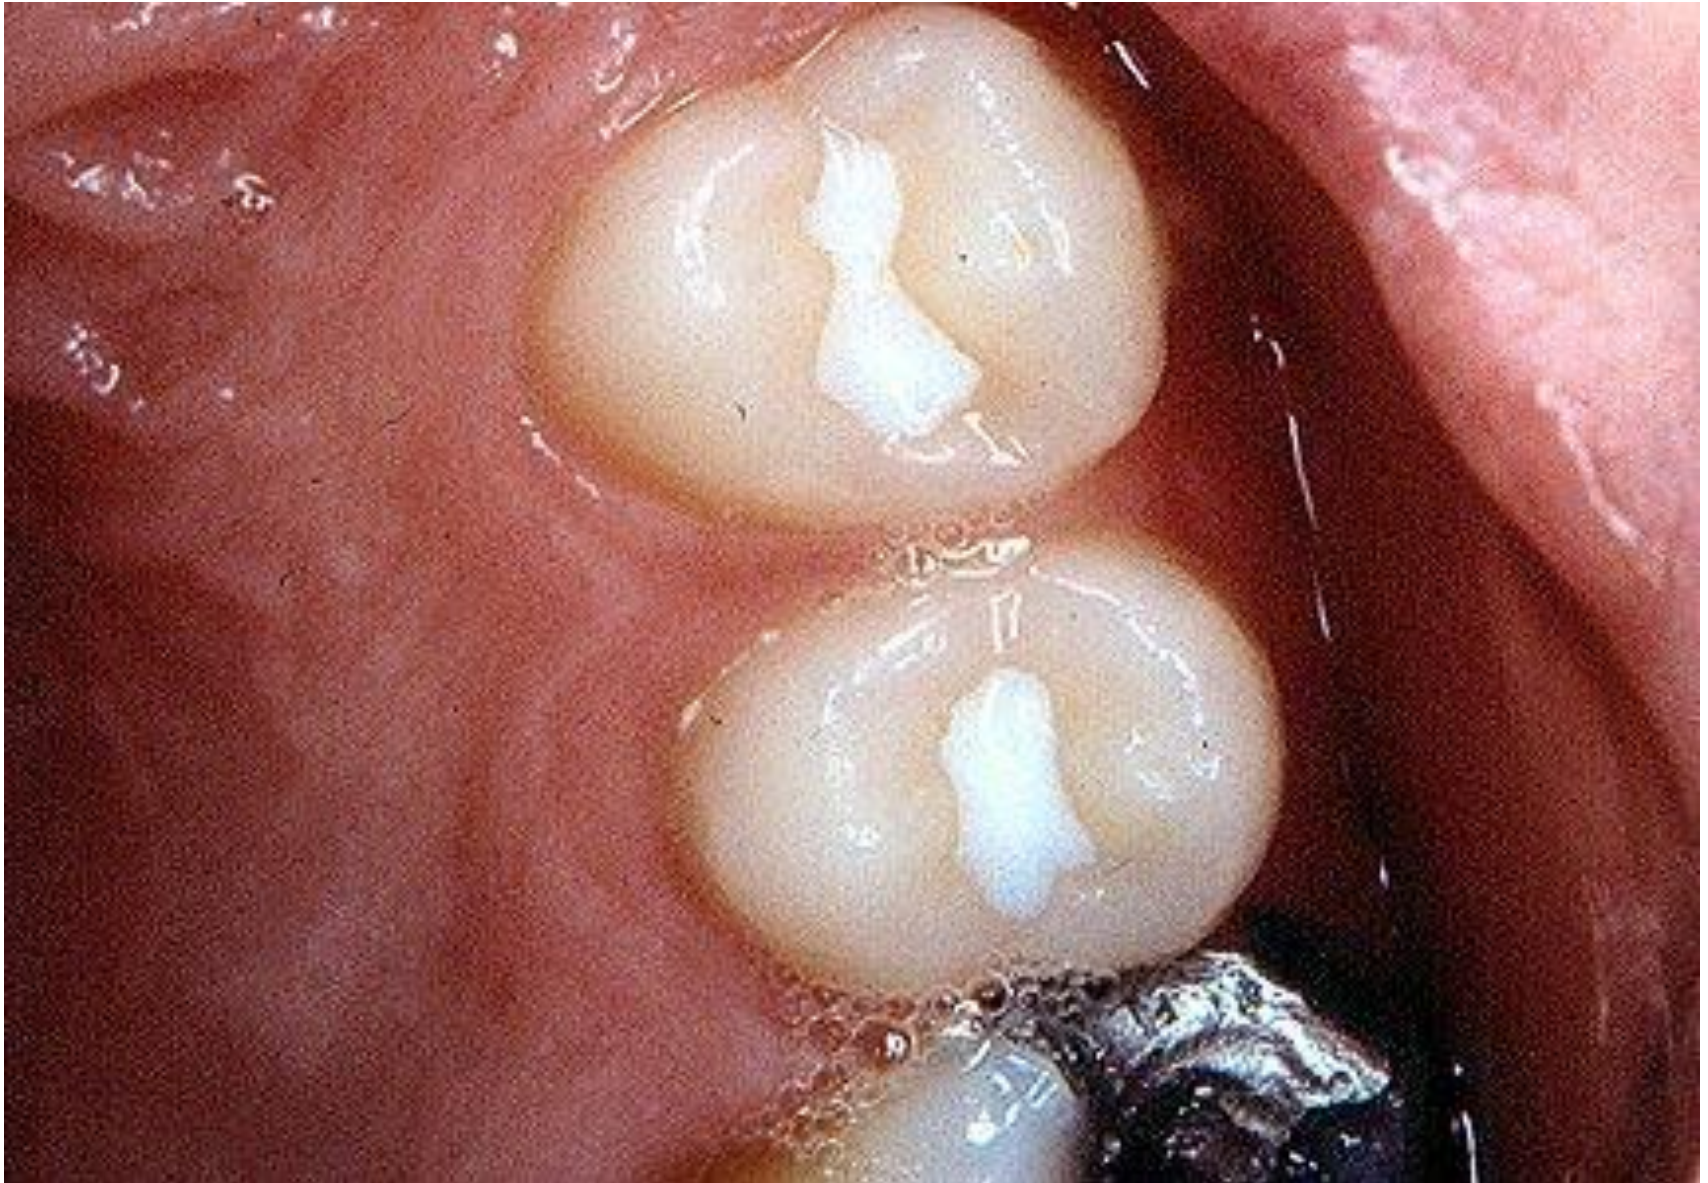
- **UL4 & UL5 –occlusal surfaces have been sealed**
- **Surfaces would be scored \$**
- **It is impossible to be certain from a visual examination that no caries was removed before placement of the sealant.**
- **However, there is no evidence of a defined cavity margin and therefore, the surfaces are coded \$.**

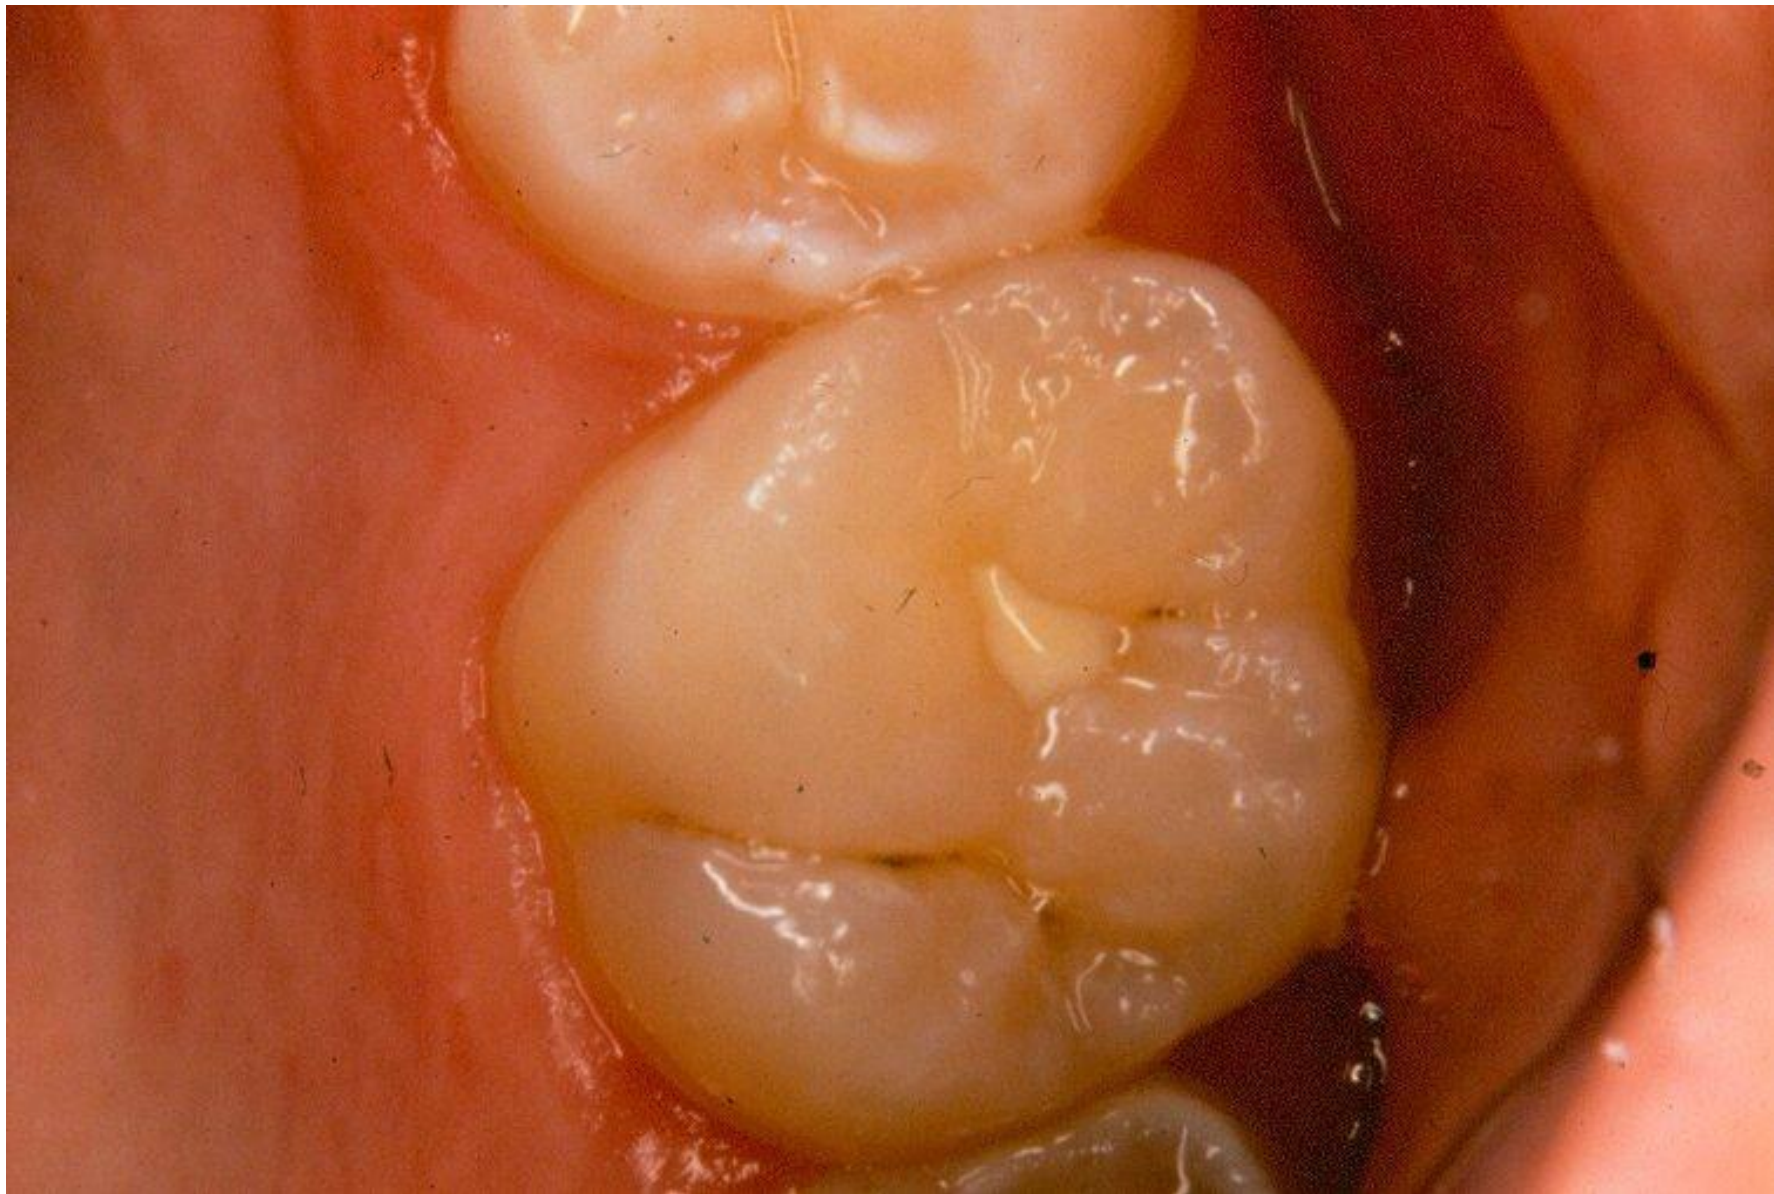
Surface code \$ - sealed surface, type unknown

- **UL6 –occlusal surface would be scored as \$ because there is evidence of a sealant in part of the anterior fissure**
- **In the distal part of the occlusal fissure, staining is evident**
- **However, there is no evidence of caries into dentine and occlusal surface would therefore be scored as \$.**

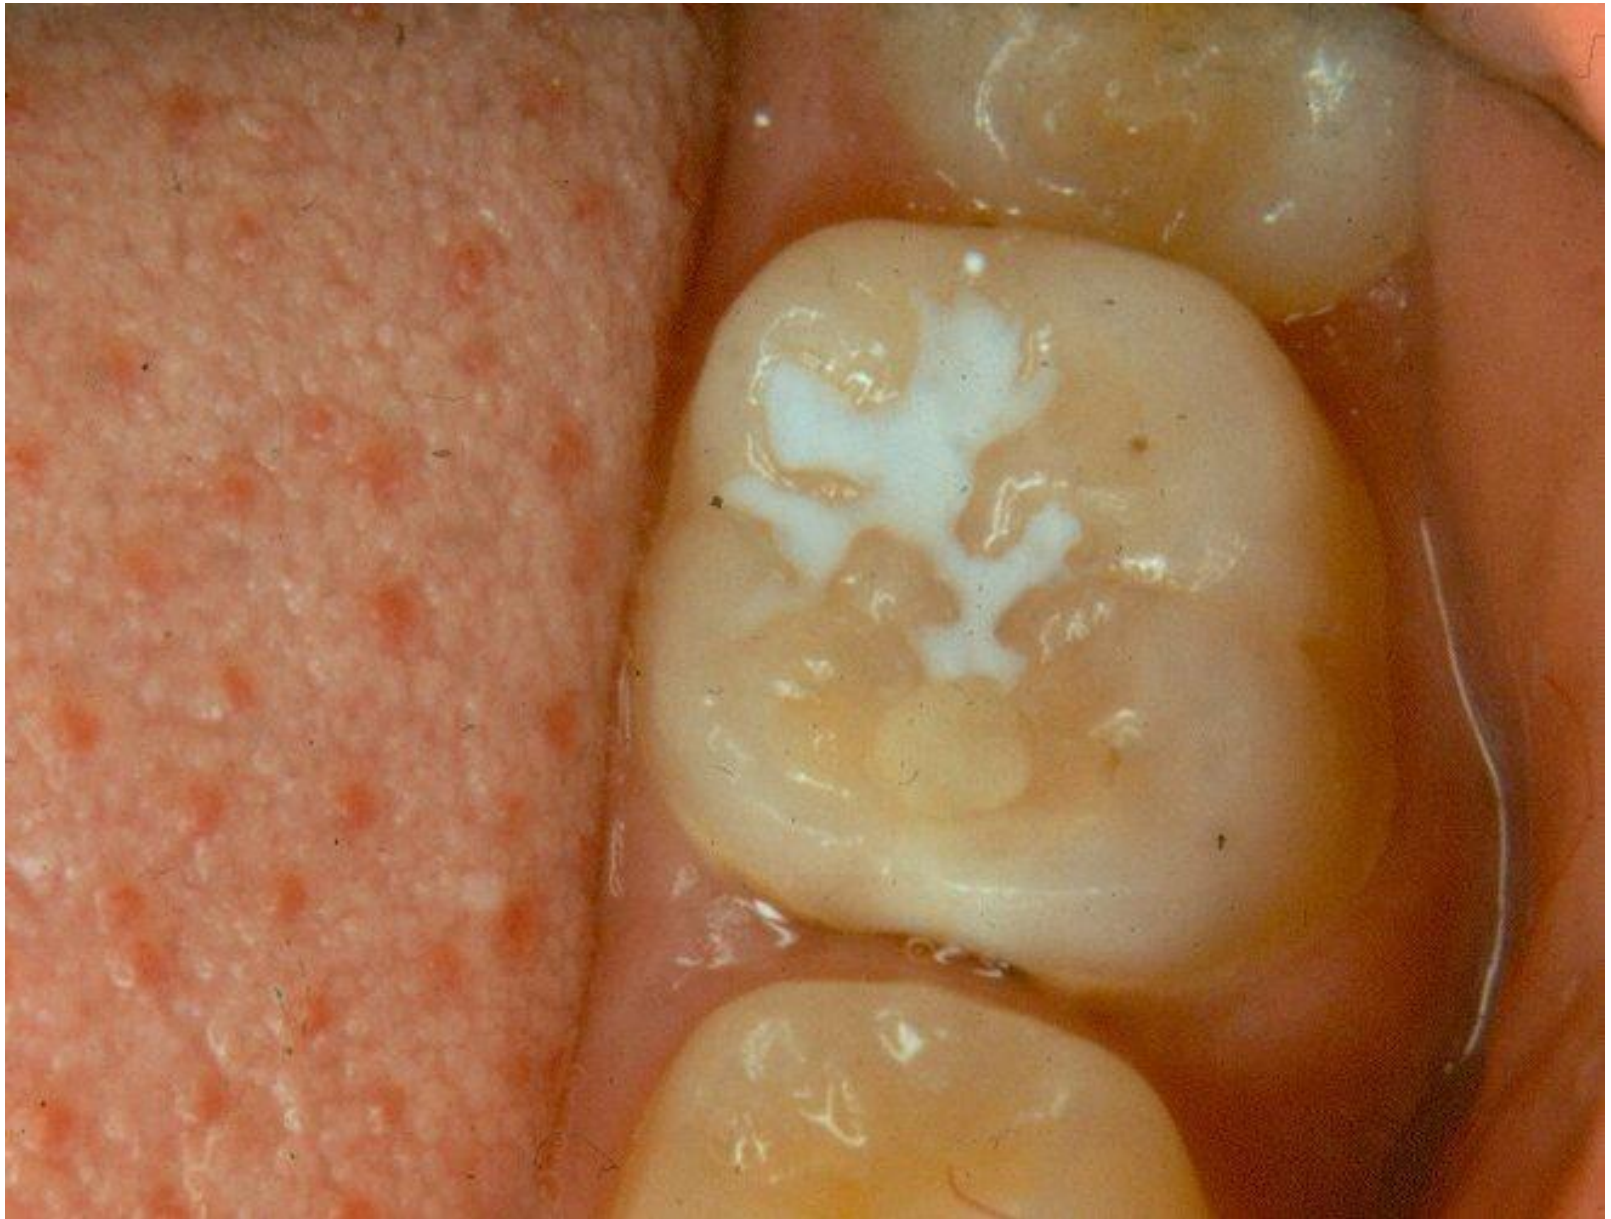
Surface code N – obvious sealant restoration

- **LL6 –occlusal surface has a sealant restoration**
- **Anterior part of occlusal fissure has a tooth coloured filling material which has been placed and there is evidence of a defined cavity margin.**
- **The rest of the fissure system is sealed.**

NB Mesial surface has a carious lesion into dentine and would be scored as 2. Lesion presents as cream shadow beneath the enamel extending from the marginal ridge. Physical cavitation can be seen at base of lesion on the mesial aspect.

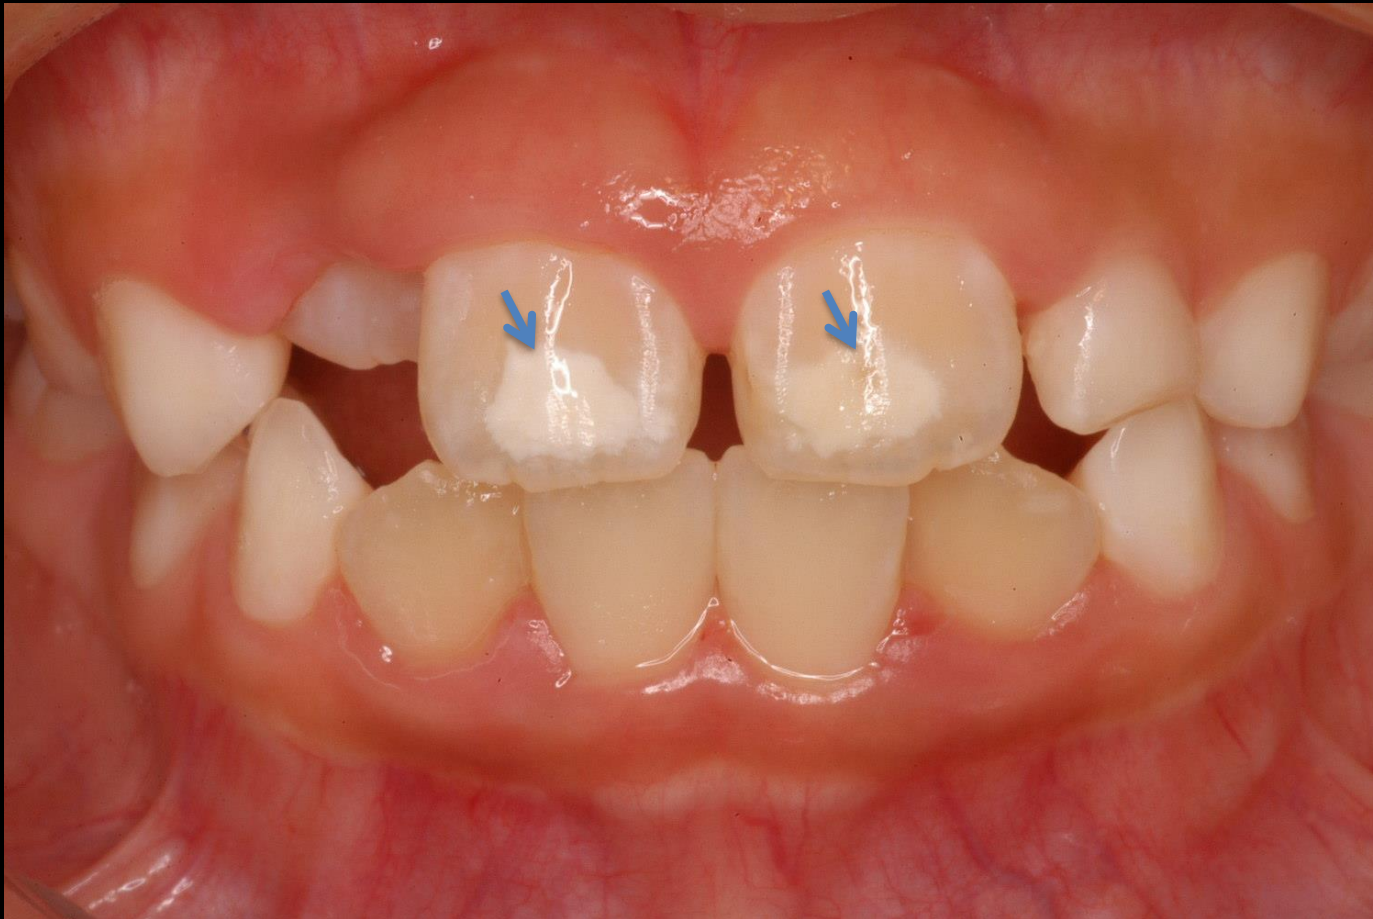
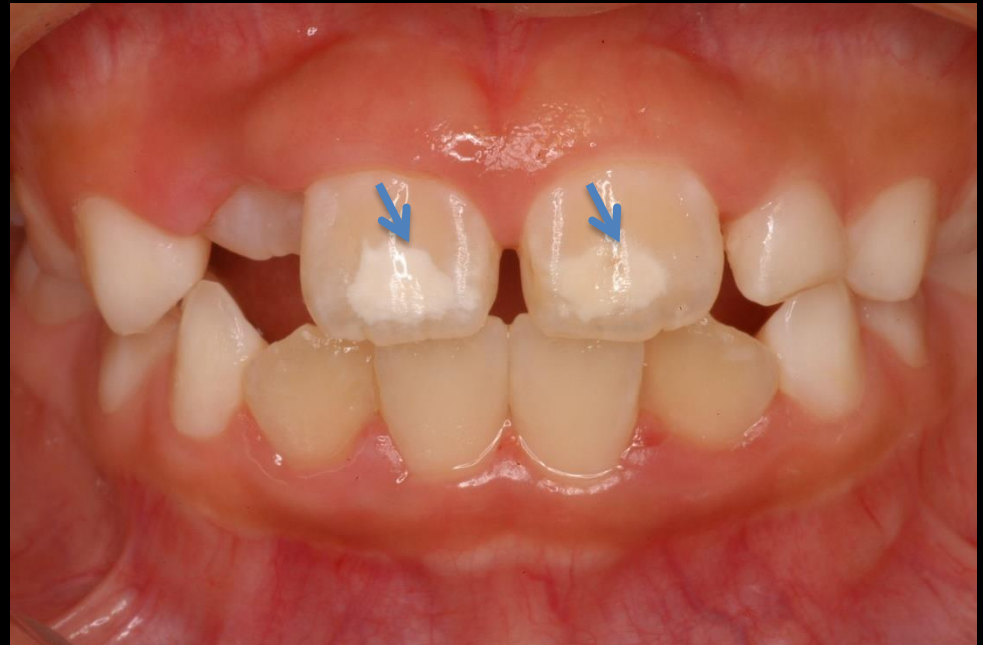
Mouth code - enamel caries absent

The arrows are pointing to developmental defects of the enamel. They are positioned in areas of the tooth surface which would not typically be prone to caries. In the absence of enamel caries in the rest of the teeth, the mouth should be coded as no enamel caries

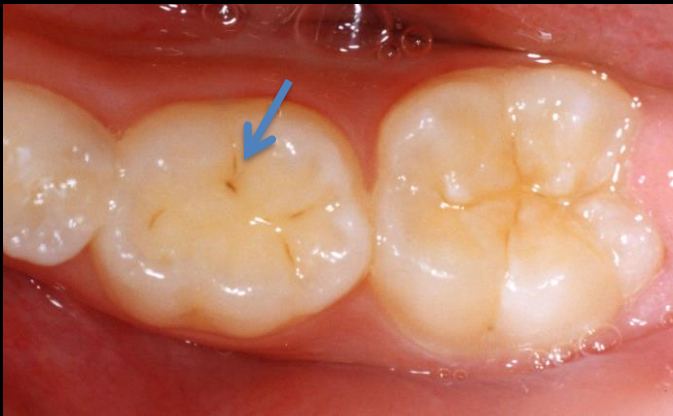
All the arrows are pointing to enamel caries lesions which have picked up dietary staining and are brown. The mouth should be coded as enamel caries present.

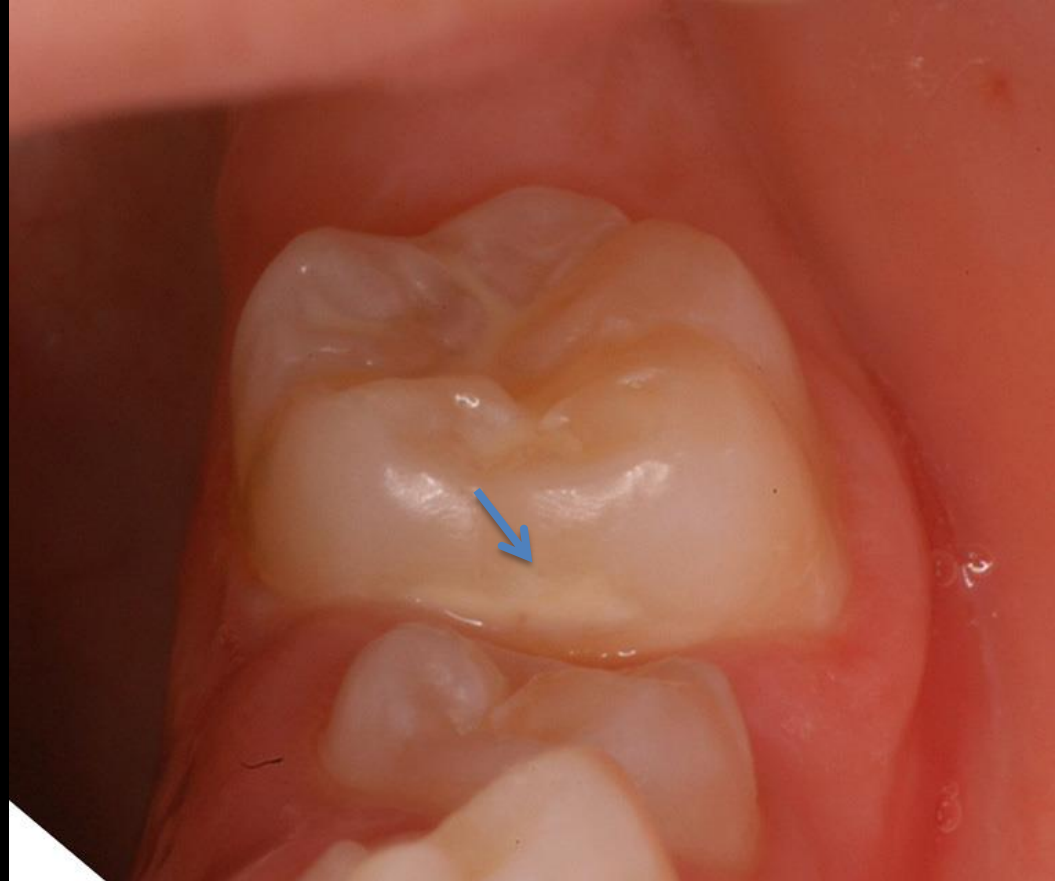
The arrow is pointing to enamel caries. This approximal location beneath the contact area is prone to caries and more easily seen when there has been loss of an adjacent tooth. The mouth should be coded as enamel caries present

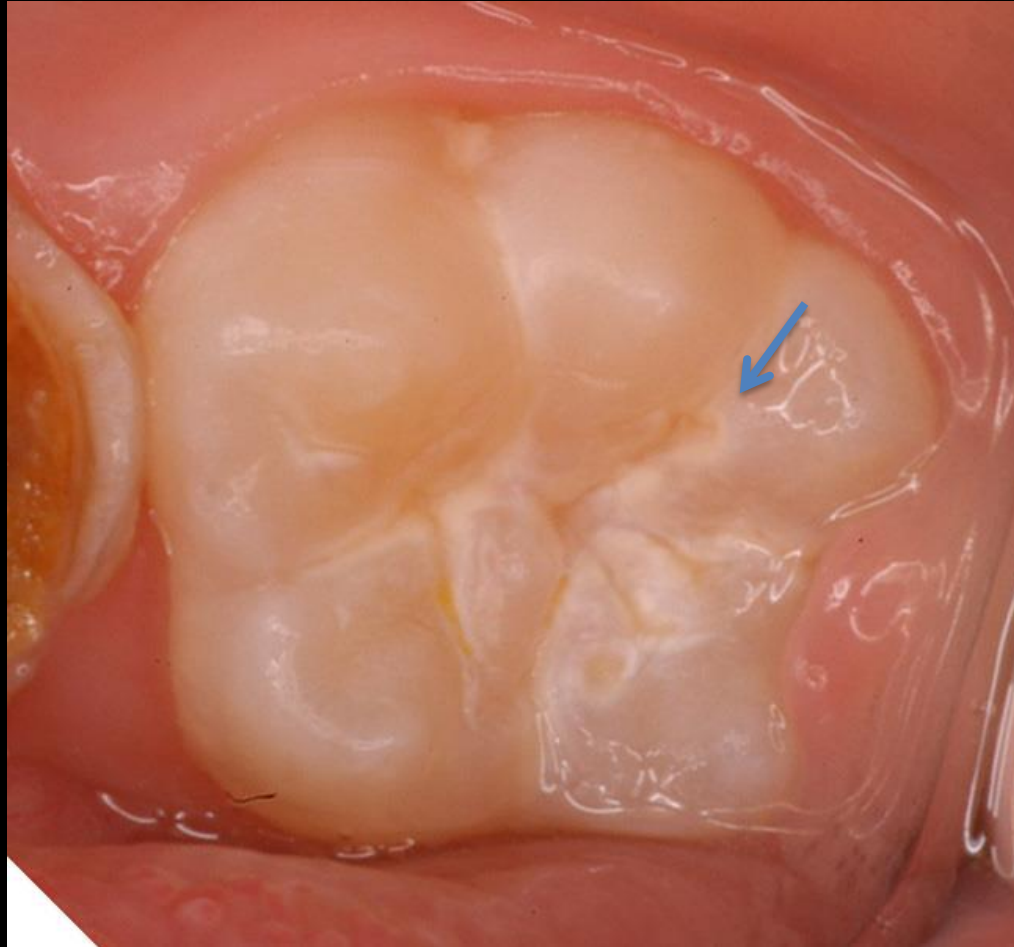
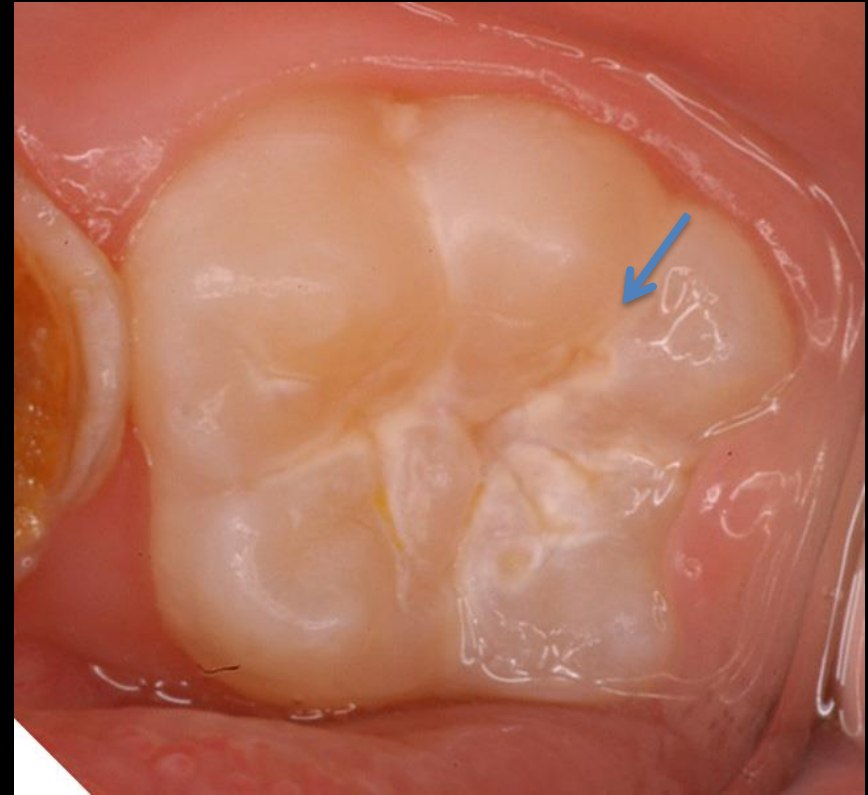
Mouth code - enamel caries present

The arrow is pointing to enamel caries. You can see that the white spot lesions are in and around the pits and fissure areas where plaque has accumulated over time in an erupting tooth. Enamel caries always forms where plaque has been left alone for a while. The mouth should be coded as enamel caries present

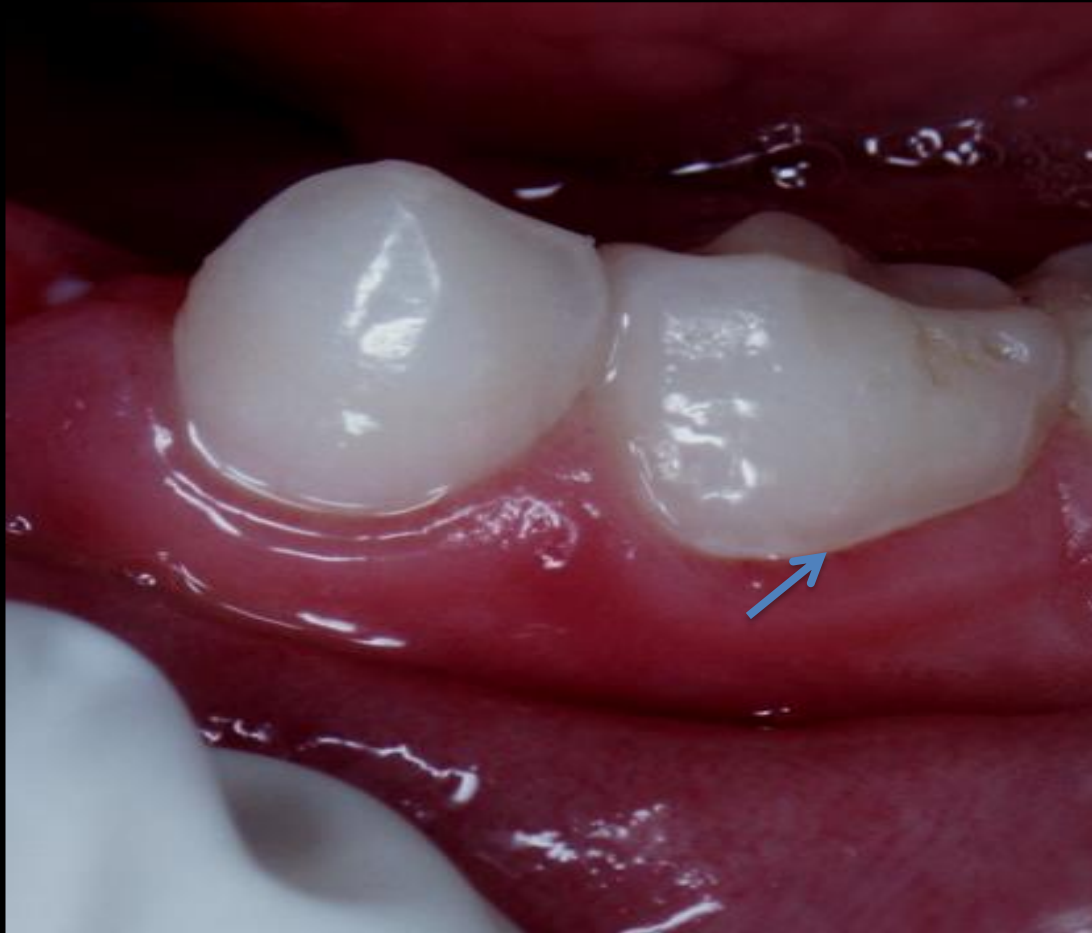
The arrow is pointing to enamel caries at the gingival margin, another area prone to plaque accumulation. Enamel caries is often seen along with marginal gingival inflammation.

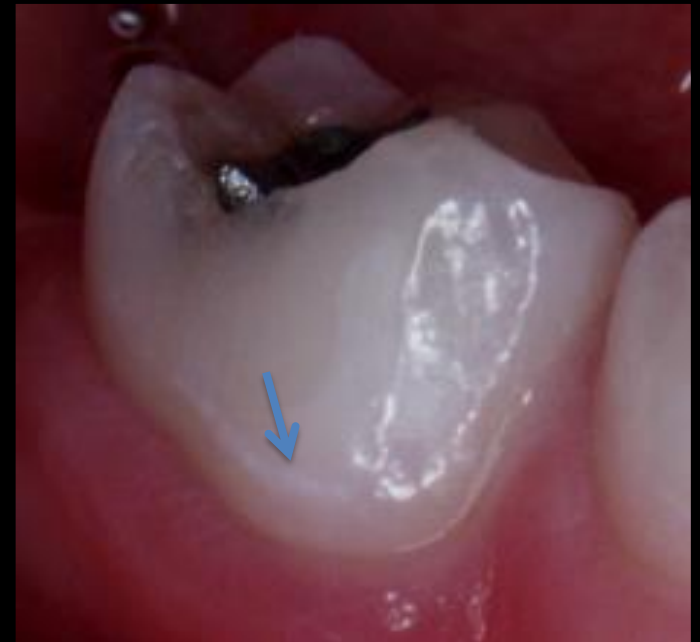
Arrested enamel caries.

In this photograph, the white line is a 'scar' on the tooth from earlier enamel caries when the tooth was not fully erupted.

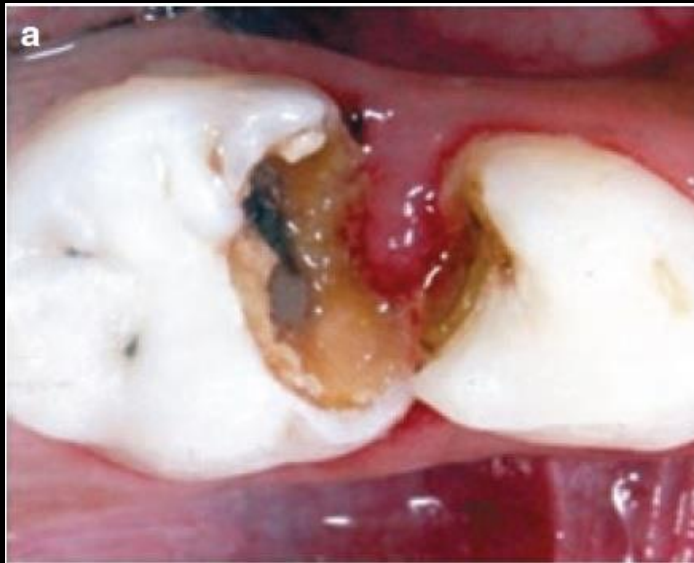
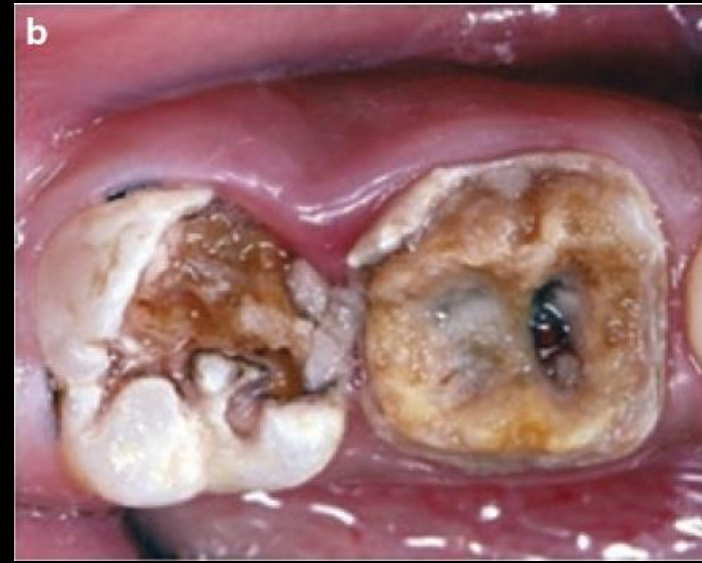
pufa - Pulp

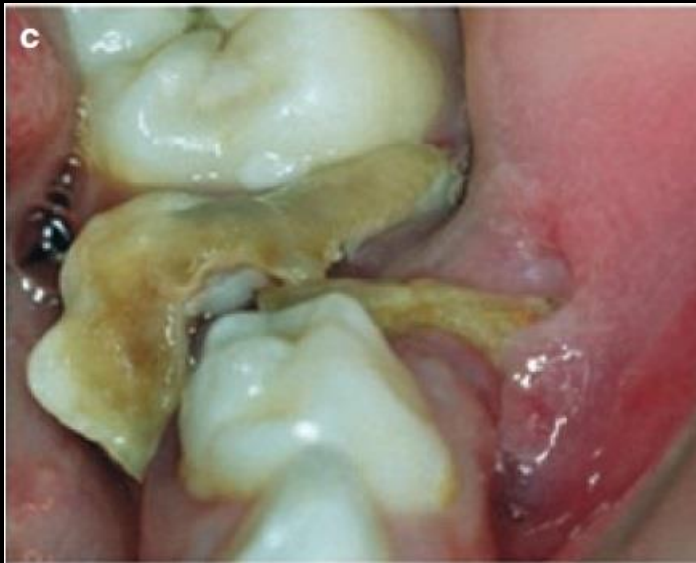
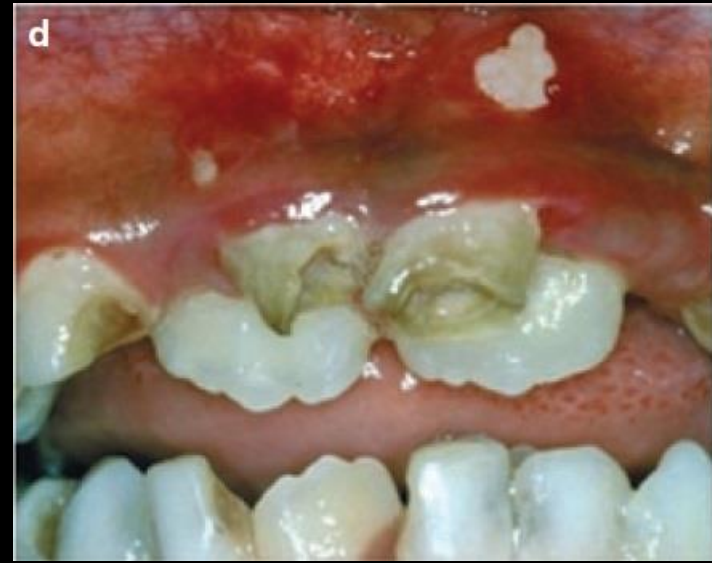
pufa - Ulceration

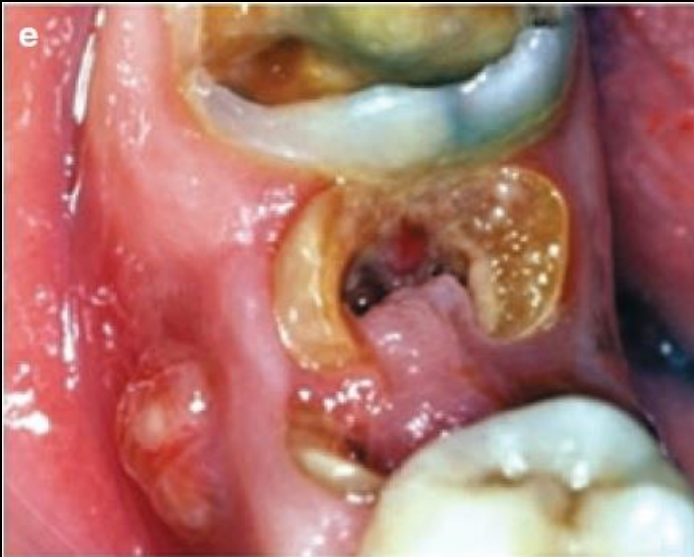
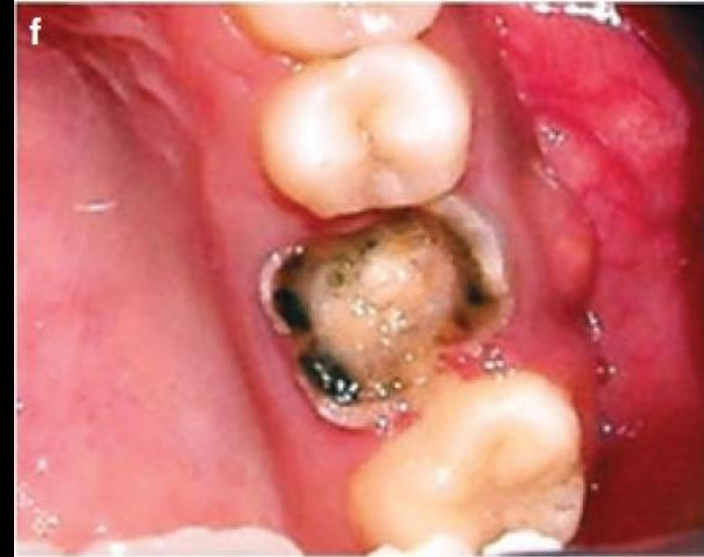
pufa - Fistula

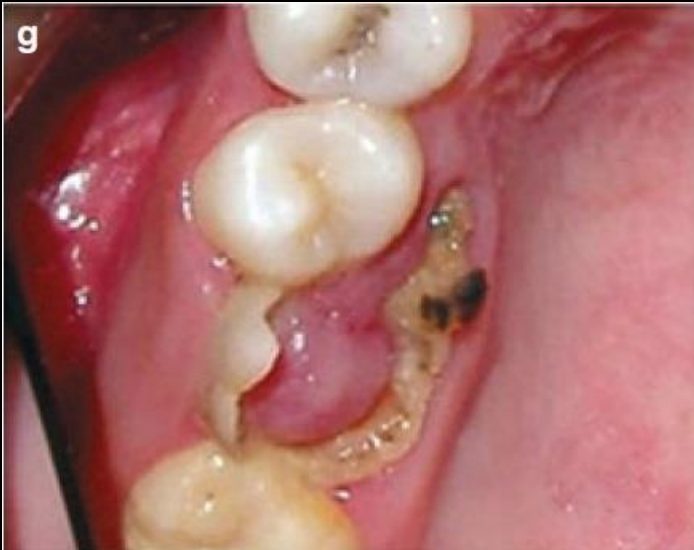
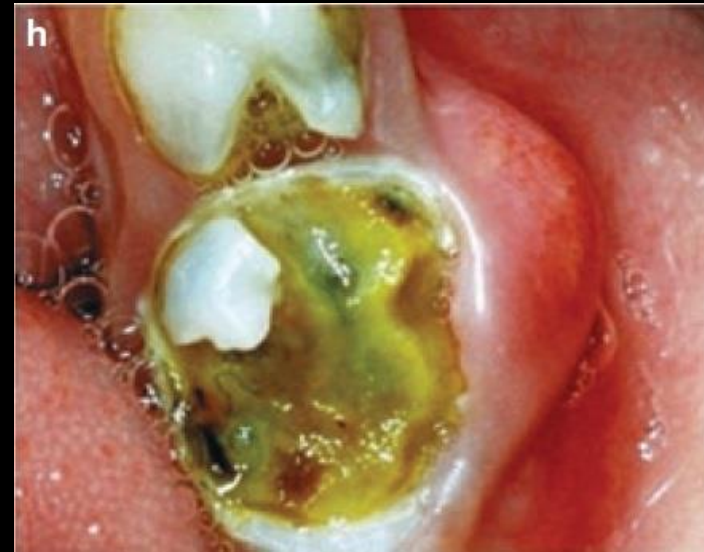
pufa - Abccss
